시험 성적서

TEST REPORT

시험 성적서 번호 Report No.		ICRT-TR-R180106-0A	
신청자 Client	기관명 Name	Hanwha Techwin Co., Ltd.	
	주 소 Address	Hanwha Techwin R&D center, 6 Pangyo-ro 319Beon-gil, Bundang-gu, Seongnam-si, Gyeonggi-do, 13488 KOREA	
시험대상품목 Sample description		Network Camera	
모델명 Type designation		XNV-6081Z	
정 격 Ratings		-	
시험기간 Date of test		2018. 10. 18 ~ 2018. 10. 19	
시험방법/항목 Test Method/Item		ISO 20653 : 2013 (IP6K9K)	
시험결과 Test Results		Reference to see Table 3), on page 8	
확 인 Affirmation	작성자 Tested by	기술책임자 Technical Manager	
	성 명 권 상 혁 Name S. H. Gwon	성 명 이 한 국 Name H. K. Lee	
<p> <input type="checkbox"/> 위 성적서는 고객이 제공한 시료에 대한 시험결과이며, 용도 이외의 사용은 금합니다. This is certified that the above mentioned products have been tested for the sample provided by customer and forbid the use except for original purpose. </p> <p> <input type="checkbox"/> 위 성적서는 한국인정기구(KOLAS)인정과 관련이 없습니다. The above test report is not related to accreditation by Korea Laboratory Accreditation scheme. </p> <p> <input type="checkbox"/> 위 성적서는 주식회사 아이씨알의 승인 없이는 복제 및 재발급이 금지됩니다. No part of this document may be duplicated or reproduced by any means without the express written permission of the ICR. </p>

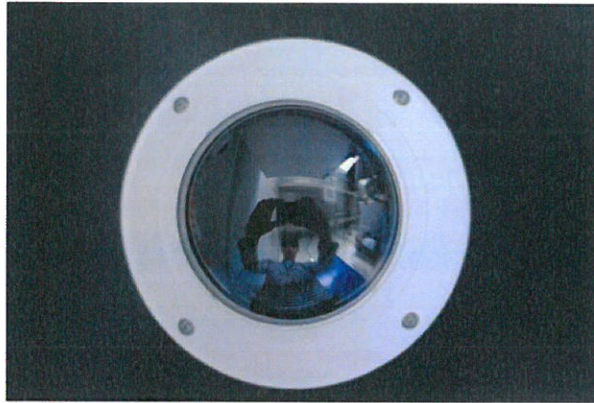
Fig. 1) Photo of the specimens

대표모델	파생 모델명	인증시험
XNV-6081Z	XNV-8081Z, XNV-6081, XNV-6081R, XNV-8081R, PNV-A6081R, PNV-A9081R, XNV-8082R, XNV-9082R, XNV-6081RE, XNV-8081RE,	IP6K9K

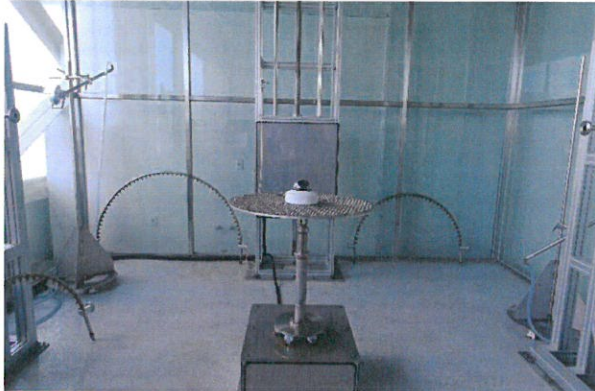
Figure 4) Photo of the specimen set up

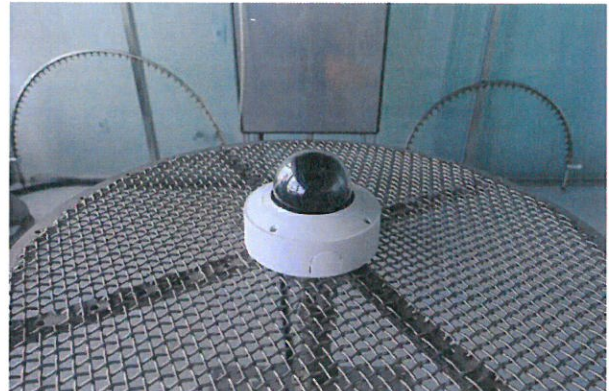
Figure 5) Photo of the specimen set up (enlarge)

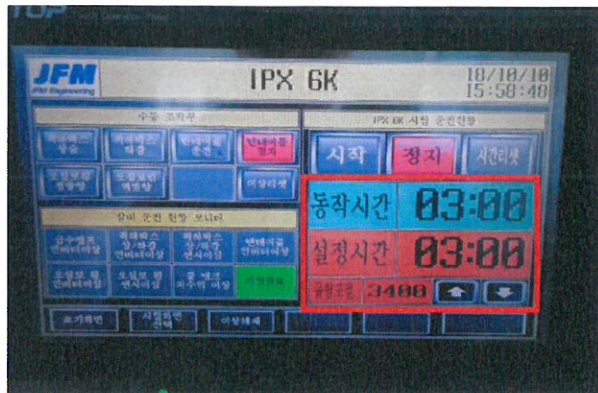
Figure 8) Photo of the test condition
(Test time)

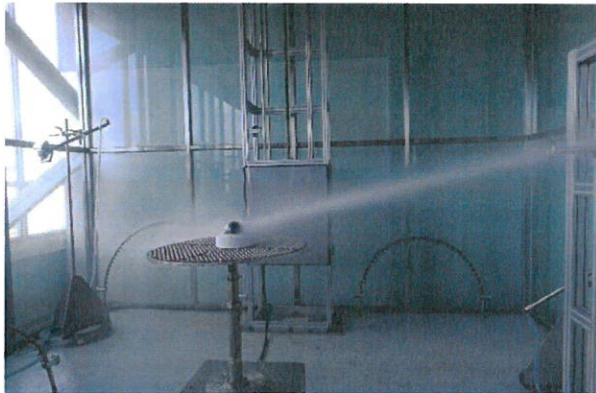
Figure 10) Photo of the specimen set up
(During the test)

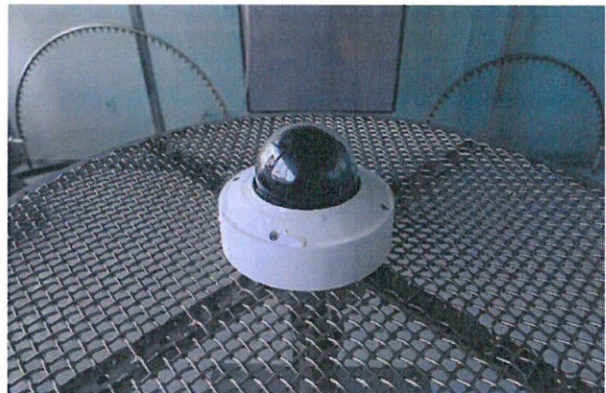
Figure 11) Photo of the specimen set up
(After of the test)

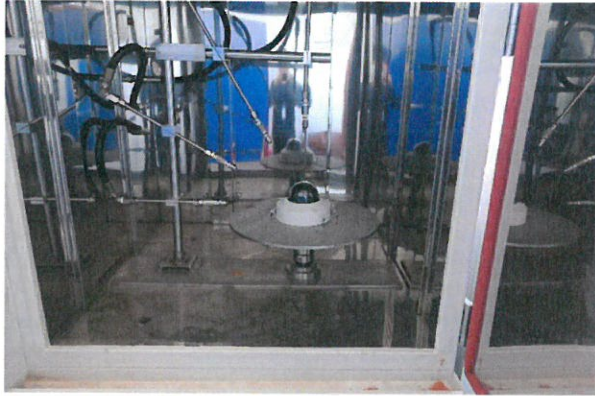
Fig. 12) Photo of the test set up

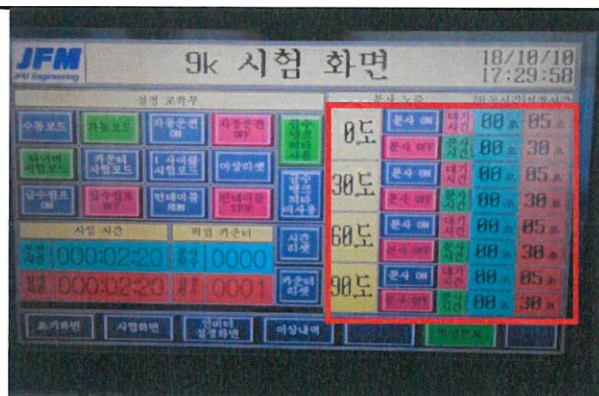
Fig. 18) Photo of the test condition
(Exposure time - 30 s per position)

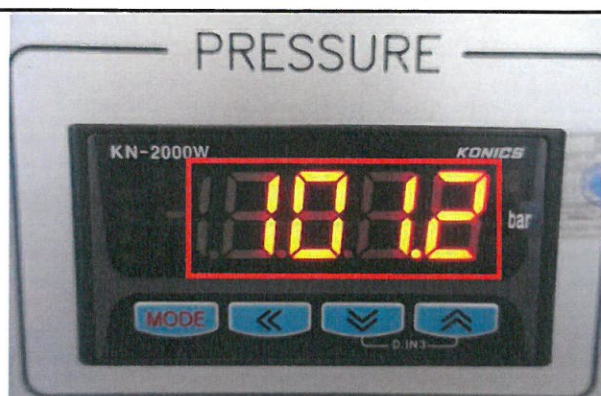
Fig. 19) Photo of the test specimen set up
(Water pressure)

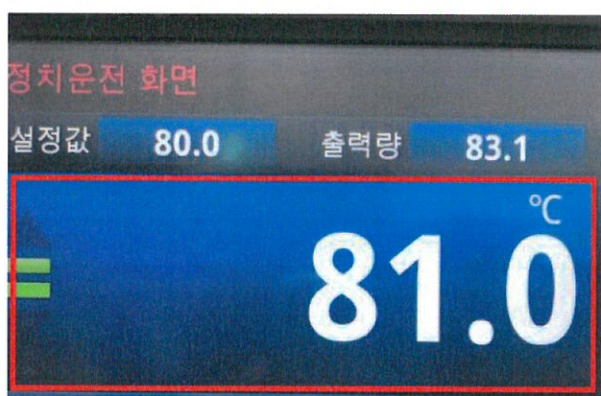
Fig. 21) Photo of the test specimen set up
(Water temperature)

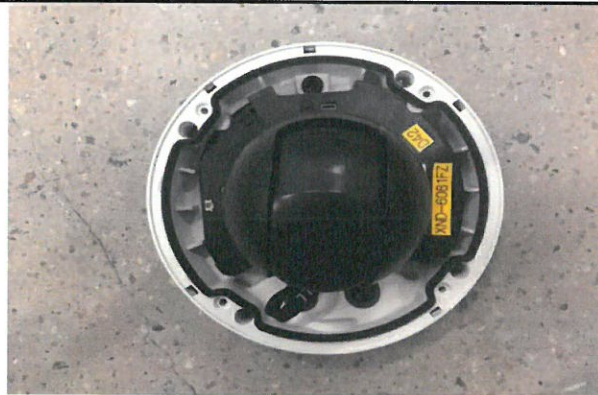
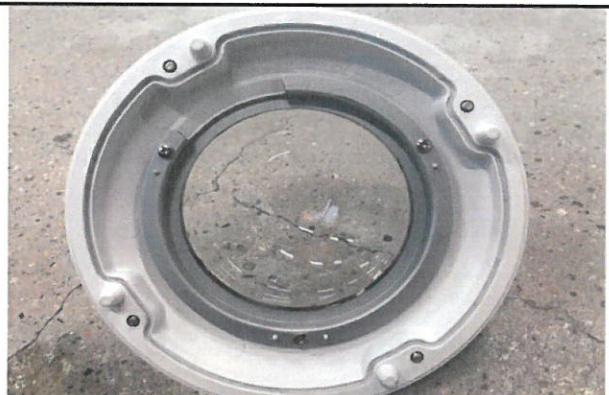
Fig. 23) Photo of specimen after the test

Fig. 24) Photo of specimen after the test

Test name	Test result	Note
IPX6K	No water penetrated inside the tester	Visual inspection
IPX9K	No water penetrated inside the tester

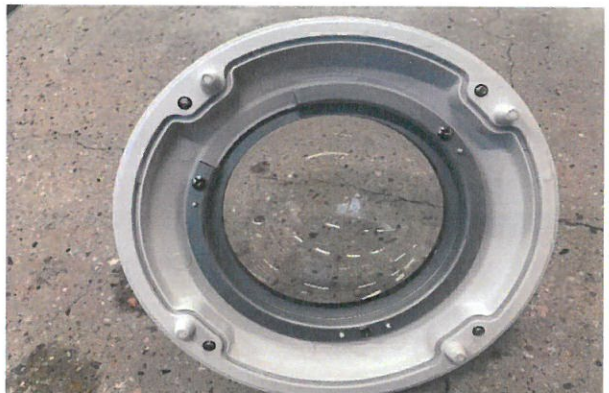
Fig. 25) Photo of specimen after the test

Fig. 26) Photo of specimen after the test

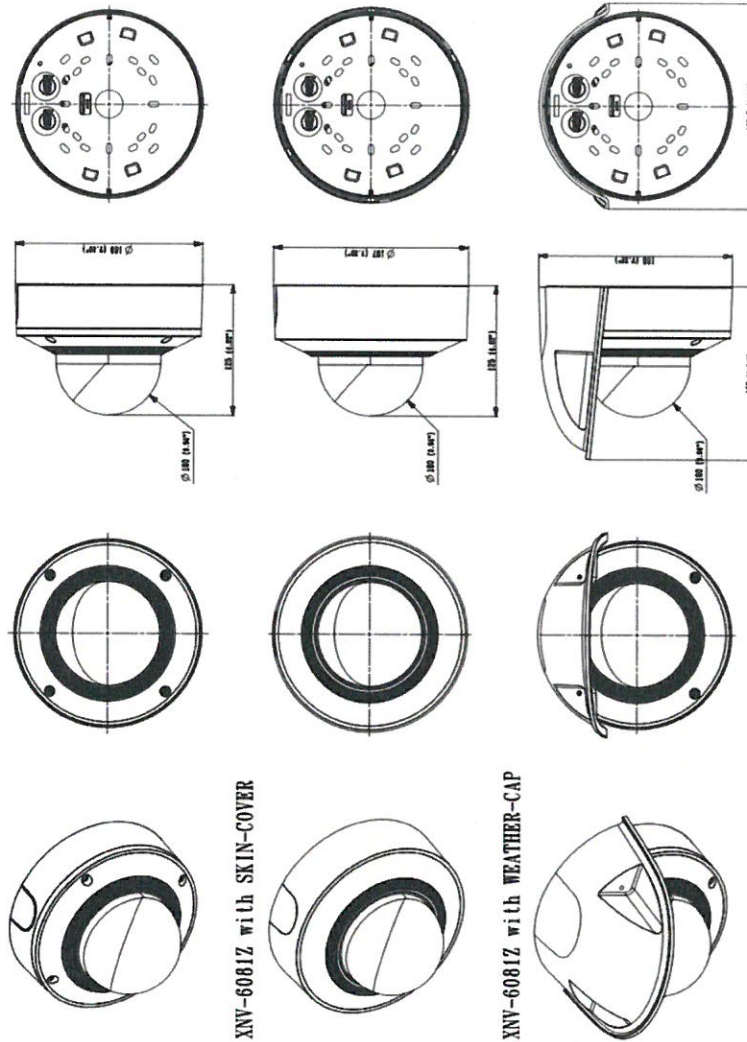
APPERANCE-XNV-6081Z ver.180912

Unit : mm (inch)
