TEST REPORT

REPORT No.:
CTK-2025-01005
Page (1) / (13) pages

NETWORK CAMERA / PNM-C19183RVTP

IEC 62262:2002+AMD1:2021

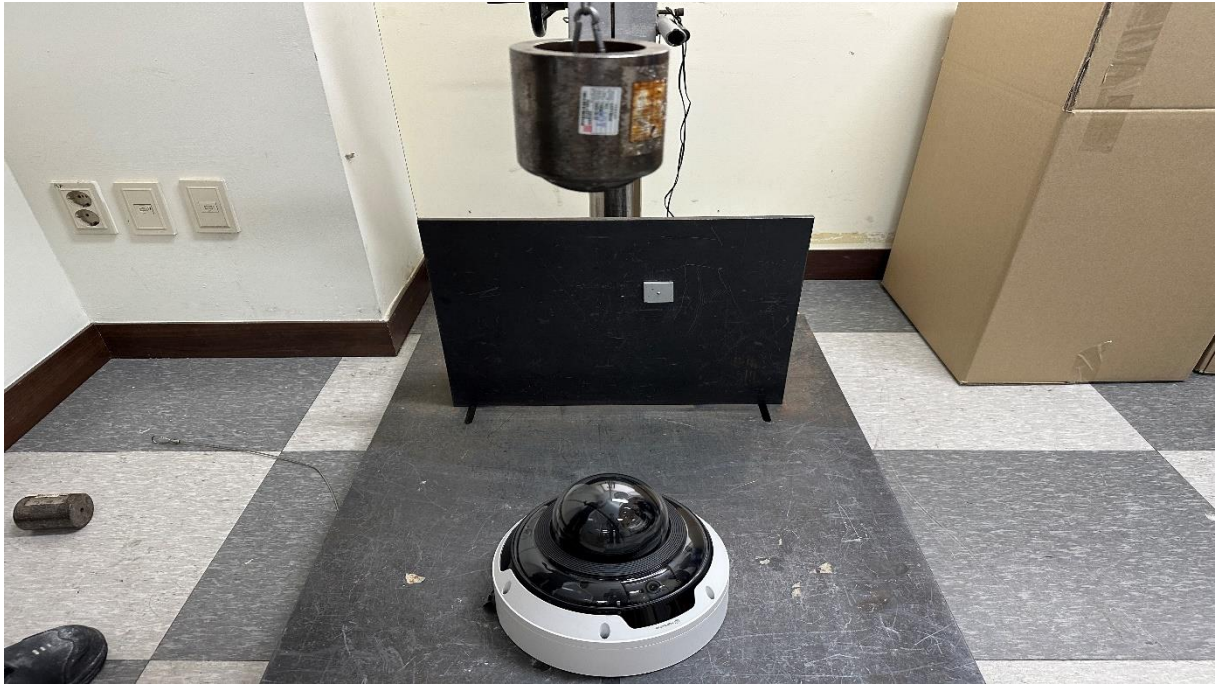
3.3.1 Evidence of test setting

Impact times: five times for each of the exposed surface. (Do not impact more than 3 times in the same spot)

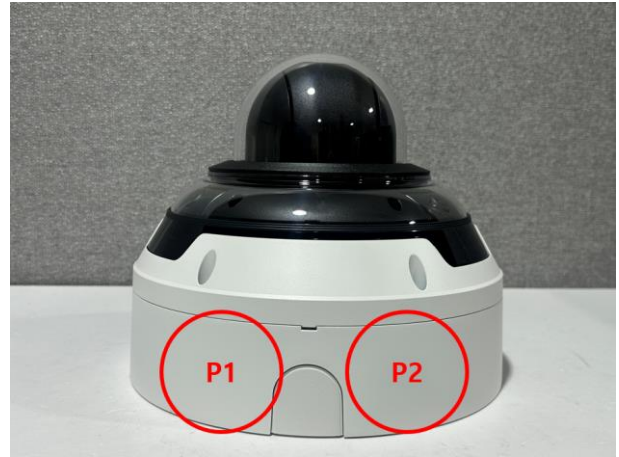
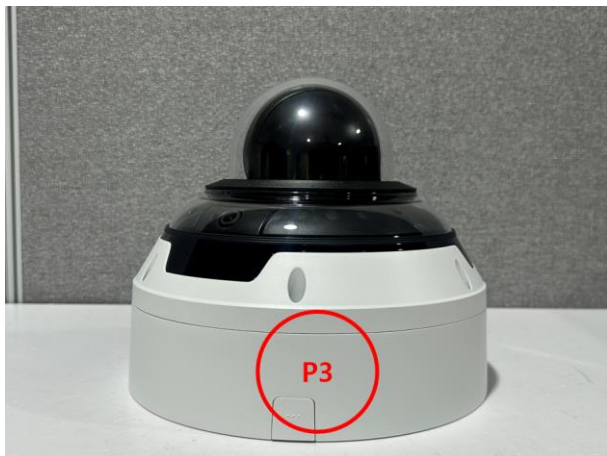
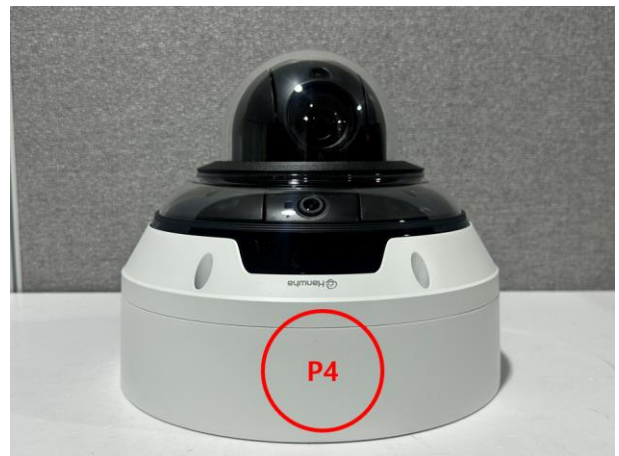
3.5.1 Check the hit area during the test

Check the hit area the test_1

Check the hit area the test_2

Check the hit area the test_3

Check the hit area the test_4

Check the hit area the test_5

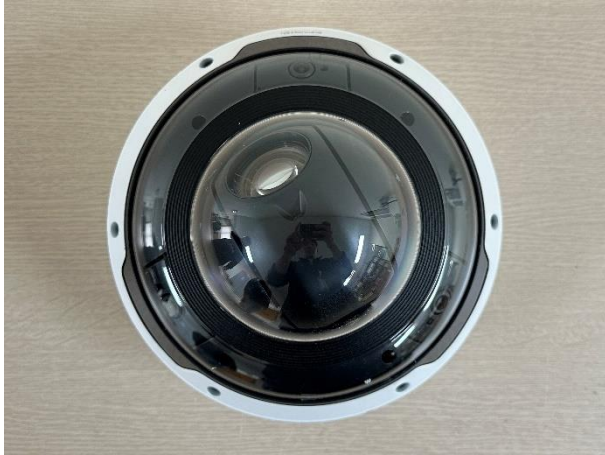
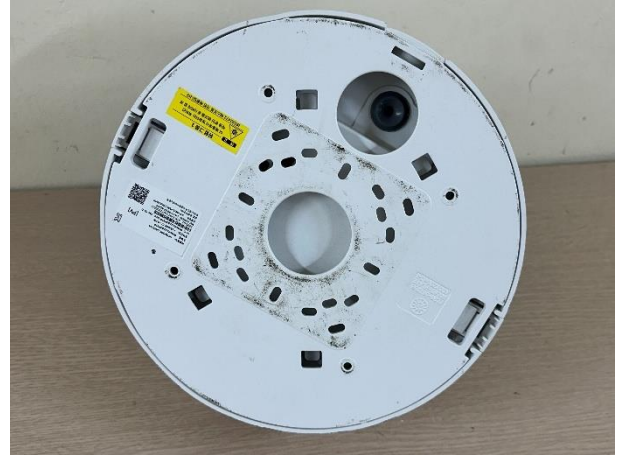
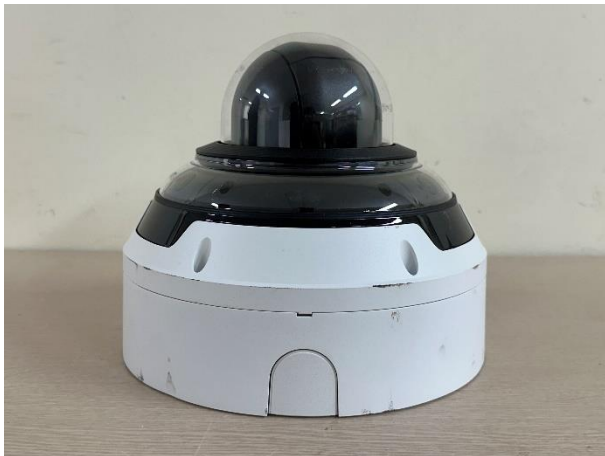
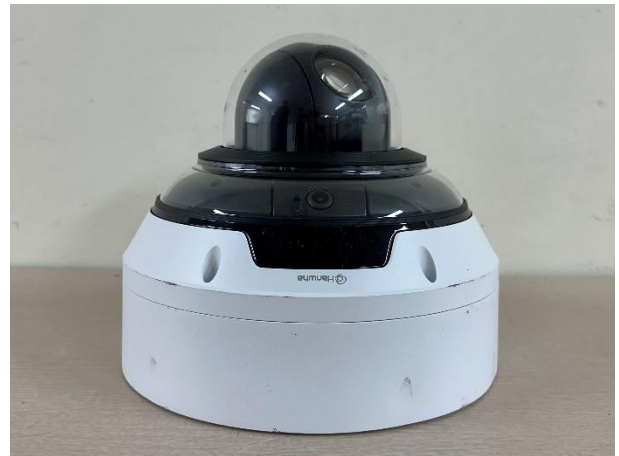
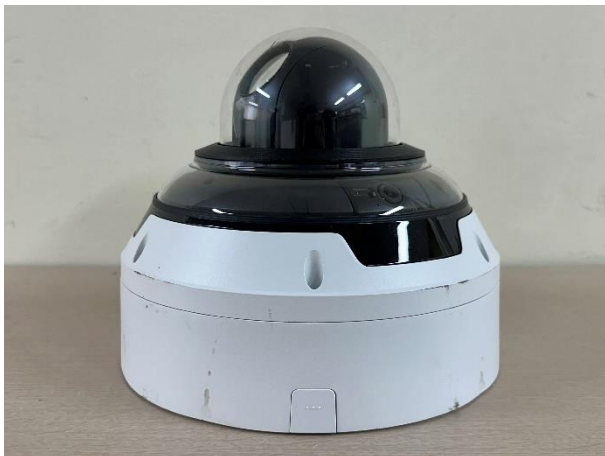
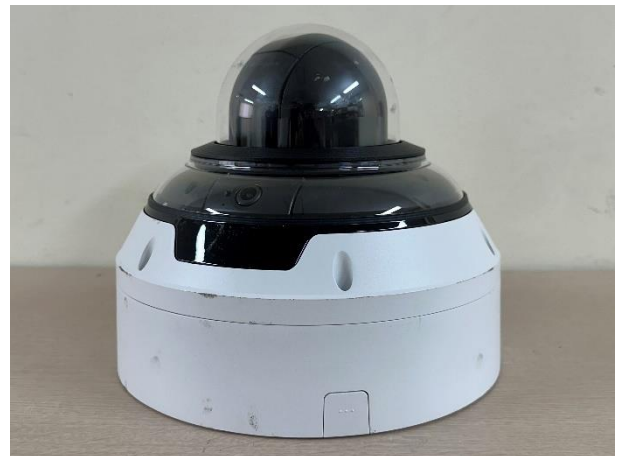
3.5.2 Post-test product images

Evaluation Criteria	Test Results	Remark
Visual Inspection	Some scratches were generated on the outside of the product.	-

※ Refer to the product photos after the completion of testing in section 3.5.2
