# TEST REPORT

REPORT No.:  
CTK-2024-02124  
Page (1) / (14) pages

NETWORK CAMERA / QNO-C8023R

IEC 60529:1989 +A1:1999+A2:2013

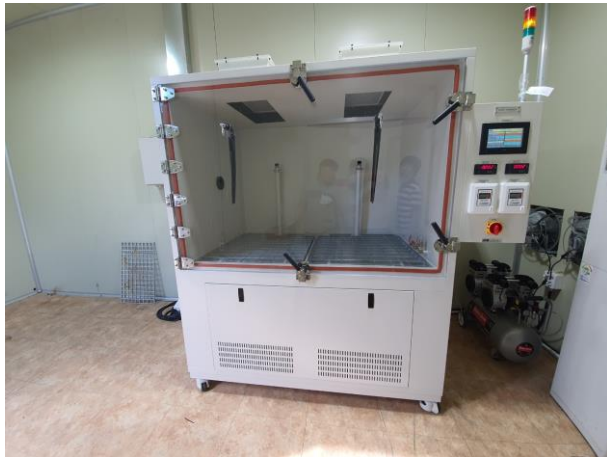
Dust Chamber

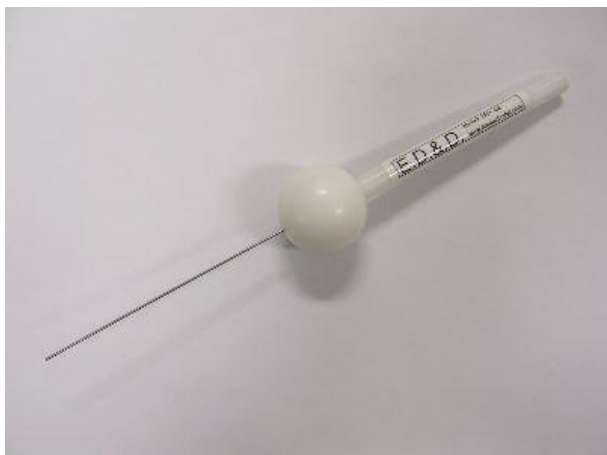
Test Rod Probe Ø1.0

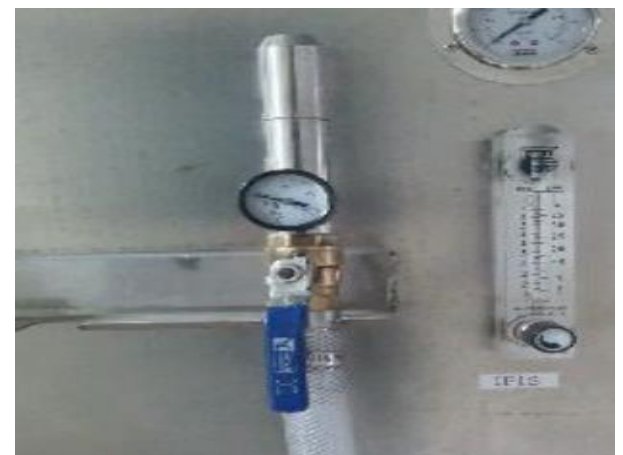
Hose Nozzle (12.5 mm)

Second characteristic numeral	Degrees of protection	Application
6	<p>The product must not be harmed in any direction even strong jet water.</p> <p>Water jet hose nozzle Fig.6, Nozzle 12.5 mm diameter</p> <p>Water flow rate: 100 l/min ± 5 % : <b>100 LPM</b></p> <p>Distance: 2.5 m to 3 m: <b>3 m</b></p> <p>Duration of test: 1 min/m<sup>2</sup> at least 3 min: <b>3 min</b></p>	<input checked="" type="checkbox"/>

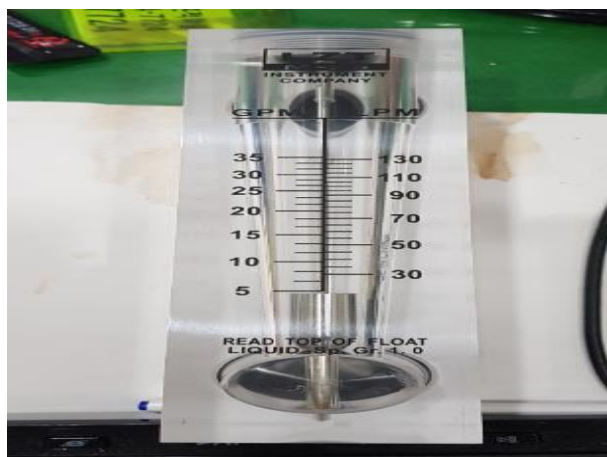
Water flow meter with IPX6

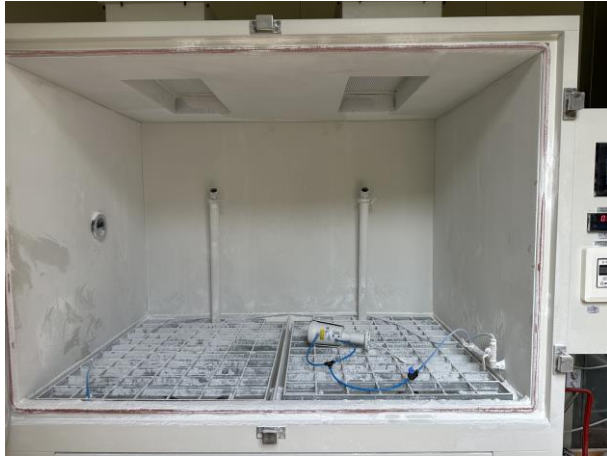
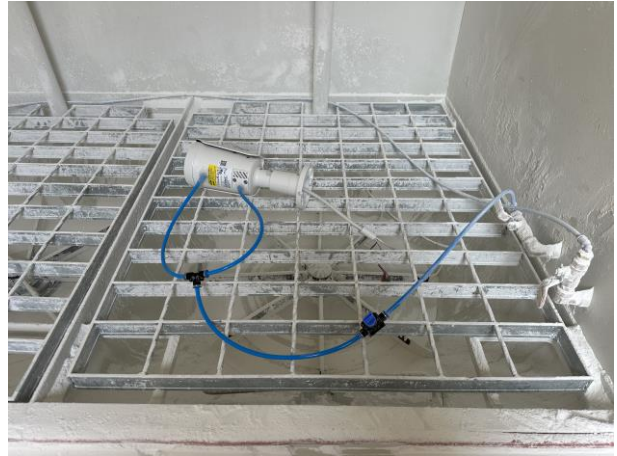
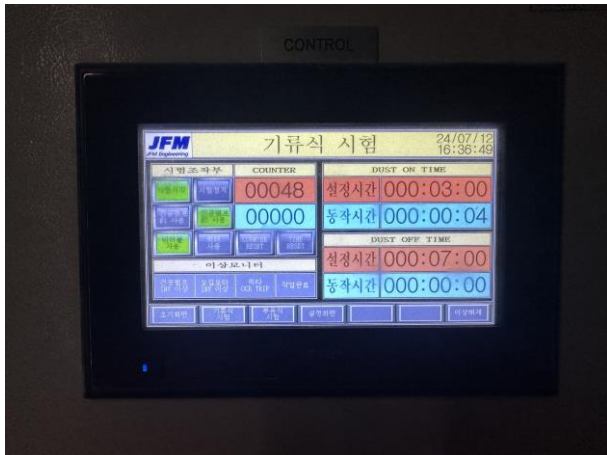
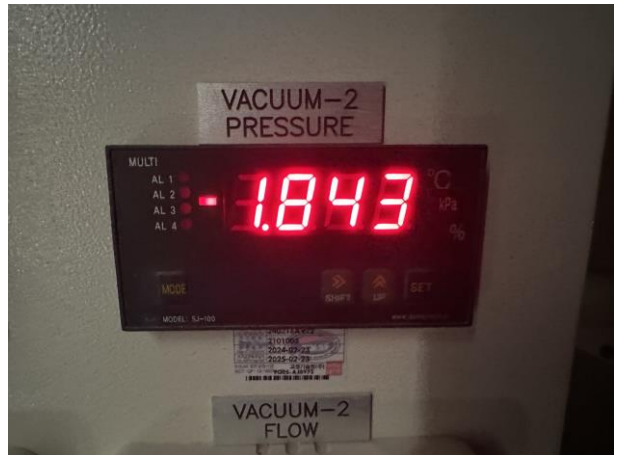
#### 3.3.1 Test Environment Set-up Images

Dust test

Dust test Monitor

Digital Vacuum Pressure

First characteristic numeral	Degree of protection	Application
6	<p>In Dust Testing Equipment, the test sample has to have no ingress of dust after testing atmospheric pressure present condition for 8 hr.</p> <p>(Talcum powder have to go through the measured sieve by <math>\Phi</math> 50 um wire that are spacing 75 um in squared, per volume and union Talcum powder have to be 2 kg/m<sup>3</sup>)</p> <p>Products in volume .....:     <b>2 140.76 cm<sup>3</sup> → 2.14 L</b></p> <p>Target intake volume (Products in volume 80) .....:     <b>171.26 L</b></p> <p>Suction volume (Max product in volume 60) .....:     <b>128.45 LPH → 2.14 LPM</b></p> <p>Actual Suction volume .....:     <b>2.14 L</b></p> <p>Suction pressure (Up to 2 kPa) .....:     <b>1.84 kPa</b></p> <p>Test time (Up to 8 time) .....:     <b>8 hr</b></p>	<input checked="" type="checkbox"/>
<sup>1)</sup> The full diameter of the object probe shall not pass through an opening of the enclosure. Due to the simultaneous requirement specified in table 2, the definition “shall not penetrate” is given in table 1.

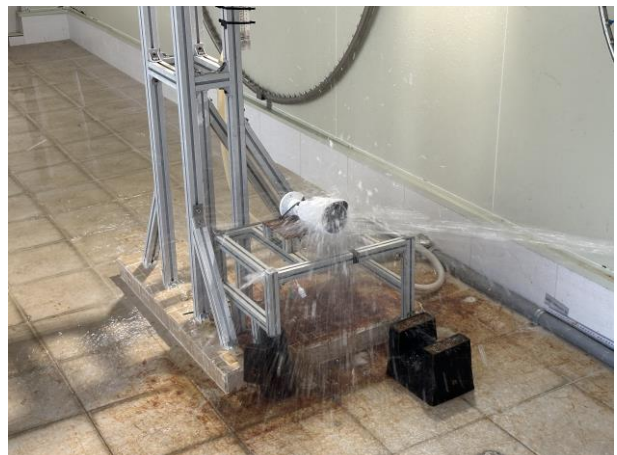
Water test

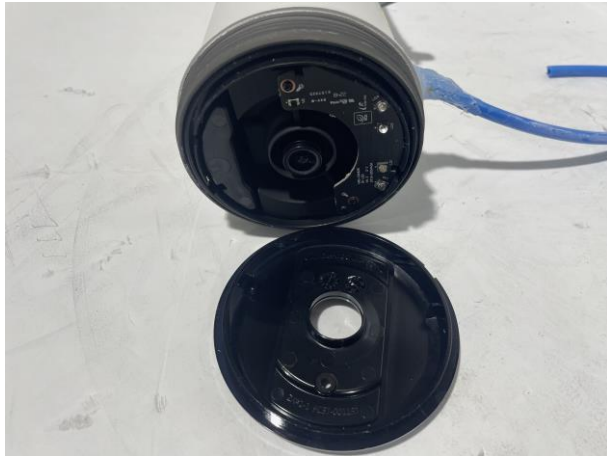
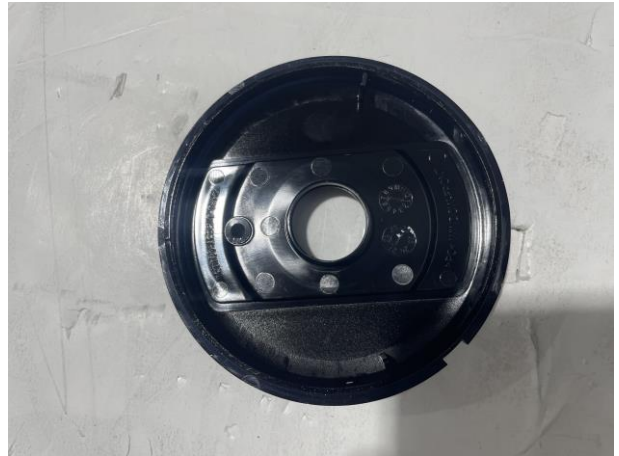
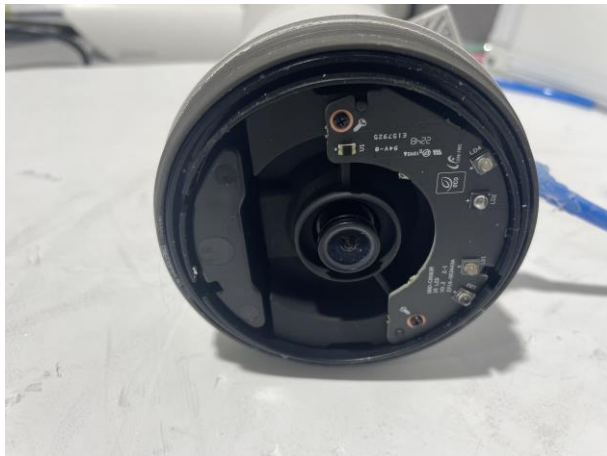
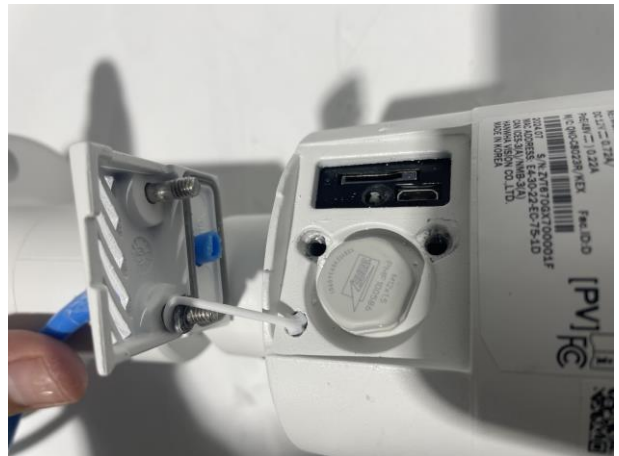
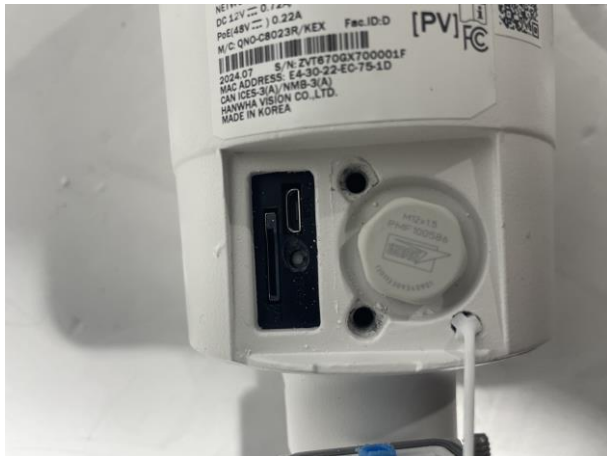
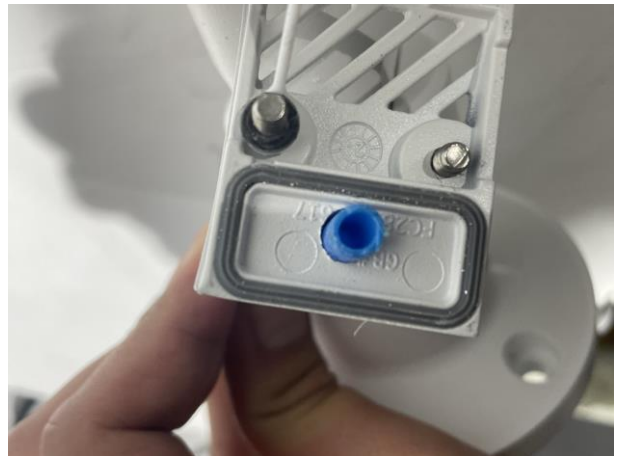
### 4.2.1 Product internal images after test [The First characteristic Numeral Test]

IP code	Evaluation Criteria	Test Results	Remark
IP 6X	No penetration of probe.	<b>Normal</b>	-
	No ingress of dust.	<b>Normal</b>	-
IP X6	No ingress of water.	<b>Normal</b>	-

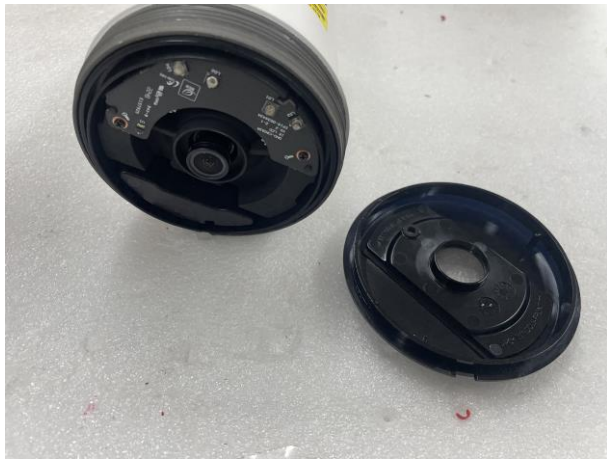
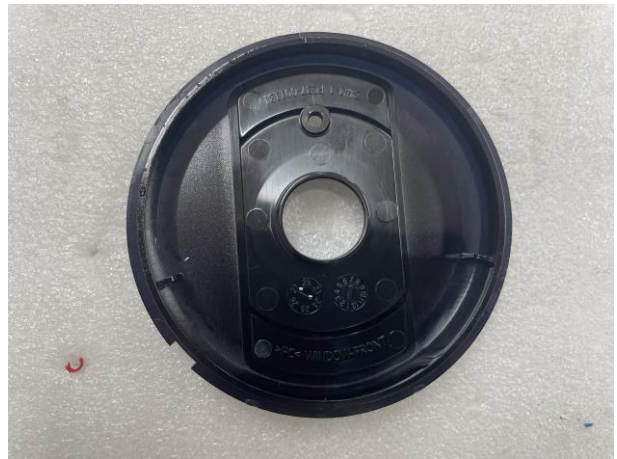
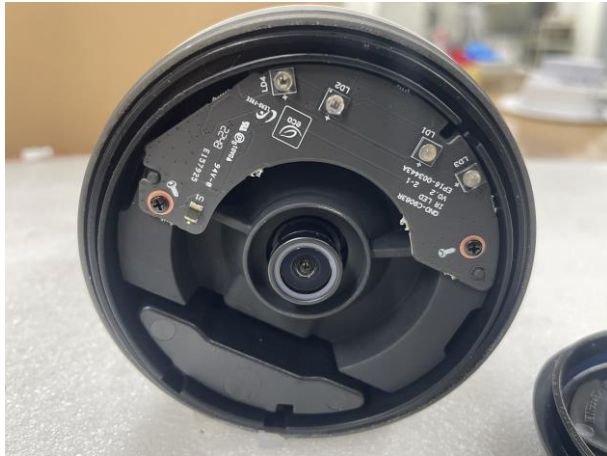
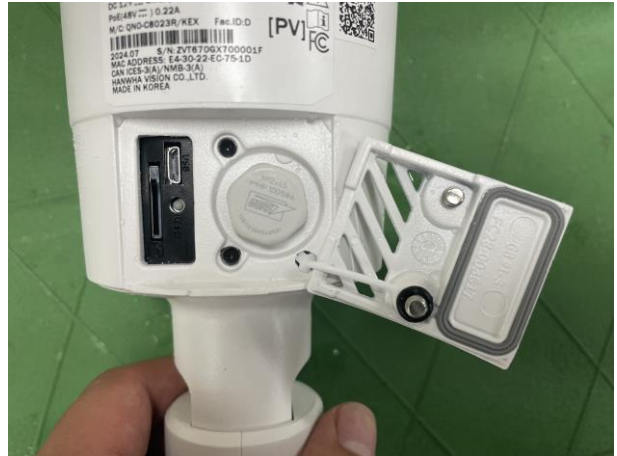
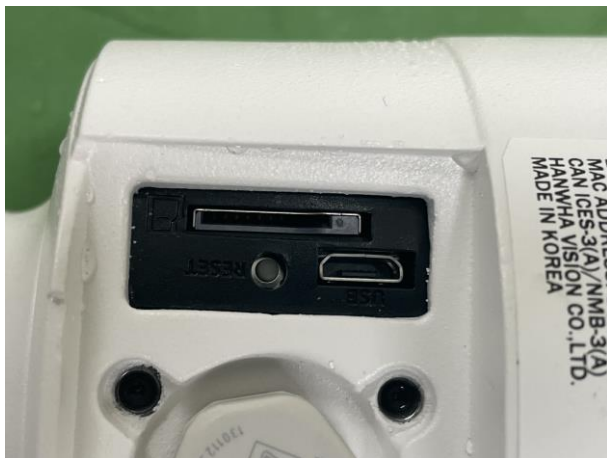
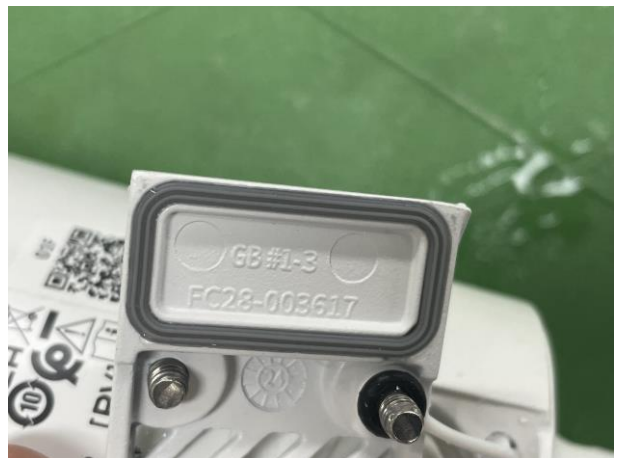
#### 4.2.2 Product internal images after test [The Second characteristic Numeral Test]
