TEST REPORT

CTK Co., Ltd. <small>The Power Leader of Global Republics Certification</small>	CTK Co., Ltd. 5 Dongbu-ro 221beon-gil, Cheoin-gu, Yongin-si, Gyeonggi-do, Republic of Korea Tel: +82-31-339-9970 Fax: +82-31-624-9501	REPORT No.: CTK-2024-02126 Page (1) / (14) pages	
---	--	--	--

1. Applicant	◦ Name : Hanwha Vision Co., Ltd ◦ Address : 6 Pangyo-ro 319Beon-gil, Bundang-gu, Seongnam-si, Gyeonggi-do, 13488 KOREA ◦ Date of Receipt : JUL 09, 2024
2. Manufacturer	◦ Name : Hanwha Vision Co., Ltd
3. Use of Report :	For customer submission
4. Test sample / Model :	NETWORK CAMERA / QNO-C8023R
5. Date(s) of test :	JUL 12, 2024
6. Test Standard (Method) used :	KS C IEC 62262: 2005
7. Testing Environment :	Temperature: (25 ±10) °C, Humidity: (50 ±25) %R.H. Pressure: (96 ±10) kPa
8. Test Results :	Clause 4. Refer to the test results
9. Location of Test :	<input checked="" type="checkbox"/> Permanent Testing Lab <input type="checkbox"/> On Site Testing (5 Dongbu-ro 221beon-gil, Cheoin-gu, Yongin-si, Gyeonggi-do, Republic of Korea)

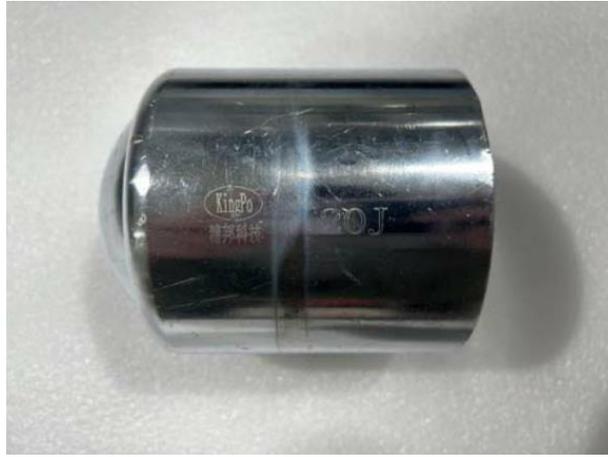
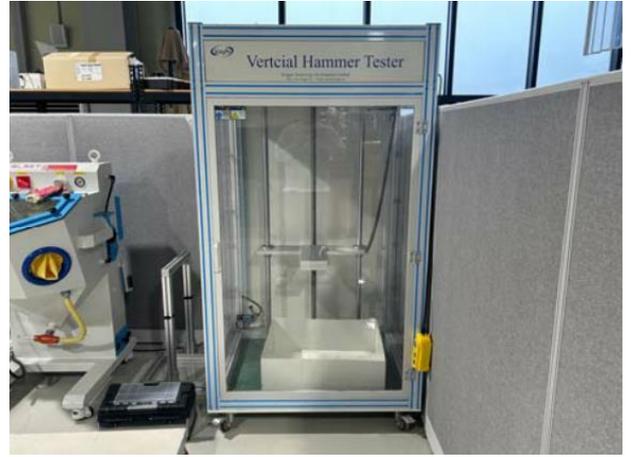
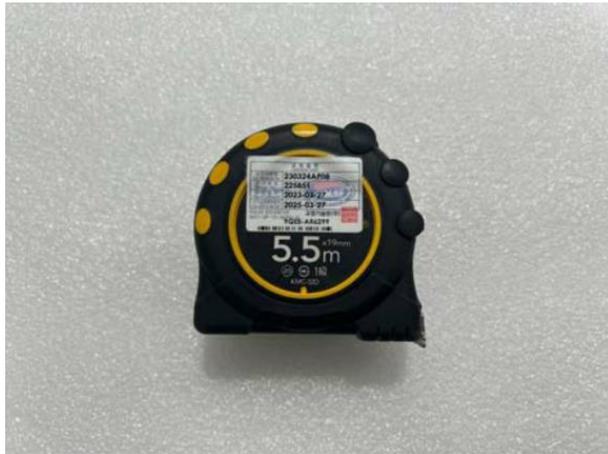
Vertical Hammer

Vertical Hammer Tester

Steel measuring meter

Testing equipment	Model Name	Manufacturer	Manufacturing Number	Calibration Date
Vertical Hammer Tester	Vertical Hammer	Kingpo	0190605A01002	
Vertical Hammer	20J	Kingpo	TX028-3	
Steel measuring meter	5.5 m	KOMELON	225851	2025.03.27

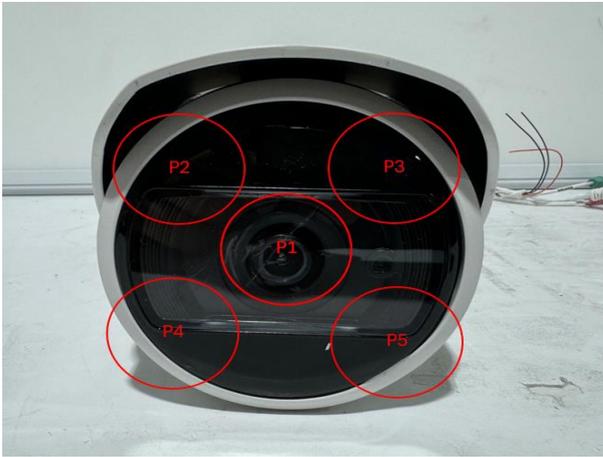
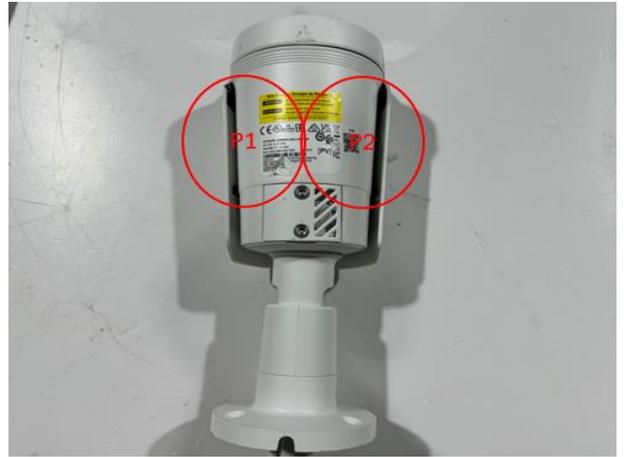
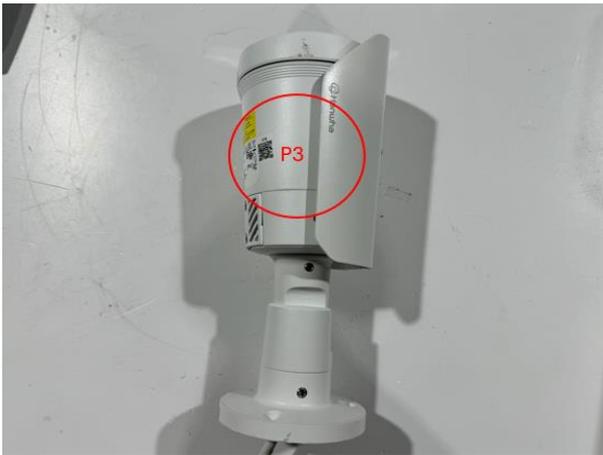
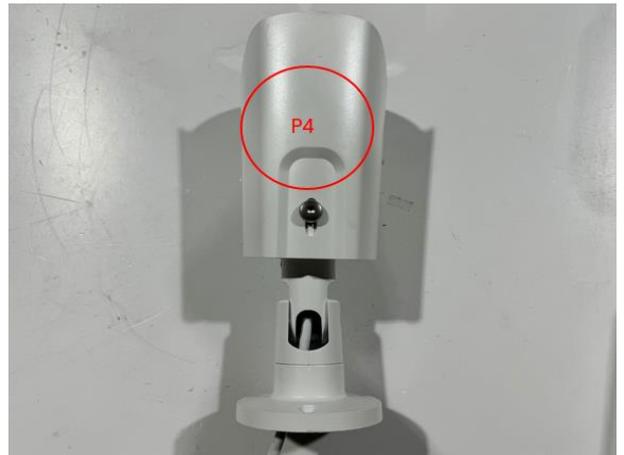
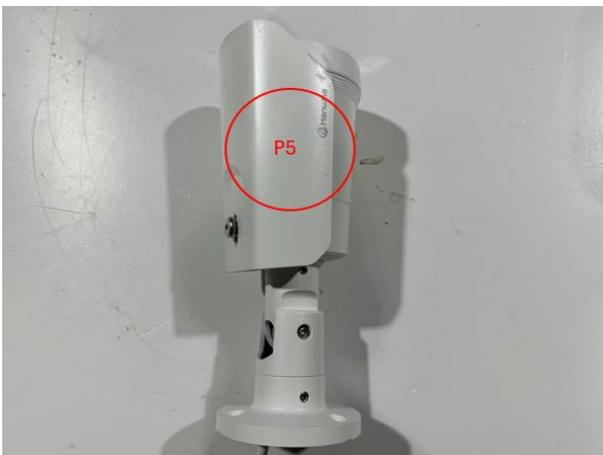
Check the hit area the test_1

Check the hit area the test_2

Check the hit area the test_3

Check the hit area the test_4

Check the hit area the test_5

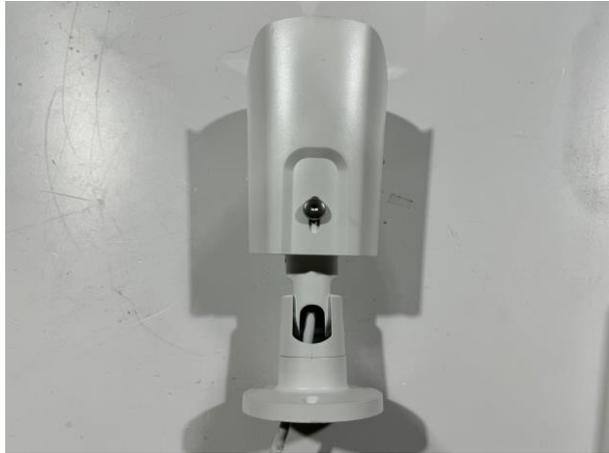
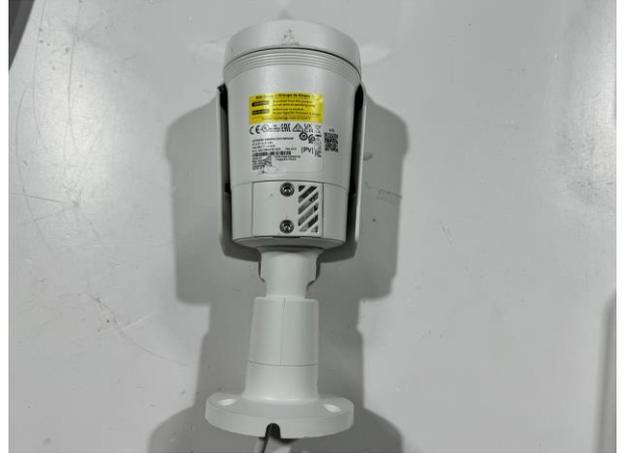
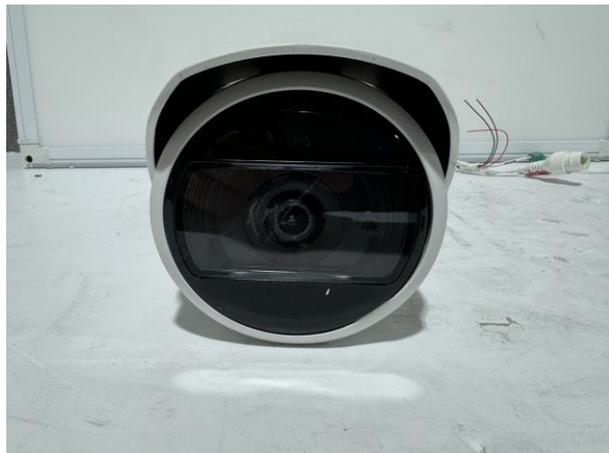
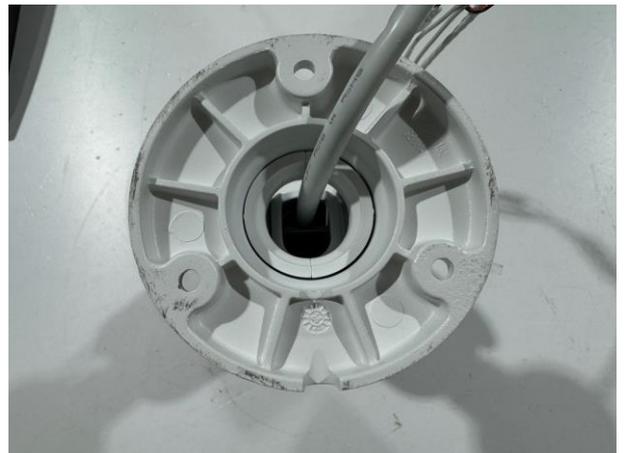
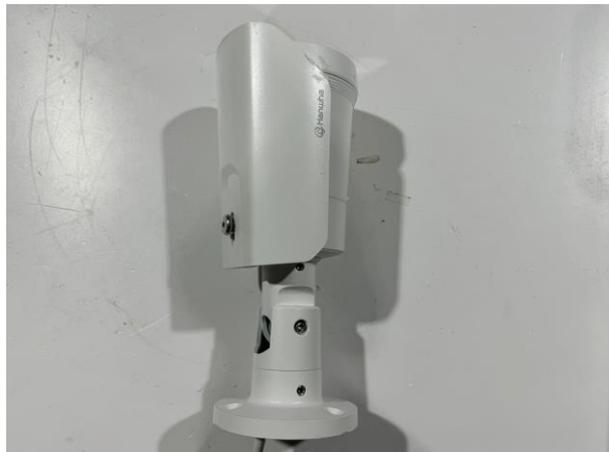
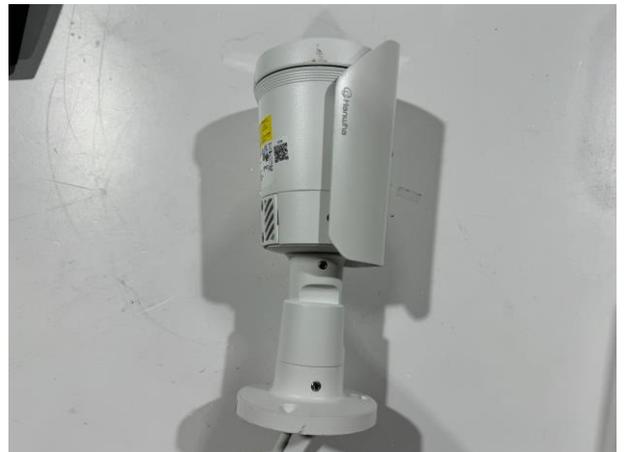
4.2.2 Post-test product images

Evaluation Criteria		Test Results
Visual Inspection	Pre-test	No problem with the product
	Post-test	Some scratches were generated on the outside of the product.

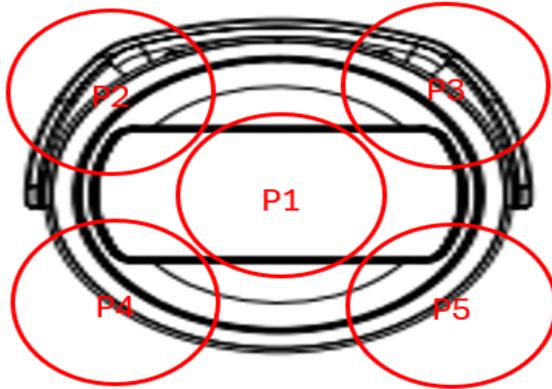
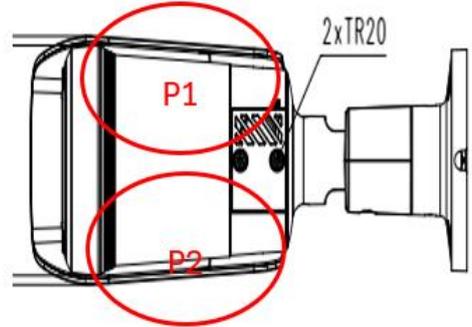
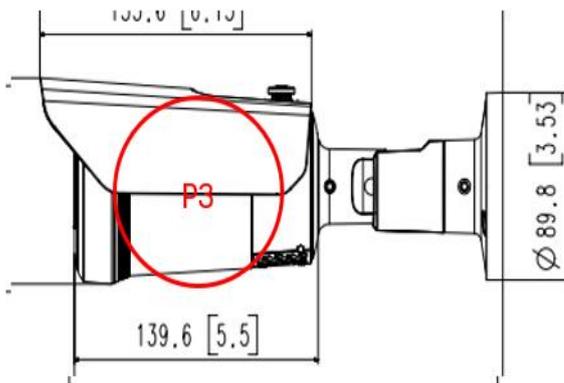
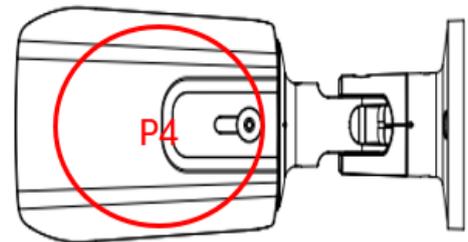
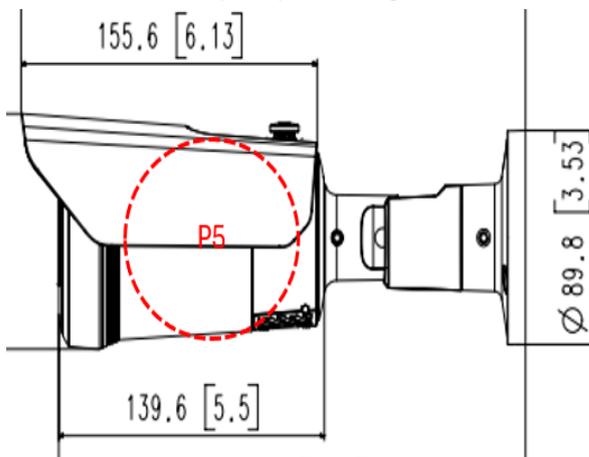
4.3.2 Impact point

Impact point image 1

Impact point image 2

Impact point image 3

Impact point image 4

Impact point image 5
