# TEST REPORT

REPORT No.:  
CTK-2024-02120  
Page (1) / (14) pages

NETWORK CAMERA / QNV-C8023R

IEC 60529:1989 +A1:1999+A2:2013

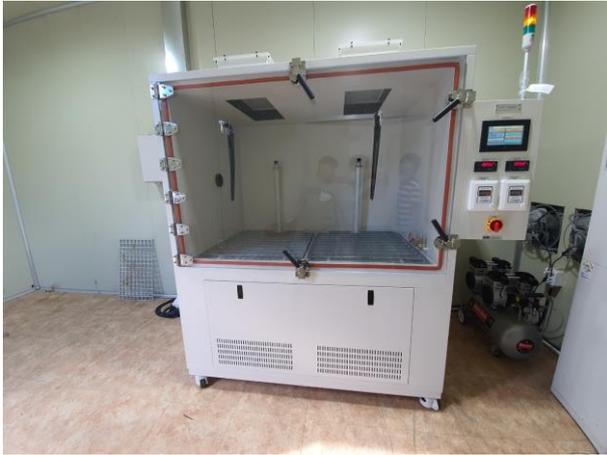
Dust Chamber

First characteristic numeral	Degree of protection	Application
6	<p>In Dust Testing Equipment, the test sample has to have no ingress of dust after testing atmospheric pressure present condition for 8 hr.</p> <p>(Talcum powder have to go through the measured sieve by <math>\Phi</math> 50 um wire that are spacing 75 um in squared, per volume and union Talcum powder have to be 2 kg/m<sup>3</sup>)</p> <p>Products in volume .....: <b>1 404 cm<sup>3</sup> → 1.40 L</b></p> <p>Target intake volume (Products in volume 80) .....: <b>112.32 L</b></p> <p>Suction volume (Max product in volume 60) .....: <b>84.24 LPH → 1.40 LPM</b></p> <p>Actual Suction volume .....: <b>1.40 L</b></p> <p>Suction pressure (Up to 2 kPa) .....: <b>1.88 kPa</b></p> <p>Test time (Up to 8 time) .....: <b>8 hr</b></p>	☒

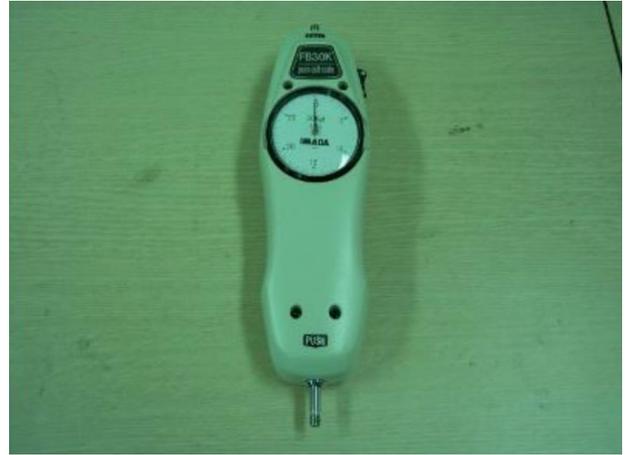
Push Pull Gage

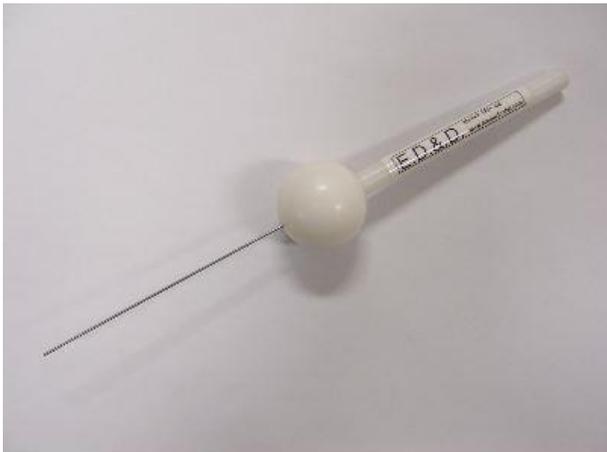
Test Rod Probe  $\varnothing 1.0$

First characteristic numeral	Degree of protection	Application
6	Protected against access to hazardous parts with a wire. The access probe of 1.0 mmØ, shall not penetrate. Test force: 1 N ± 10 %	☒

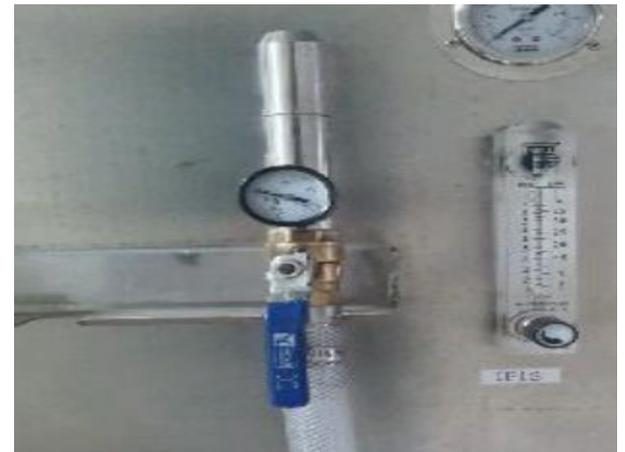
Hose Nozzle (12.5 mm)

Second characteristic numeral	Degrees of protection	Application
6	<p>The product must not be harmed in any direction even strong jet water.</p> <p>Water jet hose nozzle Fig.6, Nozzle 12.5 mm diameter</p> <p>Water flow rate: 100 l/min ± 5 % : <b>100 LPM</b></p> <p>Distance: 2.5 m to 3 m: <b>3 m</b></p> <p>Duration of test: 1 min/m<sup>2</sup> at least 3 min: <b>3 min</b></p>	☒

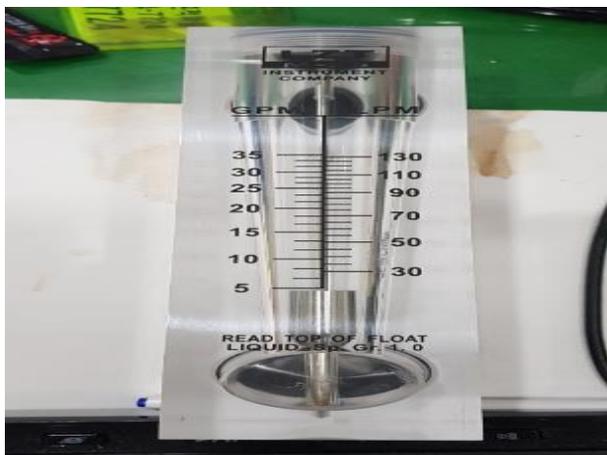
Water flow meter with IPX6

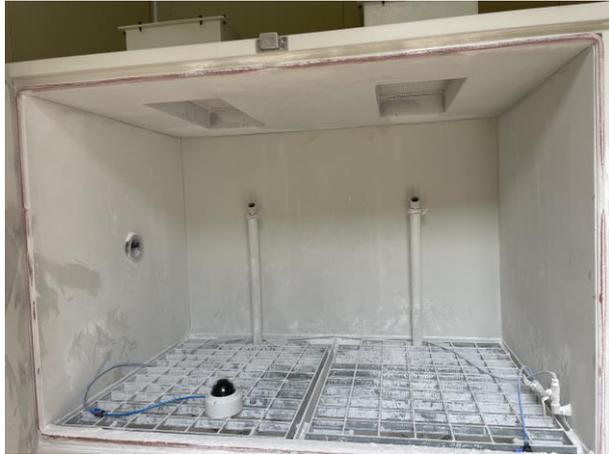
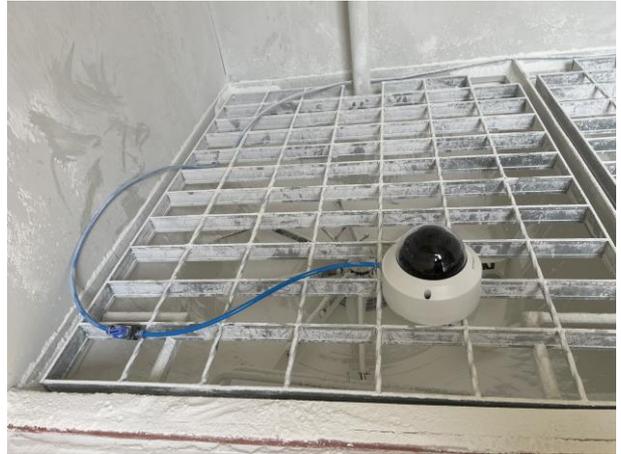
Dust test

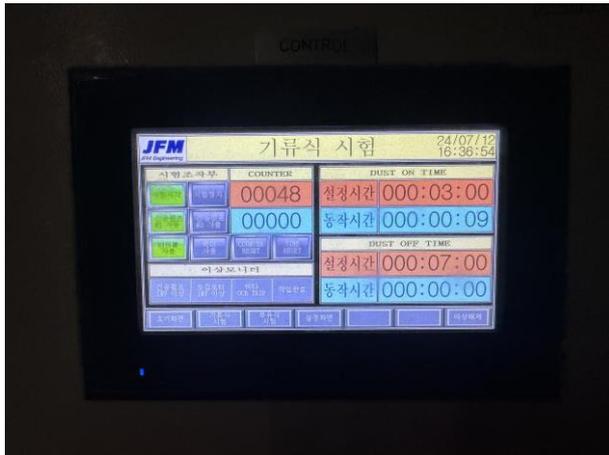
Dust test Monitor

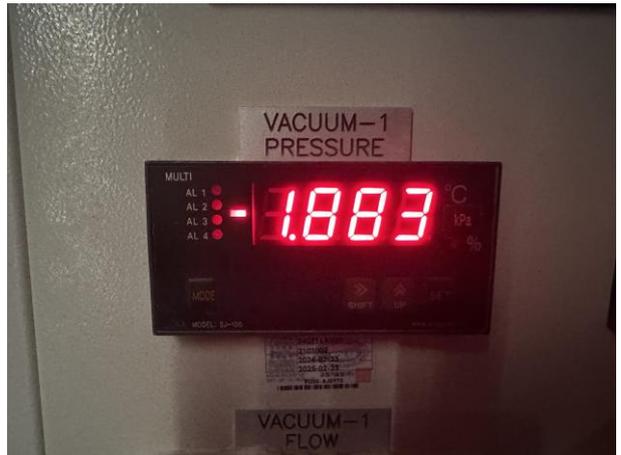
Digital Vacuum Pressure

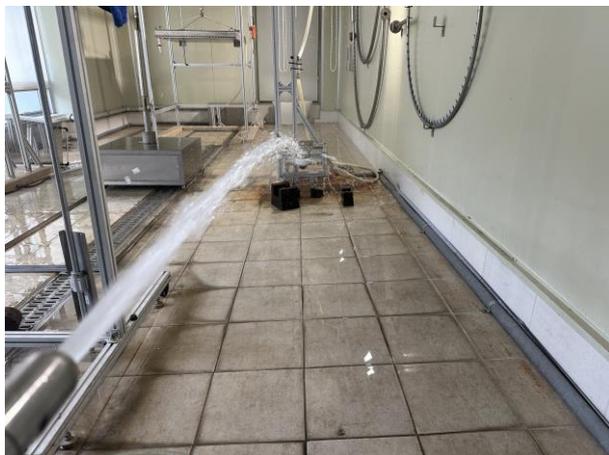
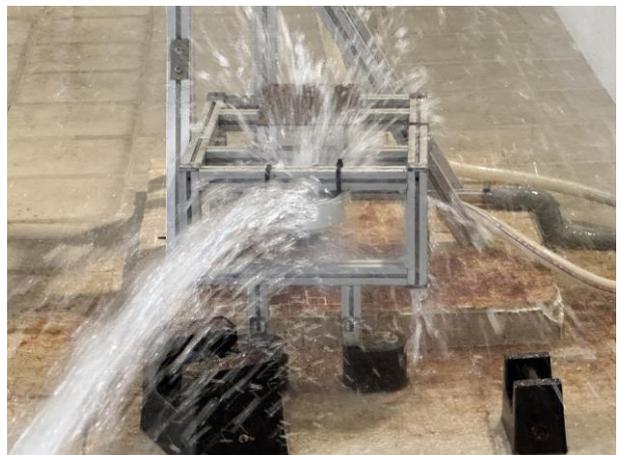
Water test

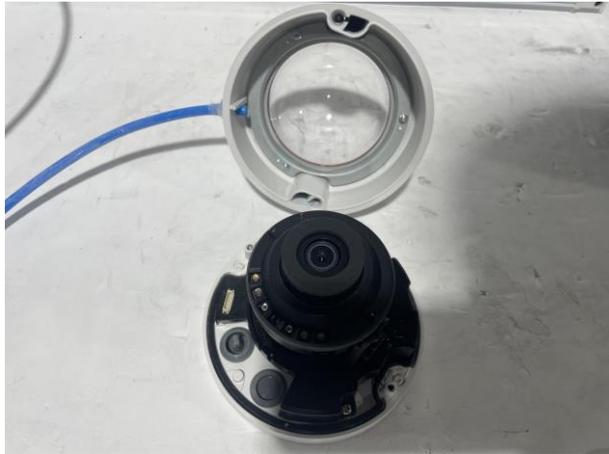
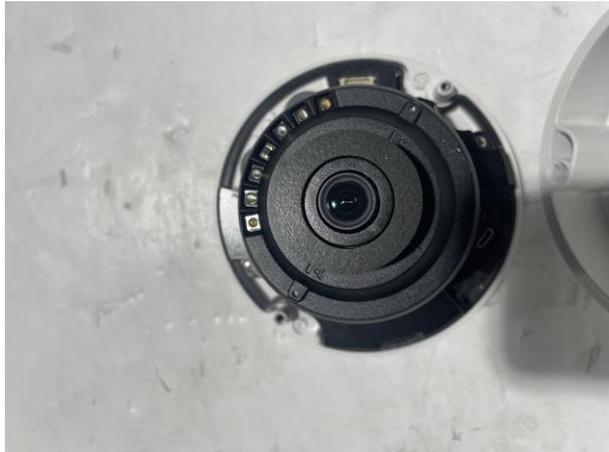
### 4.2.1 Product internal images after test [The First characteristic Numeral Test]

IP code	Evaluation Criteria	Test Results	Remark
IP 6X	No penetration of probe.	Normal	-
	No ingress of dust.	Normal	-
IP X6	No ingress of water.	Normal	-

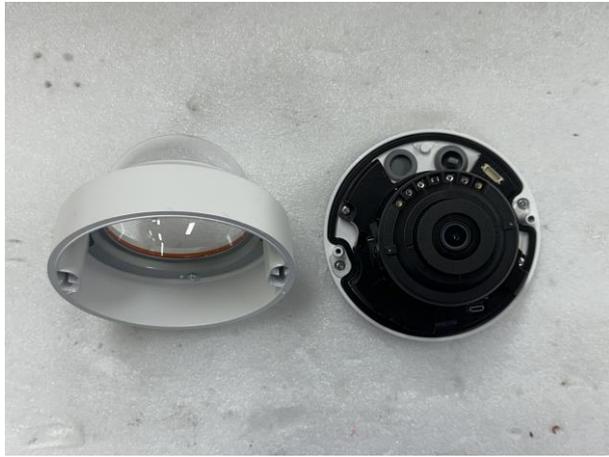
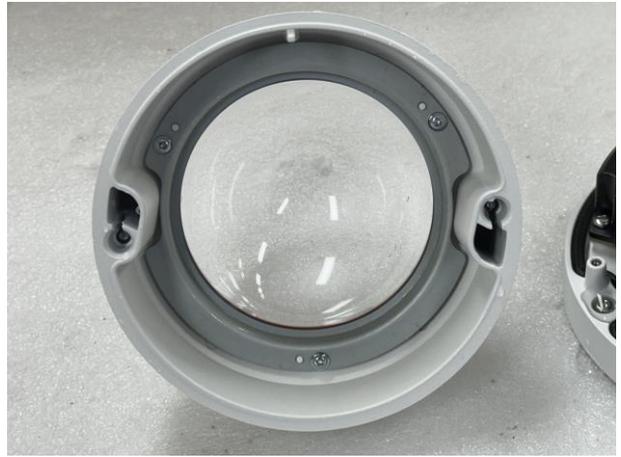
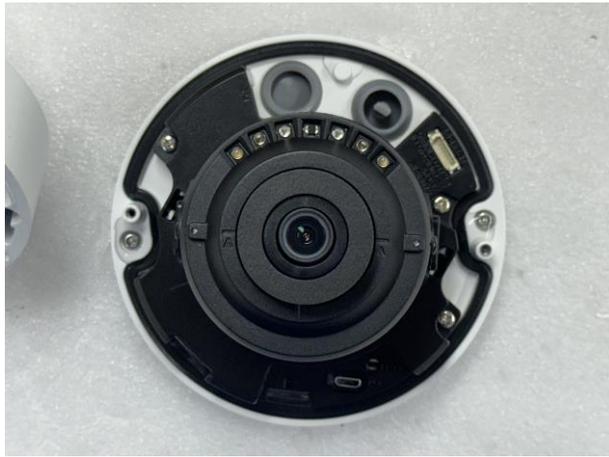
#### 4.2.2 Product internal images after test [The Second characteristic Numeral Test]
