# TEST REPORT

REPORT No.:  
CTK-2024-02806  
Page (1) / (14) pages

NETWORK CAMERA / TNV-C8014RM

IEC 60529:1989 +A1:1999+A2:2013

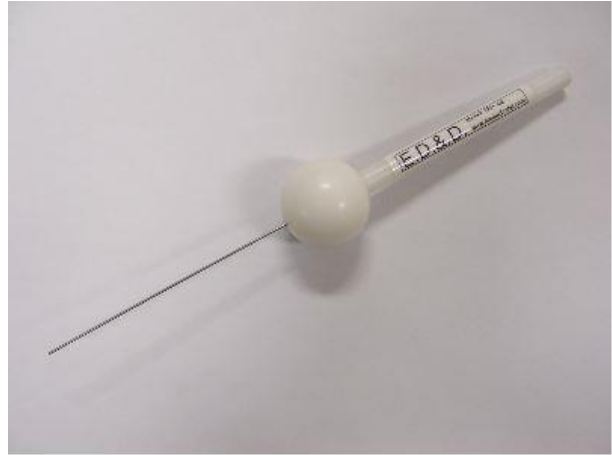
Test Rod Probe Ø1.0

First characteristic numeral	Degree of protection	Application
6	Protected against access to hazardous parts with a wire. The access probe of 1.0 mmØ, shall not penetrate. Test force: 1 N ± 10 %	<input checked="" type="checkbox"/>

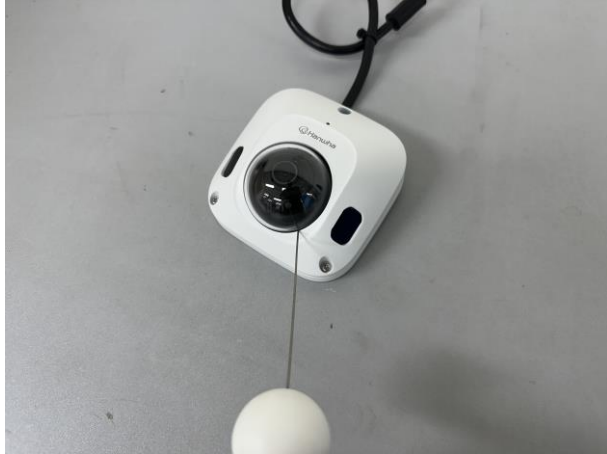
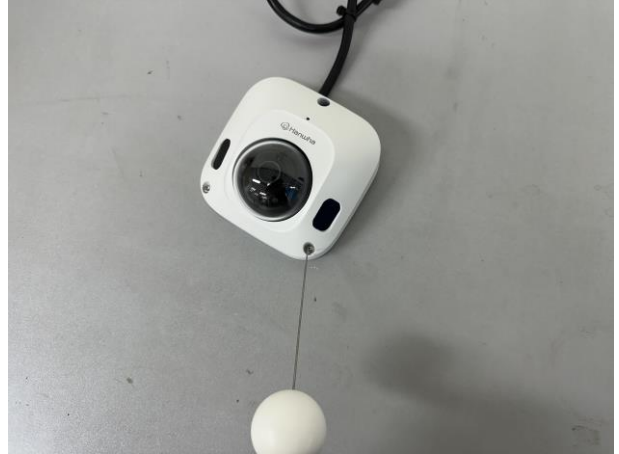
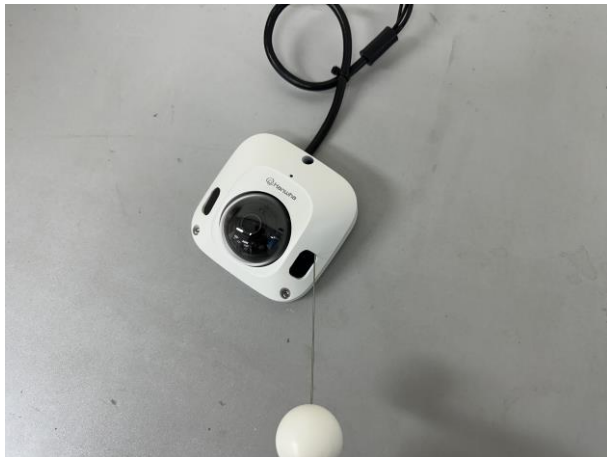
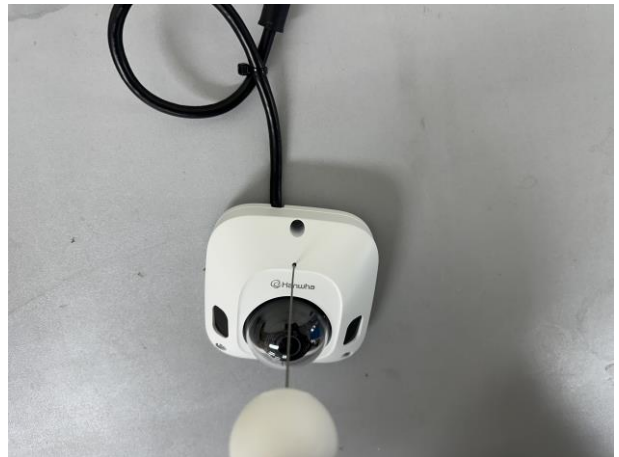
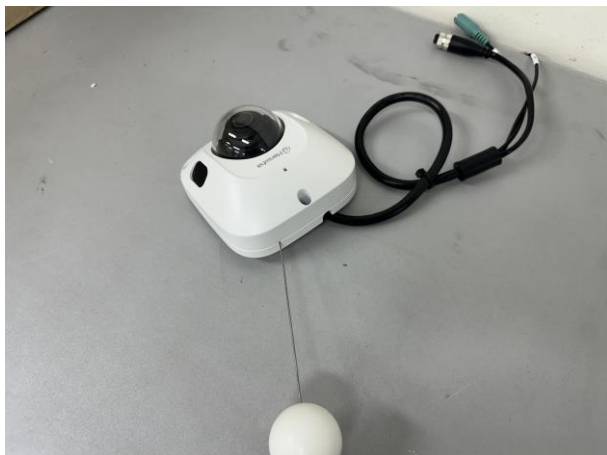
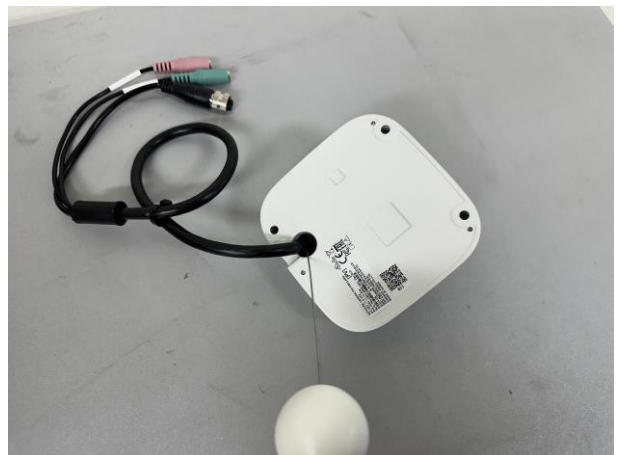
#### 3.3.1 Test Environment Set-up Images

Probe test

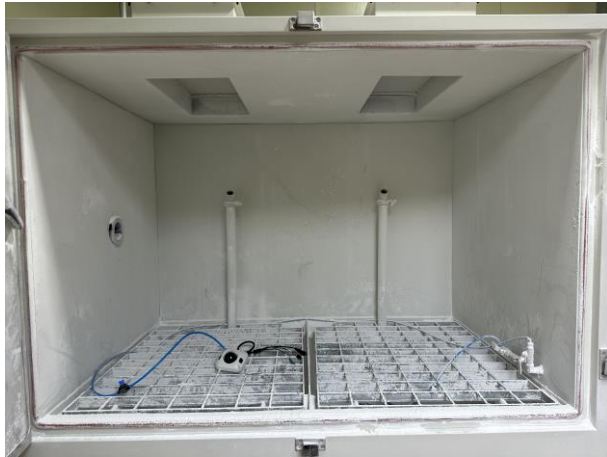
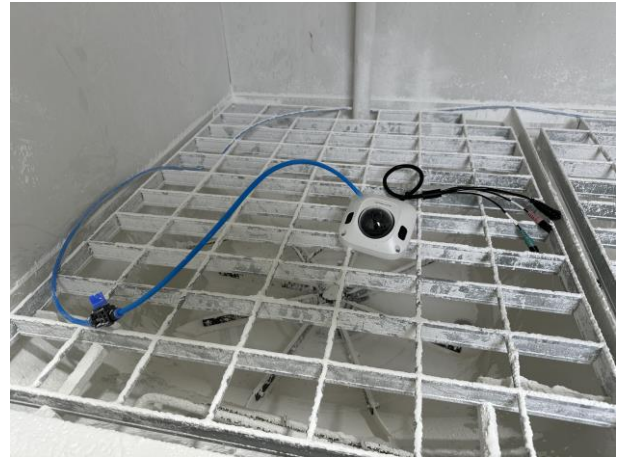
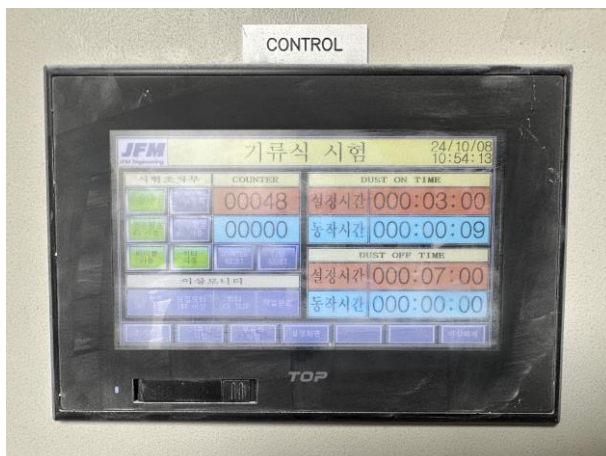
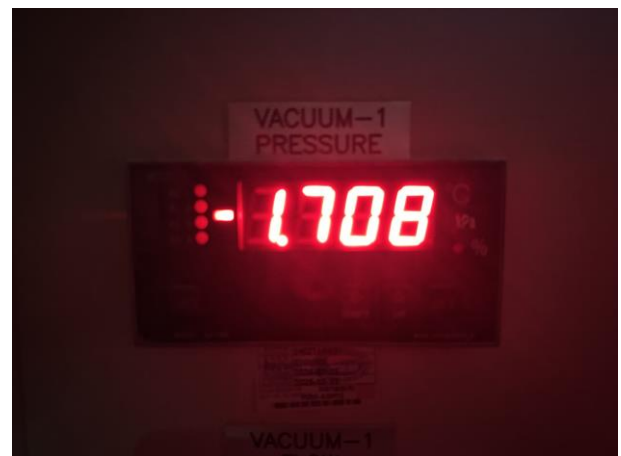
Dust test

Dust test Monitor

Digital Vacuum Pressure

First characteristic numeral	Degree of protection	Application
6	<p>In Dust Testing Equipment, the test sample has to have no ingress of dust after testing atmospheric pressure present condition for 8 hr.</p> <p>(Talcum powder have to go through the measured sieve by <math>\Phi</math> 50 um wire that are spacing 75 um in squared, per volume and union Talcum powder have to be 2 kg/m<sup>3</sup>)</p> <p>Products in volume .....: <b>612.15 cm<sup>3</sup> → 0.612 L</b></p> <p>Target intake volume (Products in volume 80) .....: <b>48.97 L</b></p> <p>Suction volume (Max product in volume 60) .....: <b>36.73 LPH → 0.612 LPM</b></p> <p>Actual Suction volume .....: <b>0.612 L</b></p> <p>Suction pressure (Up to 2 kPa) .....: <b>1.71 kPa</b></p> <p>Test time (Up to 8 time) .....: <b>8 hr</b></p>	<input checked="" type="checkbox"/>
<sup>1)</sup> The full diameter of the object probe shall not pass through an opening of the enclosure. Due to the simultaneous requirement specified in table 2, the definition “shall not penetrate” is given in table 1.

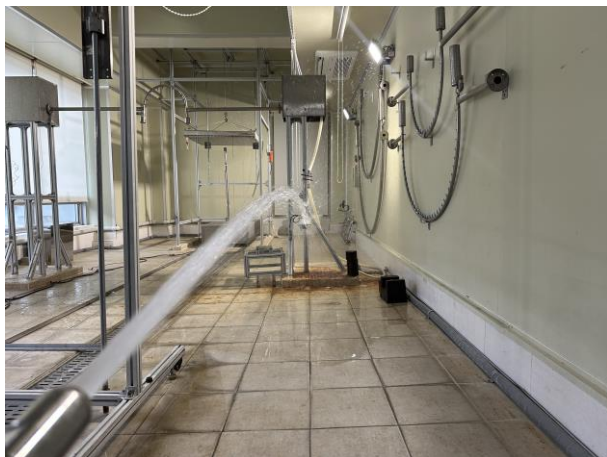
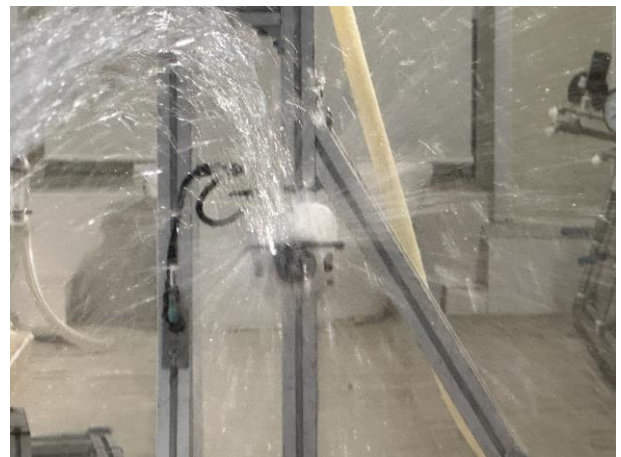
Water test

Second characteristic numeral	Degrees of protection	Application
6	<p>The product must not be harmed in any direction even strong jet water.</p> <p>Water jet hose nozzle Fig.6, Nozzle 12.5 mm diameter</p> <p>Water flow rate: 100 l/min ± 5 % : <b>100 LPM</b></p> <p>Distance: 2.5 m to 3 m: <b>3 m</b></p> <p>Duration of test: 1 min/m<sup>2</sup> at least 3 min: <b>3 min</b></p>	<input checked="" type="checkbox"/>

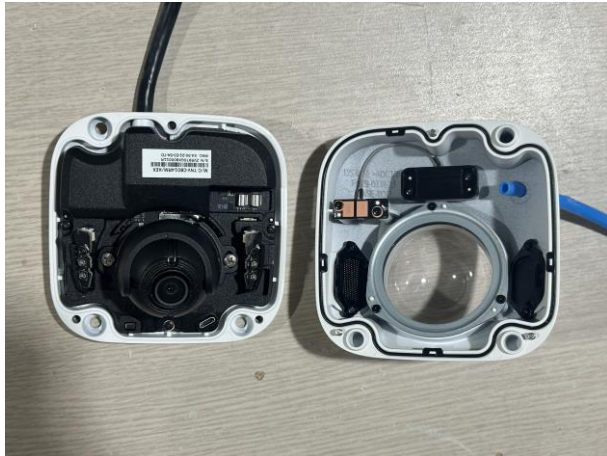
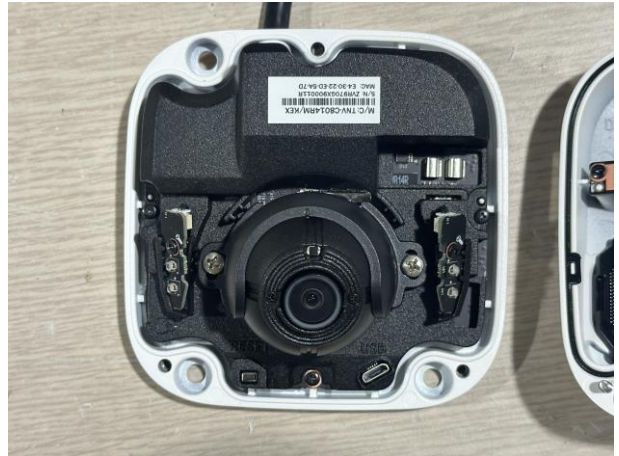
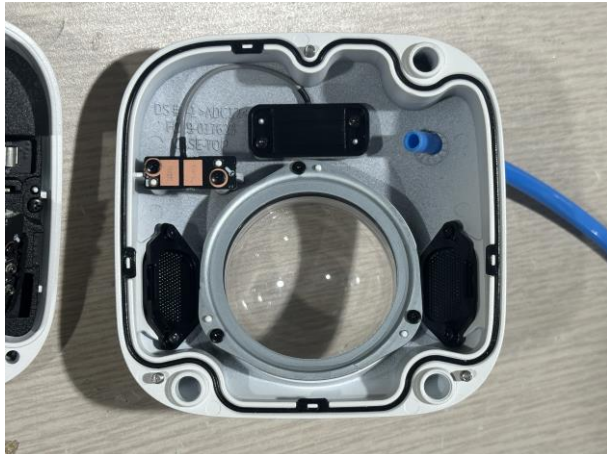
### 4.2.1 Product internal images after test [The First characteristic Numeral Test]

IP code	Evaluation Criteria	Test Results	Remark
IP 6X	No penetration of probe.	<b>Normal</b>	-
	No ingress of dust.	<b>Normal</b>	-
IP X6	No ingress of water.	<b>Normal</b>	-
