TEST REPORT

CTK-2025-00642

NETWORK CAMERA / XNV-A9084R

EN 60068-2-1, EN 60068-2-2, EN 60068-2-14, EN 60068-2-6, EN
60068-2-27, EN 60068-2-78, IEC 60068-2-1, IEC 60068-2-2, IEC
60068-2-14, IEC 60068-2-6, IEC 60068-2-27, IEC 60068-2-78

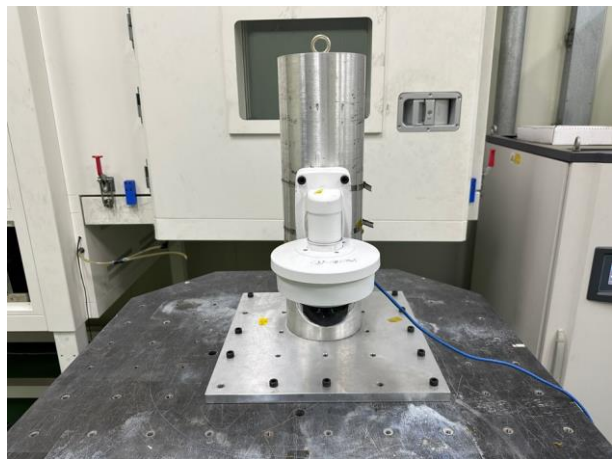
6.3.1 Evidence of test setting

- Sample status: operation
- Frequency(Hz): 5 Hz ~ 200 Hz
- Acceleration(G): 1 G
- Sweep rate: 1 oct/min
- Test Axis: Z, X, Y
- Test time(h): Total 30 min (10 min. per each axis)

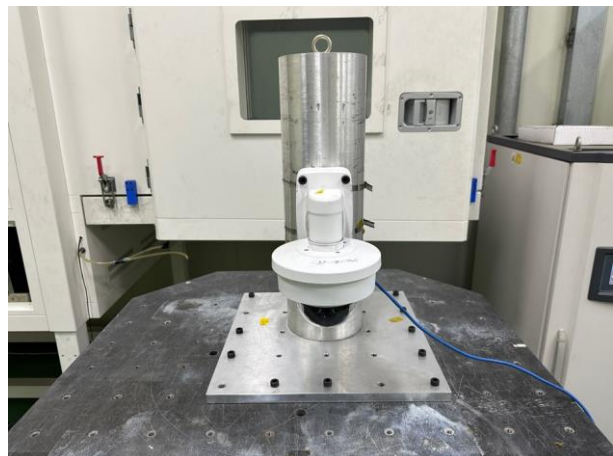
7.3.1 Evidence of test setting

7.2.1 Sample status: Non-operation

7.2.2 Acceleration(G): 10 G

7.2.3 Number of impacts: 10 per direction (total 60)

7.2.4 Test Axis: Z, X, Y

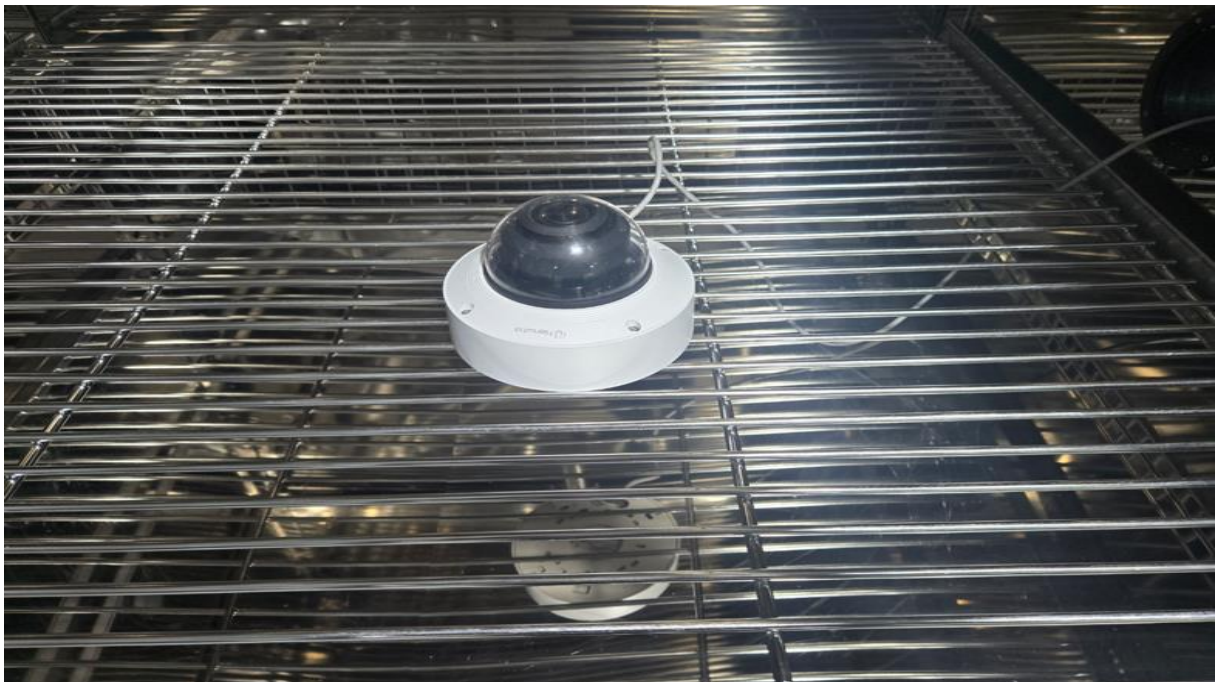
8.3.1 Evidence of test setting

8.2.1 Sample status: operation

8.2.2 Test temperature: 40 ± 2 °C

8.2.3 Test Humidity: 93 ± 3 % R.H.

8.2.4 Test time: 240 h
