TEST REPORT

REPORT No.:
CTK-2025-00641
Page (1) / (24) pages

NETWORK CAMERA / XNV-A8084R

NEMA TS 2-2013 2.2.7.2 Test B ~ 2.2.7.8, NEMA TS 2.2.8,
NEMA TS 2.2.9

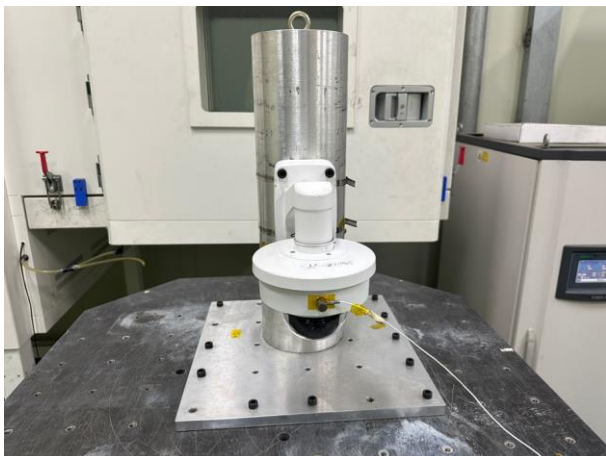
4.3.1 Evidence of test setting (NEMA TS 2-2013 2.2.8)

- Applicable axis : X, Y, Z
- Test time(h) : 12.5
- Evaluation items
 - Check for mechanical damage before and after testing
- Test methods
 - With the test unit securely fastened to the test table, set the test table for a double amplitude displacement of 0.015 inch.

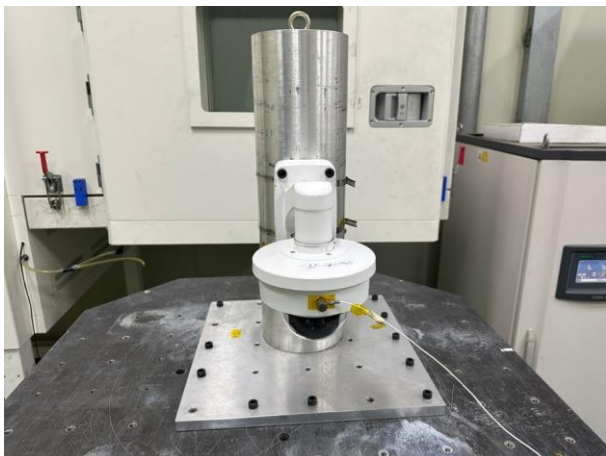
5.3.1 Evidence of test setting (NEMA TS 2-2013 2.2.9)

5.2.2 Applied waveform: Half sine

5.2.3 Acceleration(G): 10 G

5.2.4 Nominal duration (ms): 11
