# TEST REPORT

REPORT No.:  
CTK-2025-00622  
Page (1) / (13) pages

NETWORK CAMERA / XNV-A9084R

IEC 62262:2002+AMD1:2021

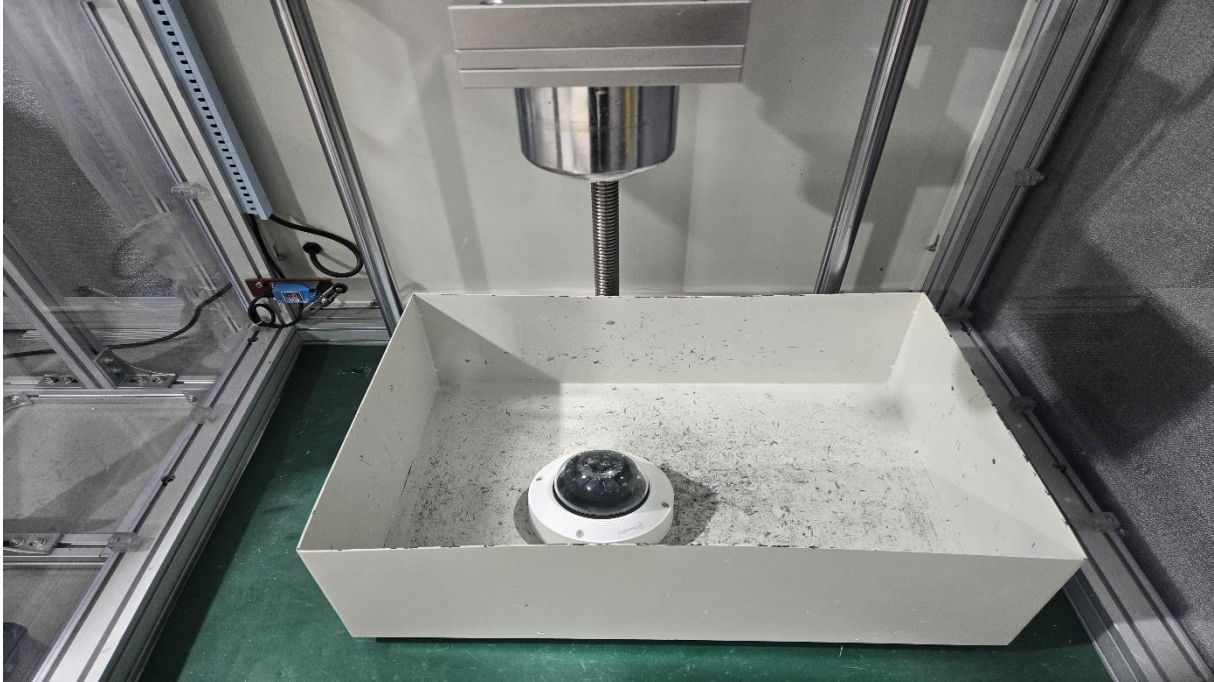
#### 3.3.1 Evidence of test setting

Impact times: five times for each of the exposed surface. (Do not impact more than 3 times in the same spot)

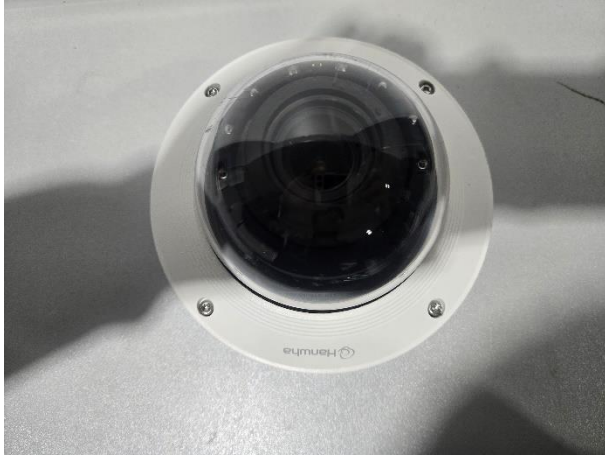
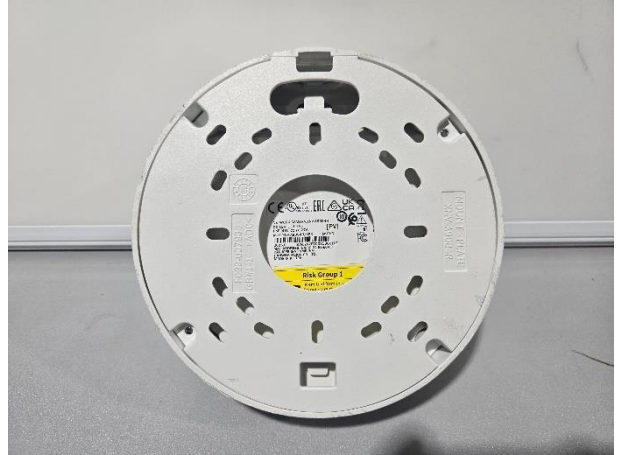
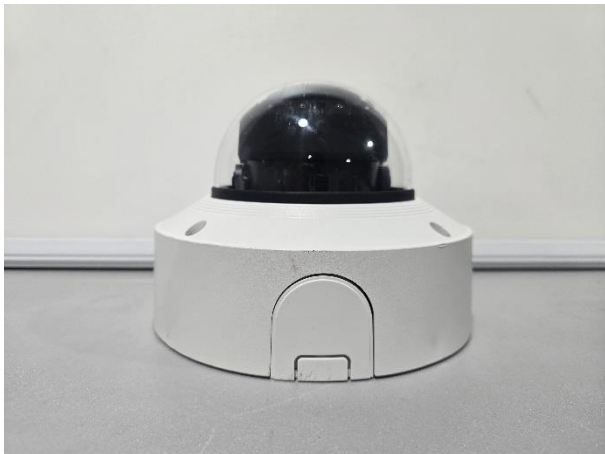
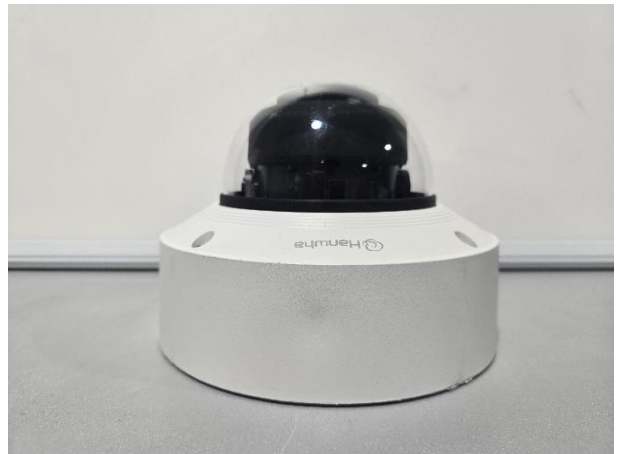
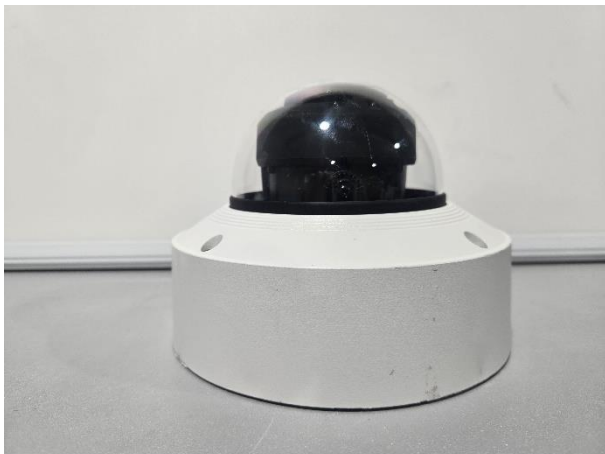
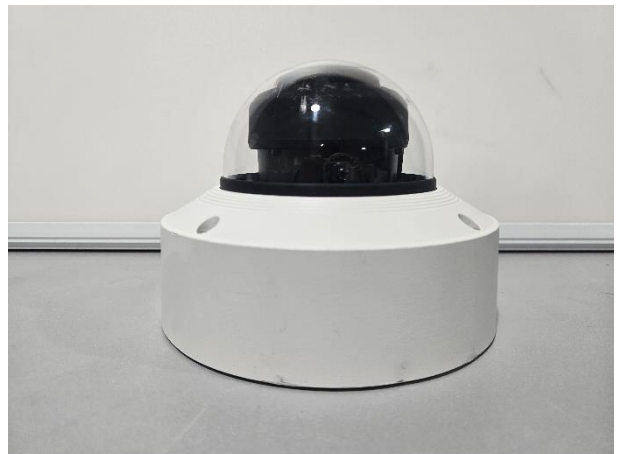
### 3.5.2 Post-test product images

Evaluation Criteria	Test Results	Remark
Visual Inspection	Some scratches were generated on the outside of the product.	-

※ Refer to the product photos after the completion of testing in section 3.5.2
