TEST REPORT

CTK-2025-00643

NETWORK CAMERA / XND-A9084RV

EN 60068-2-1, EN 60068-2-2, EN 60068-2-14, EN 60068-2-6
EN 60068-2-27, EN 60068-2-78, IEC 60068-2-1, IEC 60068-2-2,
IEC 60068-2-14, IEC 60068-2-6, IEC 60068-2-27, IEC 60068-2-78

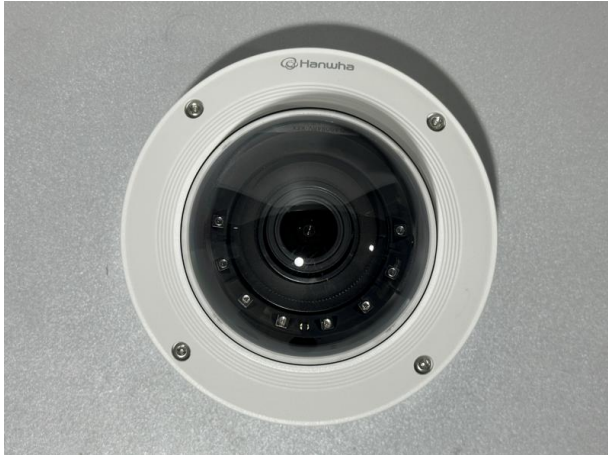
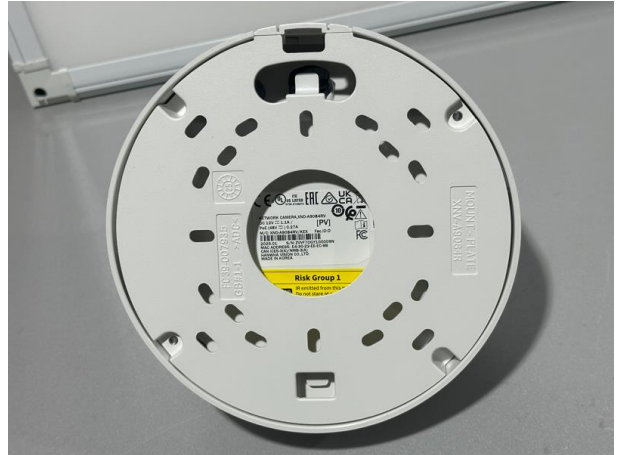
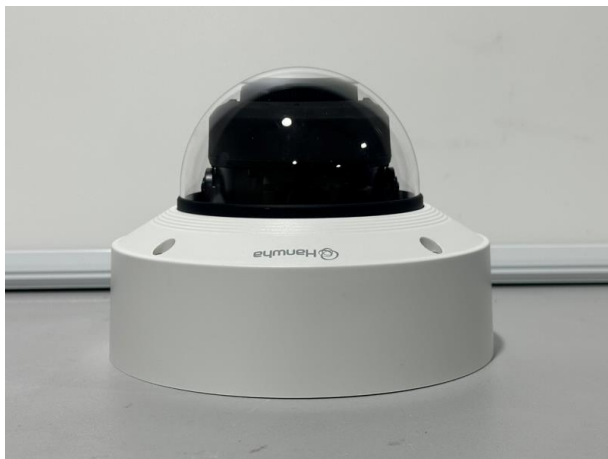
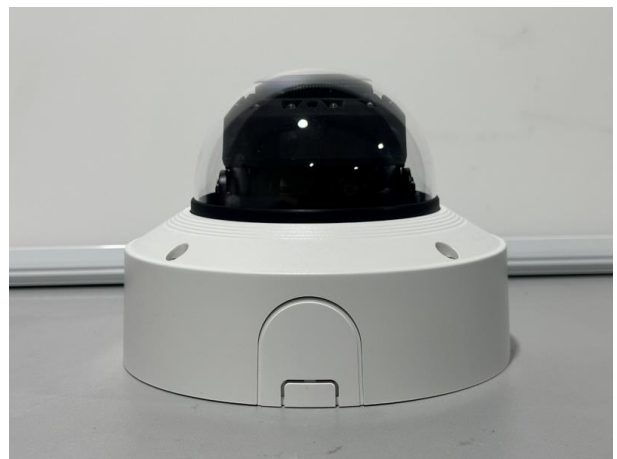
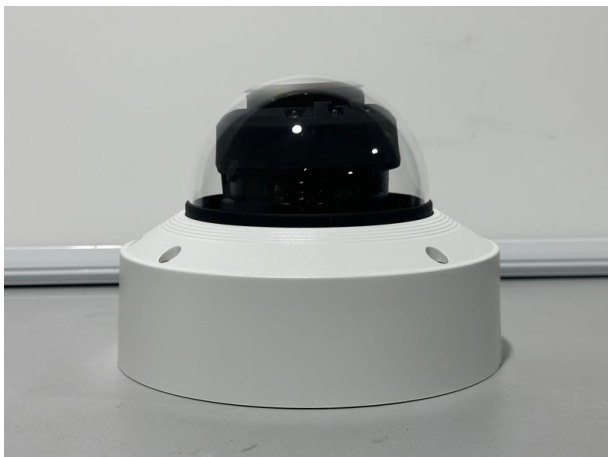
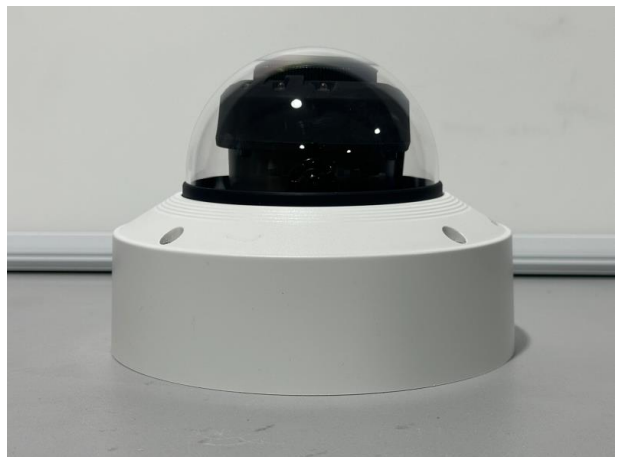
2.4.1 Test sample

2.4 Pre-test product images

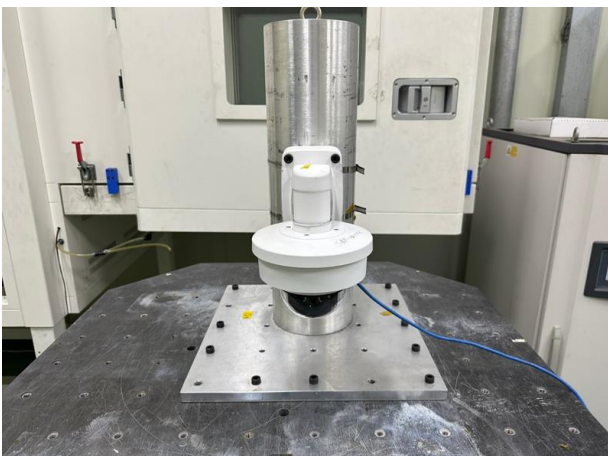
6.3.1 Evidence of test setting

- Sample status: operation
- Frequency(Hz): 5 Hz ~ 200 Hz
- Acceleration(G): 1 G
- Sweep rate: 1 oct/min
- Test Axis: Z, X, Y
- Test time(h): Total 30 min (10 min. per each axis)

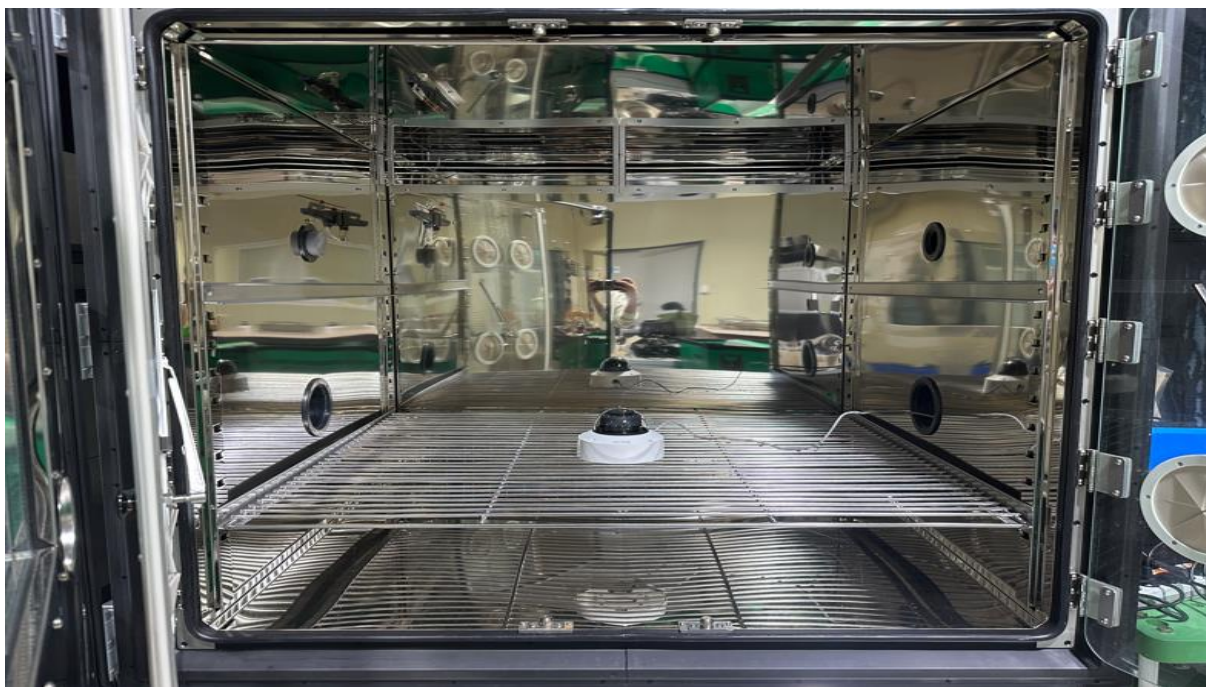
8.3.1 Evidence of test setting

8.2.1 Sample status: operation

8.2.2 Test temperature: 40 ± 2 °C

8.2.3 Test Humidity: 93 ± 3 % R.H.

8.2.4 Test time: 240 h
