TEST REPORT

REPORT No.:
CTK-2025-00620
Page (1) / (13) pages

NETWORK CAMERA / XND-A9084RV

IEC 62262:2002+AMD1:2021

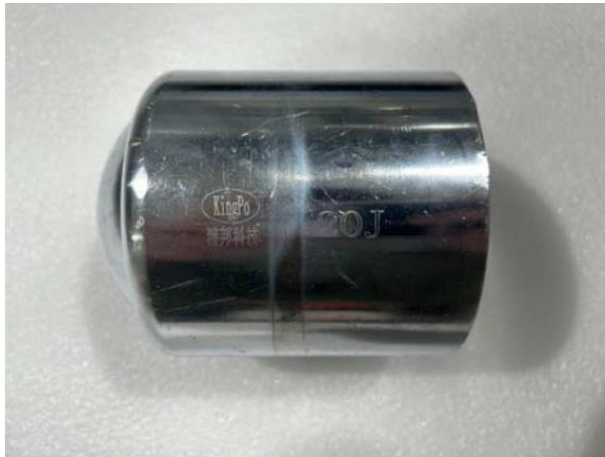
Testing equipment	Model Name	Manufacturer	Manufacturing Number	Calibration Date
Vertical Hammer Tester	Vertical Hammer	Kingpo	0190605A01002	-
Vertical Hammer	20J	Kingpo	TX028-3	-
Steel measuring meter	5.5 m	KOMELON	225851	Jan. 01, 2026

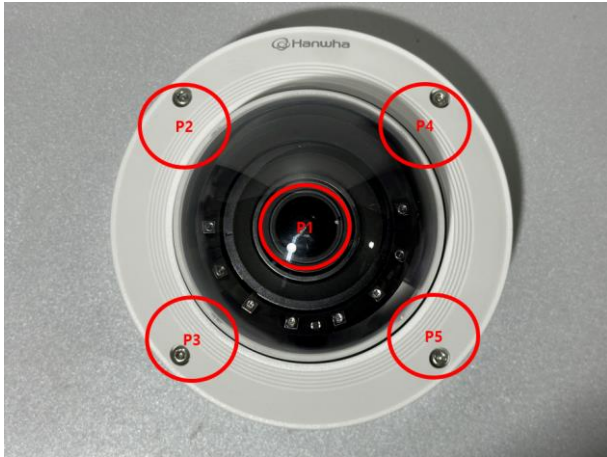
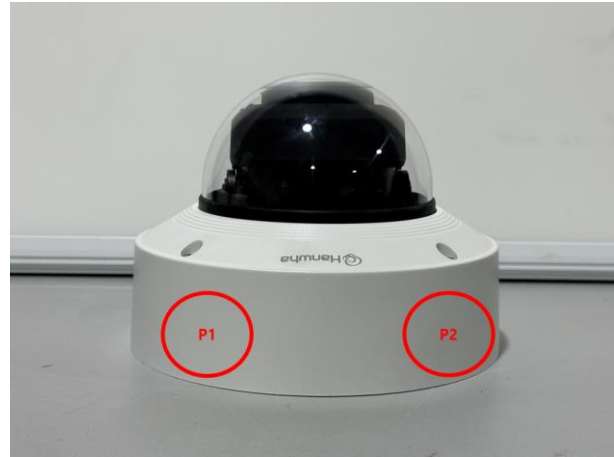
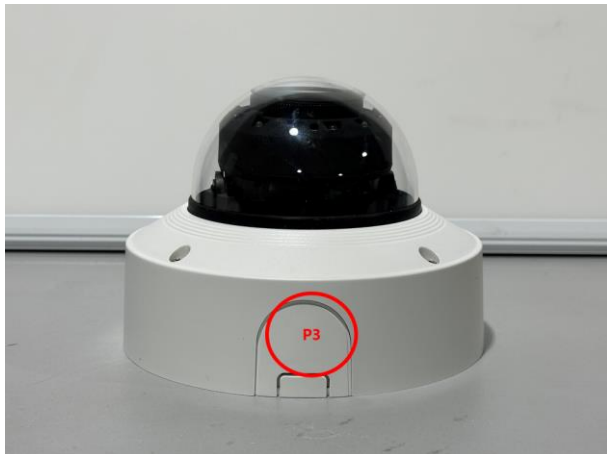
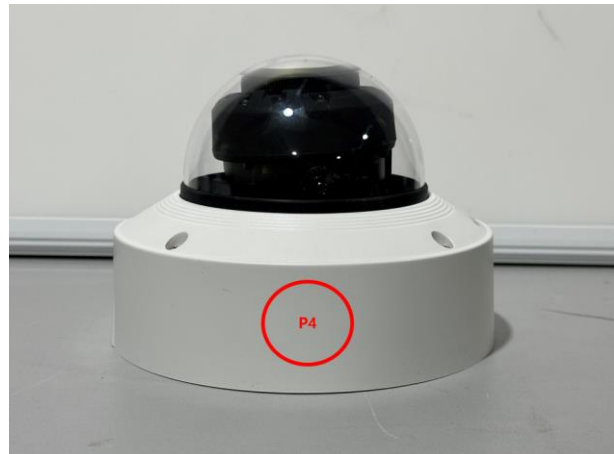
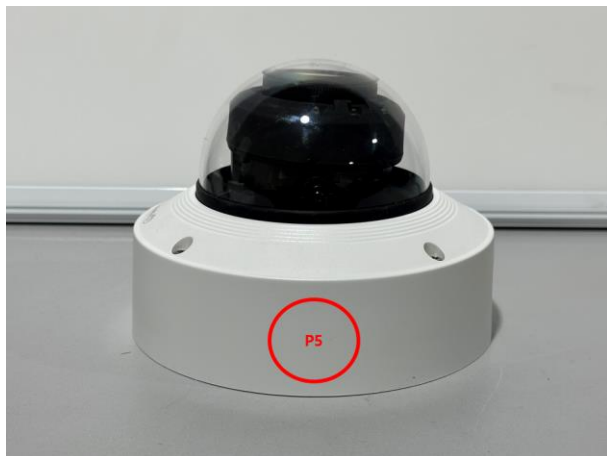
3.5.1 Check the hit area during the test

Check the hit area the test_1

Check the hit area the test_2

Check the hit area the test_3

Check the hit area the test_4

Check the hit area the test_5

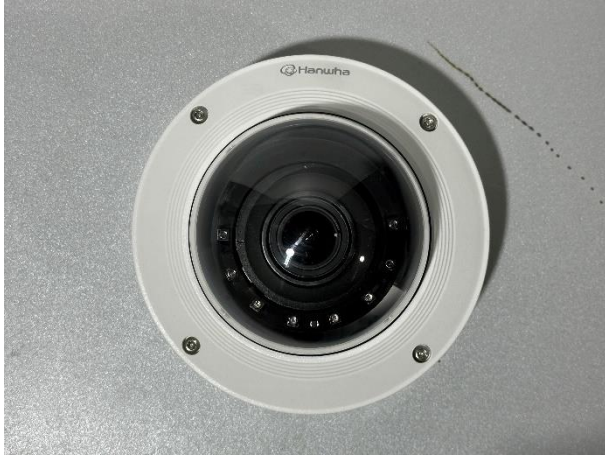
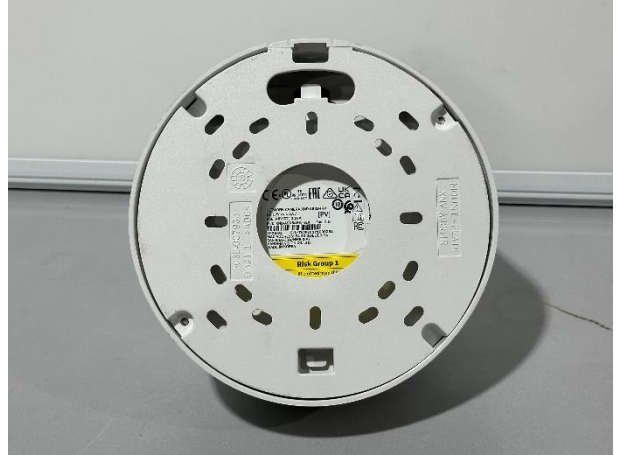
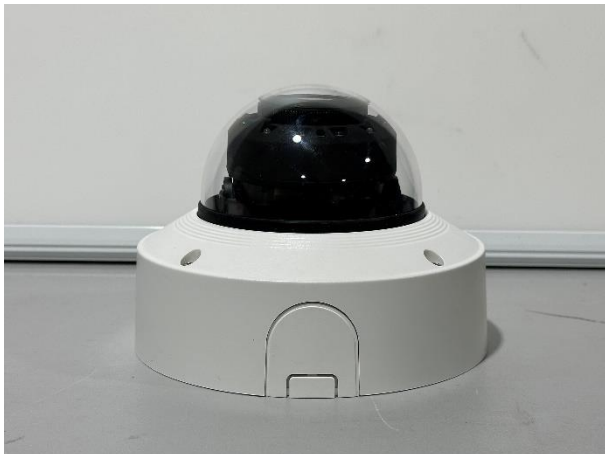
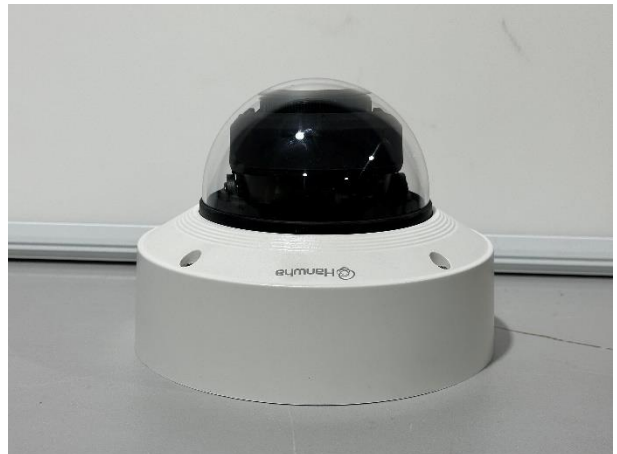
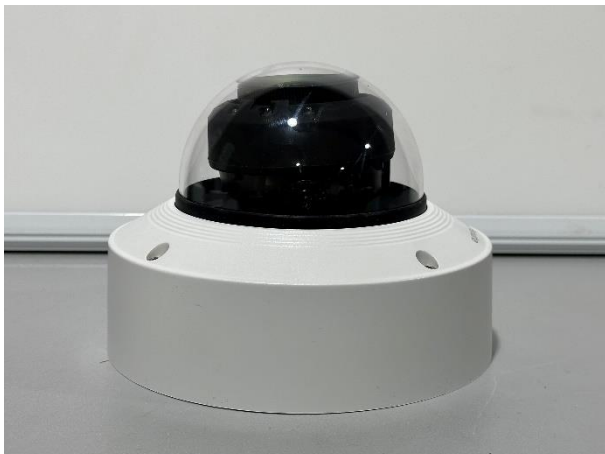
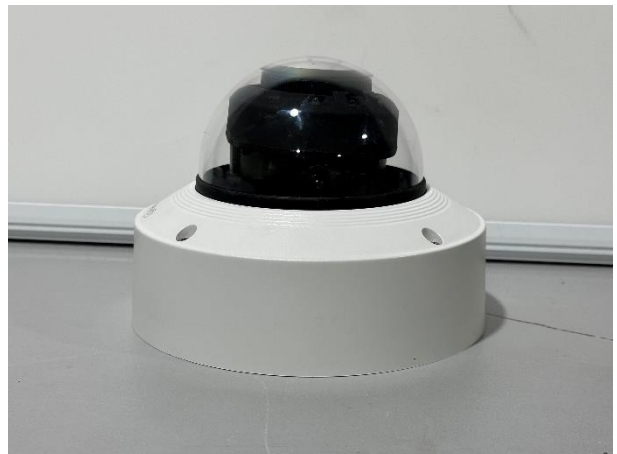
3.5.2 Post-test product images

Evaluation Criteria	Test Results	Remark
Visual Inspection	Some scratches were generated on the outside of the product.	-

※ Refer to the product photos after the completion of testing in section 3.5.2
