# TEST REPORT

REPORT No.:  
CTK-2025-00638  
Page (1) / (15) pages

NETWORK CAMERA / XND-A9084RV

IEC 60529:1989 +A1:1999+A2:2013

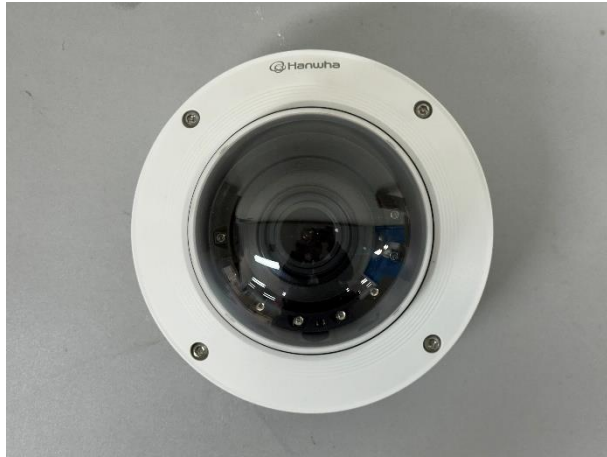
Top

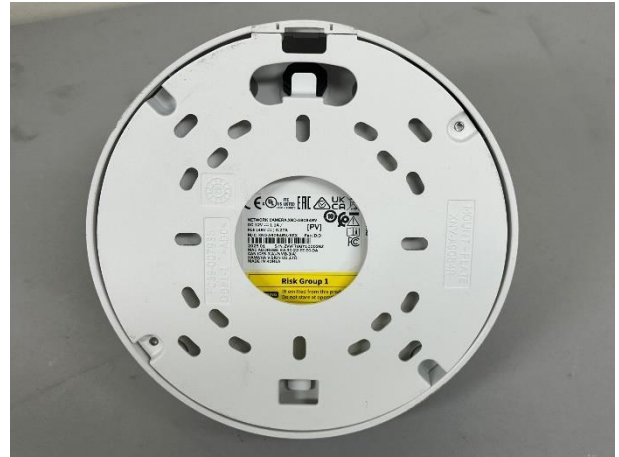
Bottom

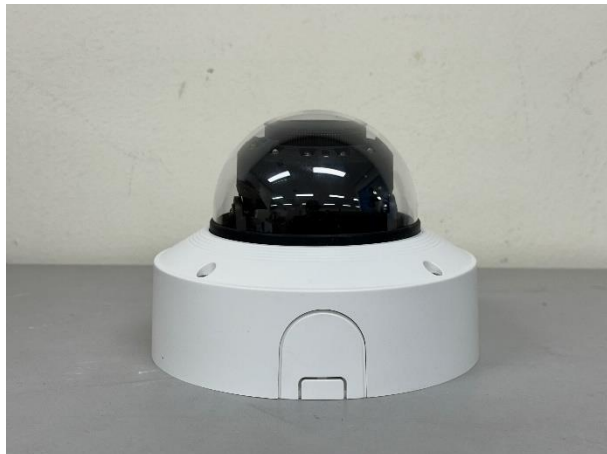
Front

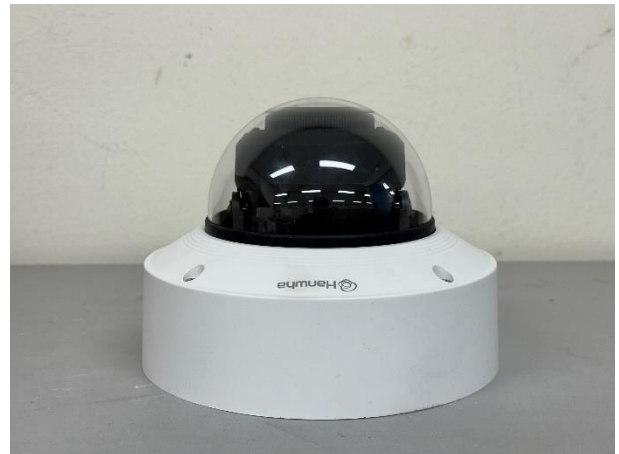
Rear

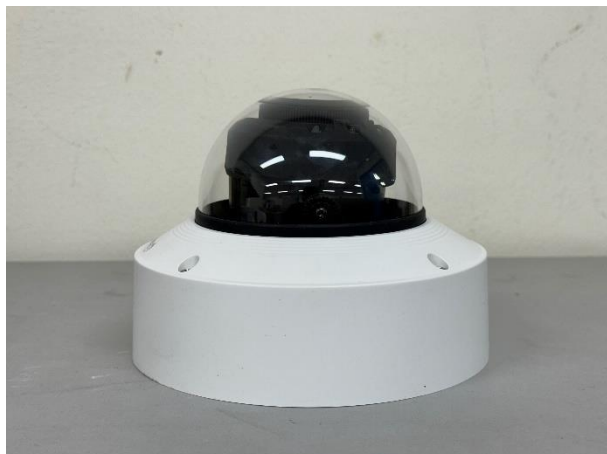
Left side

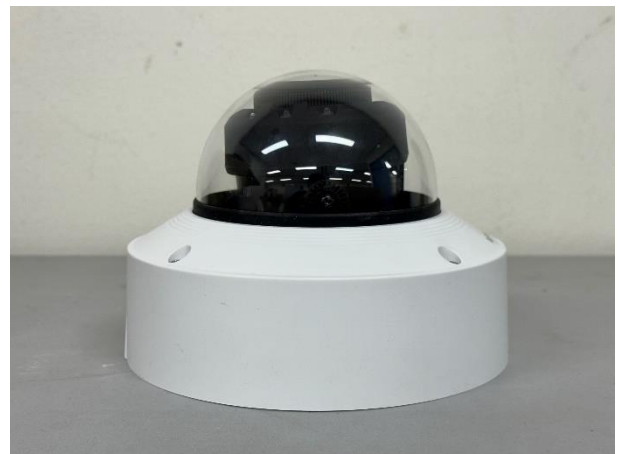
Right side

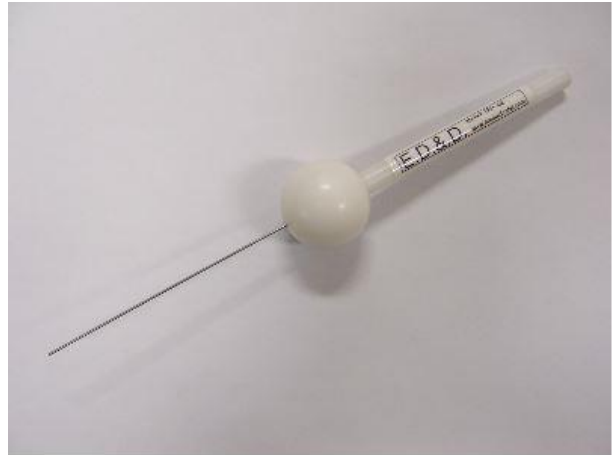
Test Rod Probe Ø1.0

First characteristic numeral	Degree of protection	Application
5	Protected against access to hazardous parts with a wire. The access probe of 1.0 mmØ, shall not penetrate. Test force: 1 N ± 10 %	<input checked="" type="checkbox"/>

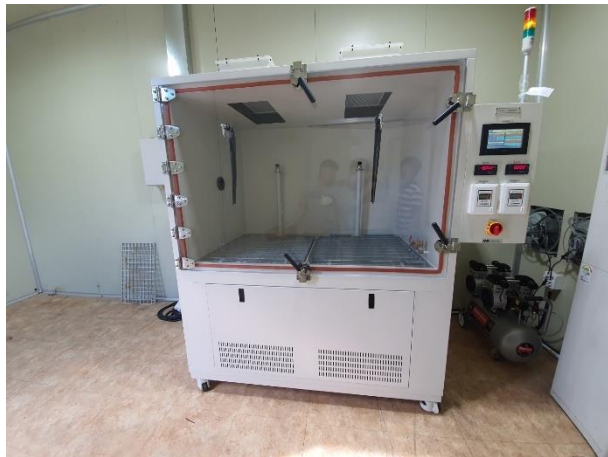
Dust Chamber

First characteristic numeral	Degree of protection	Application
5	<p>Dust Testing Equipment</p> <p>Whether reductions in pressure below the atmospheric pressure are present or not, ingress of dust is not totally preventive, but dust shall not penetrate in a quantity to interfere with satisfactory operation of the apparatus or to impair safety.</p> <p>(The talcum powder must pass through a calibrated sieve with a 50 µm wire mesh, spaced at 75 µm intervals in a square pattern. Additionally, the bulk density of the talcum powder should be 2 kg/m³)</p>	—
	<p><b>Category 1:</b> Enclosures where the normal working cycle of the equipment causes reductions in air pressure within the enclosure below that of the surrounding air, for example, due to thermal cycling effects.</p> <p>Products in volume .....: cm³ → L</p> <p>Target intake volume (Products in volume 80) : L</p> <p>Suction volume (Max product in volume 60) ...: LPH → LPM</p> <p>Actual Suction volume .....: L</p> <p>Suction pressure (Up to 2 kPa) .....: kPa</p> <p>Test time (Up to 8 time) .....: hr</p>	<input type="checkbox"/>

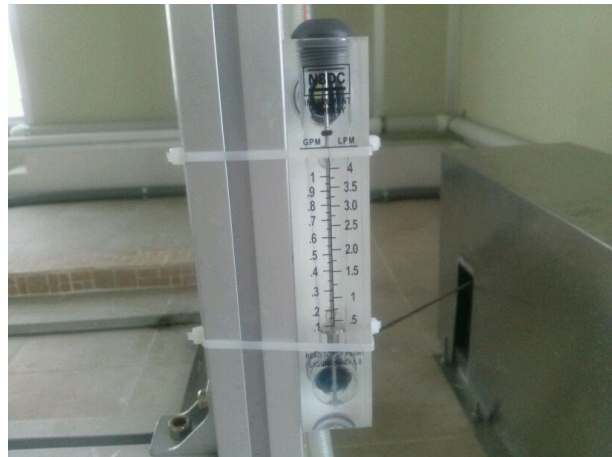
Water flow meter with Drip box

Second characteristic numeral	Degrees of protection	Application
2	<p>When outskirts of the product have been tilted by 15° Water that drops verticality has to be harmless.</p> <p>Drip box Fig.3, Enclosure in 4 fixed positions of 15° tilt</p> <p>Water flow rate: 3 mm/min</p> <p>Duration of test: 2.5 min for each position of tilt</p>	<input checked="" type="checkbox"/>

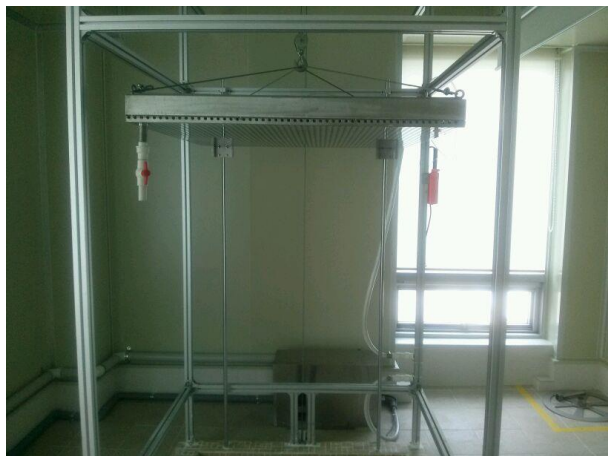
Drip box

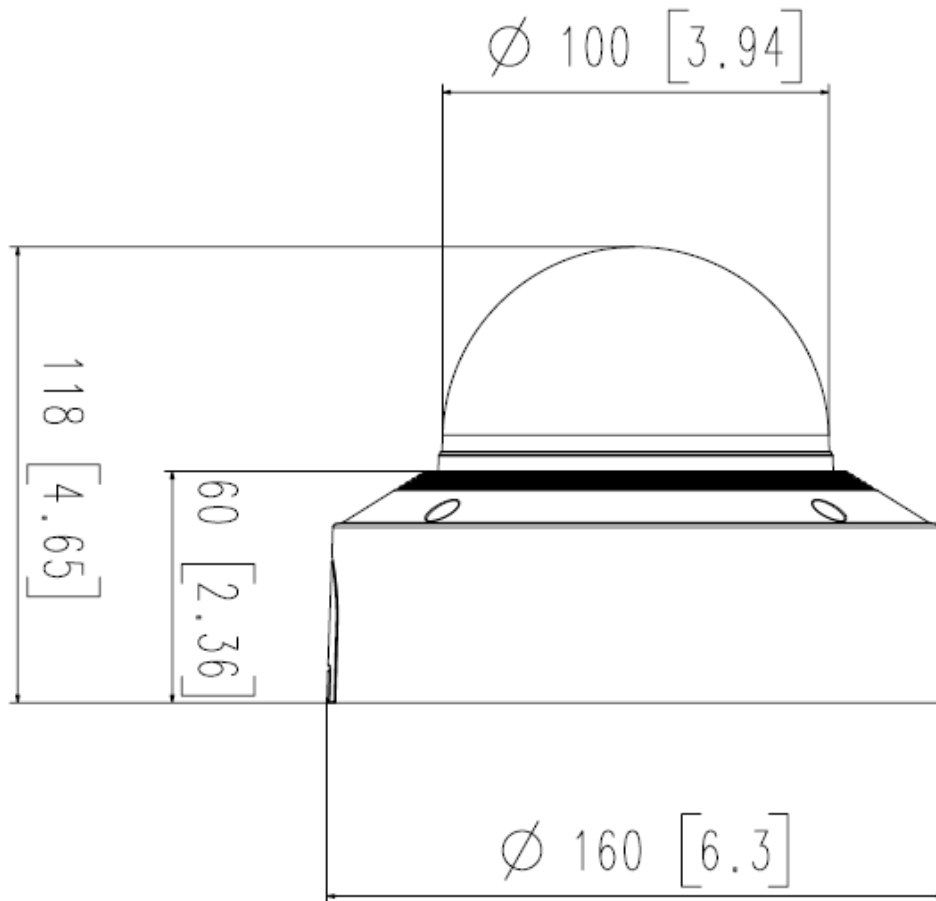
Enclosure dimensions [unit : mm]

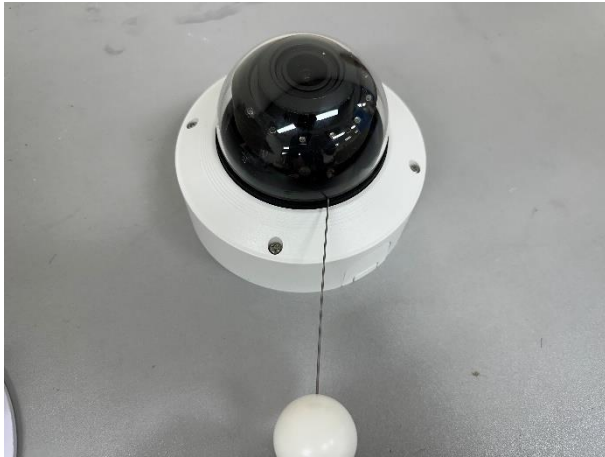
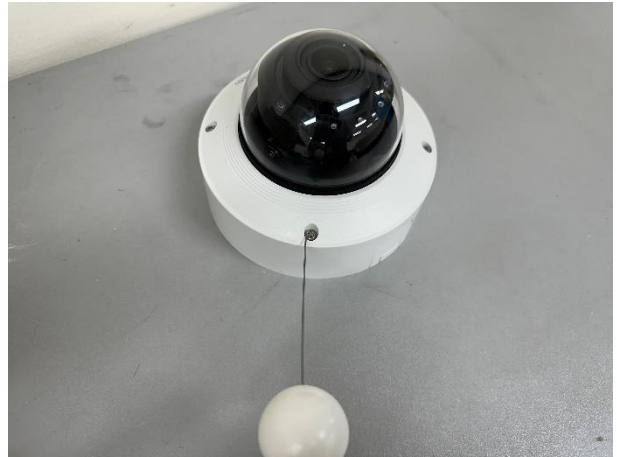
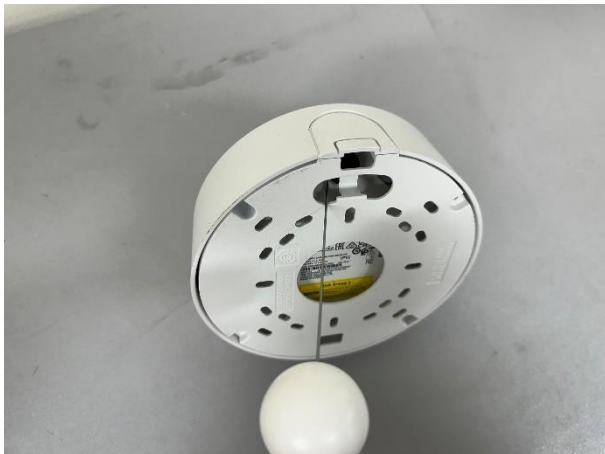
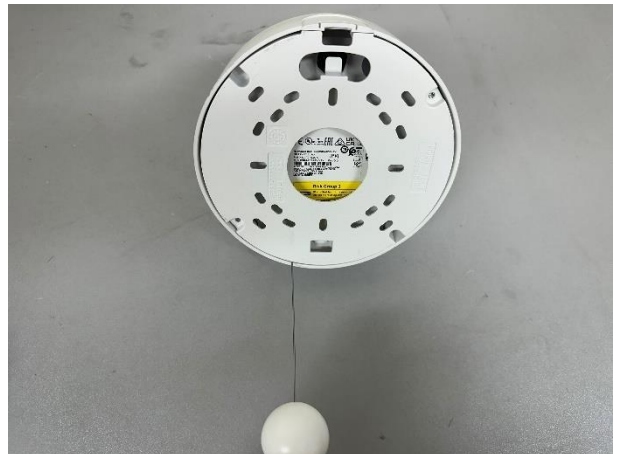
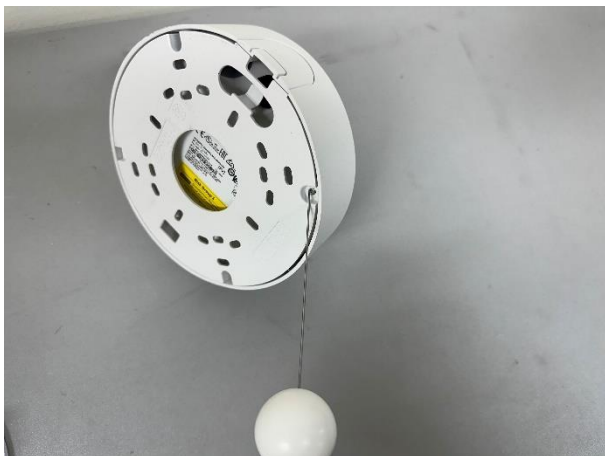
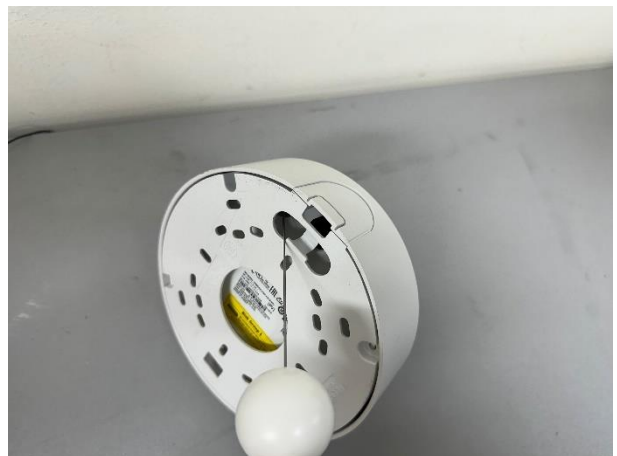
#### 3.3.1 Evidence of test setting (1)

Probe test

IP code	Evaluation Criteria	Test Results	Remark
IP 5X	No ingress of Probe	Normal	-
	No ingress of dust	Normal	
IP X2	No ingress of water	Normal

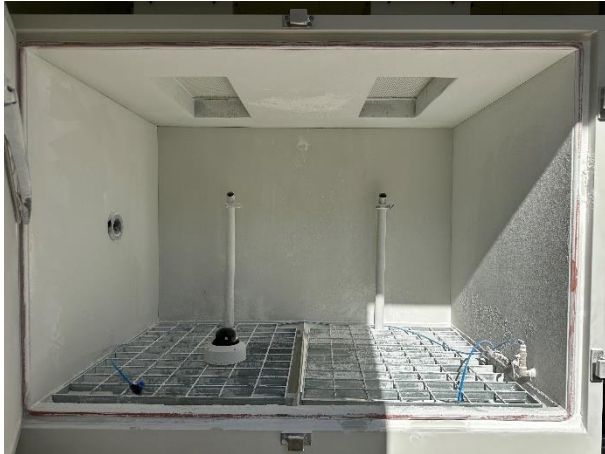
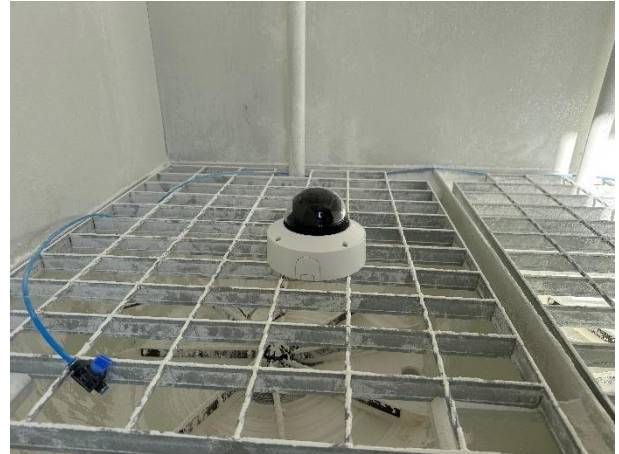
Dust test

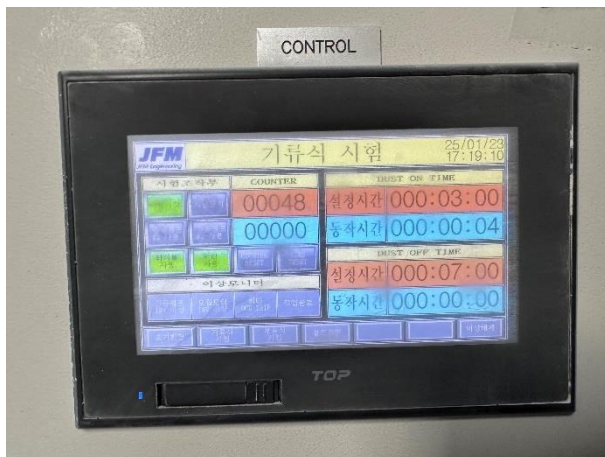
Dust test Monitor

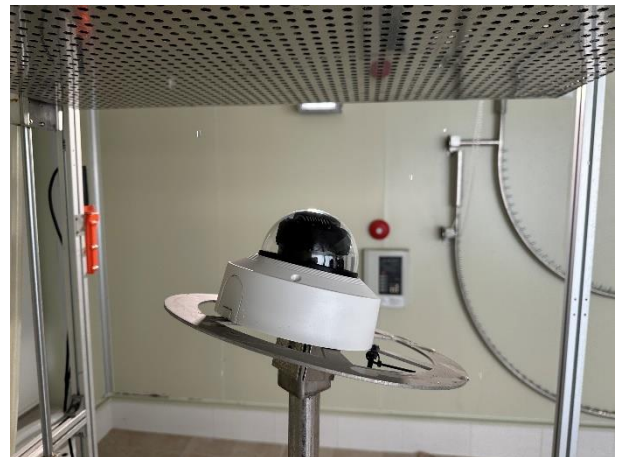
Water test

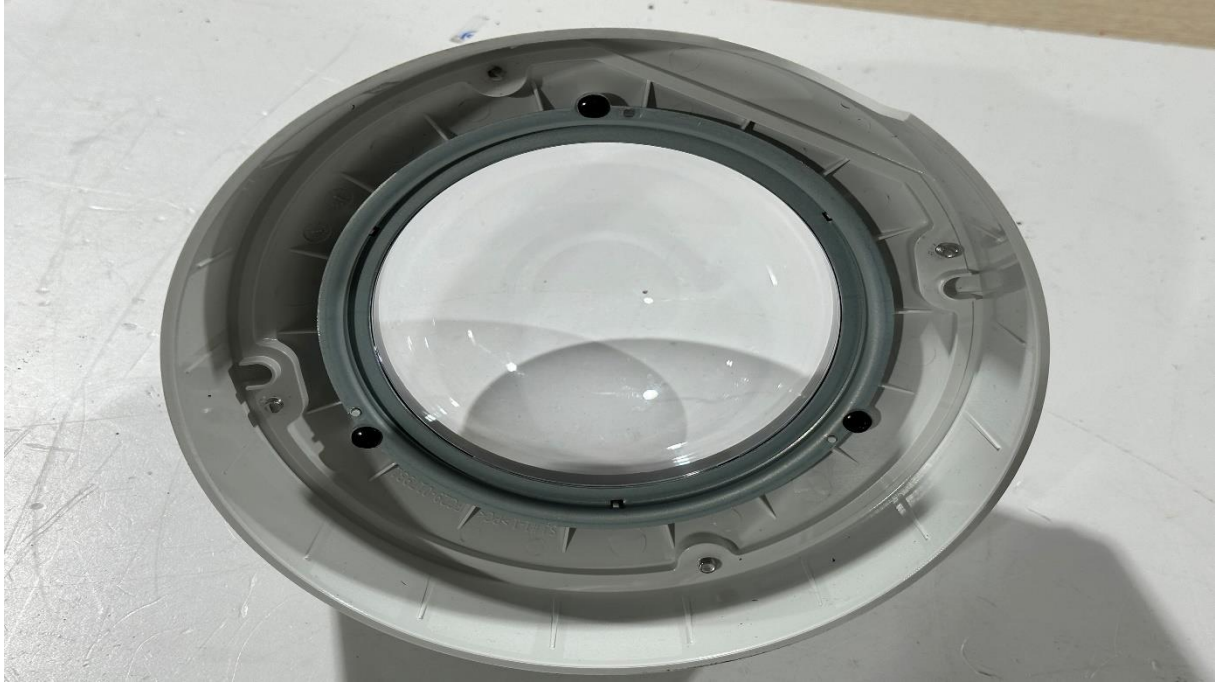
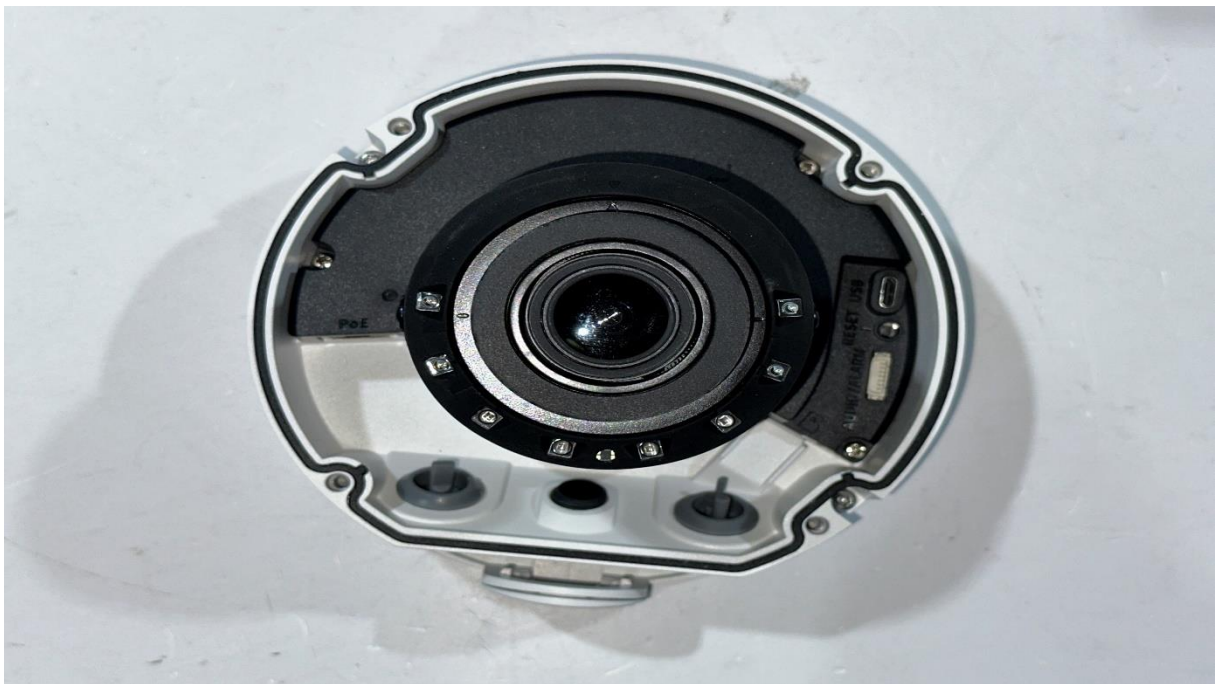
#### 3.5.1 Product internal images after test [The first characteristic numeral test]

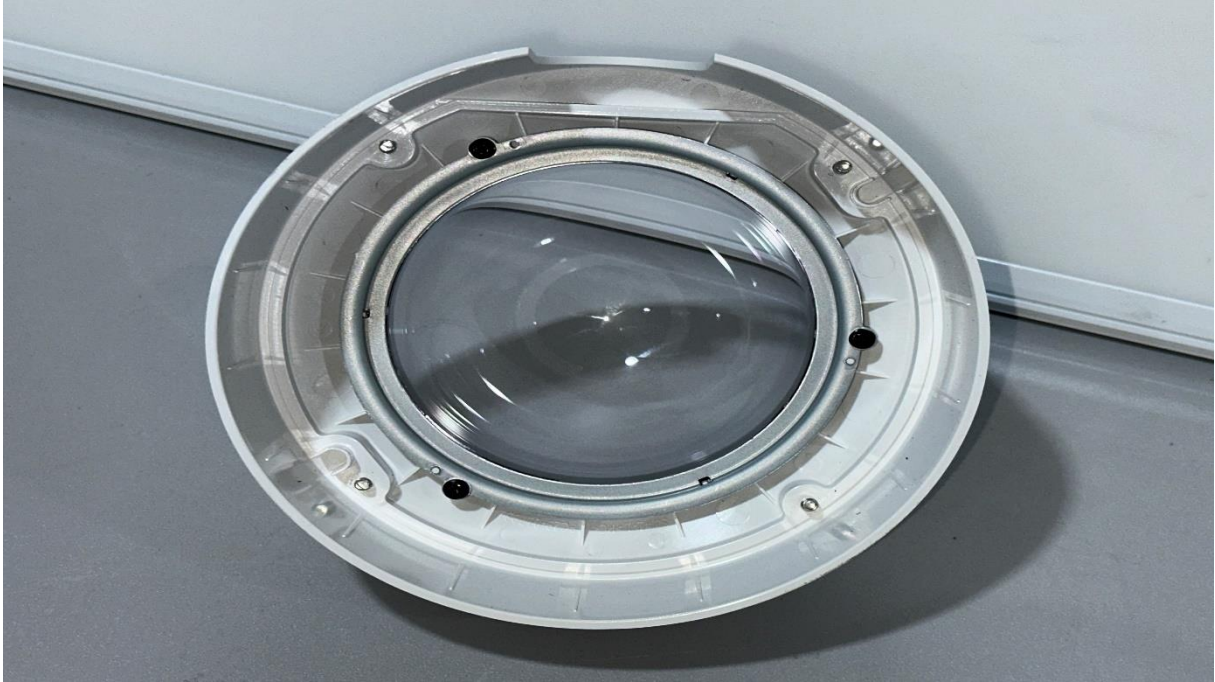
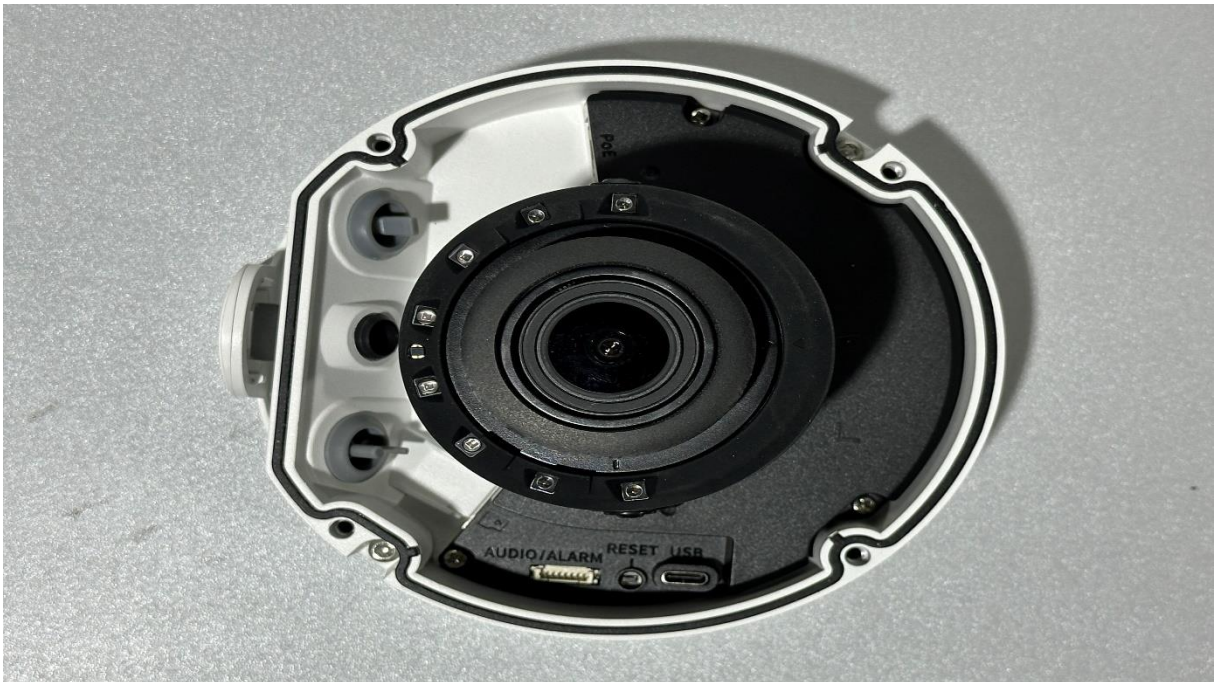
### 3.5.2 Product internal images after test [The second characteristic numeral test]
