# TEST REPORT

REPORT No.:  
CTK-2025-01000  
Page (1) / (14) pages

NETWORK CAMERA / PNM-C19183RVTP

IEC 60529:1989 +A1:1999+A2:2013

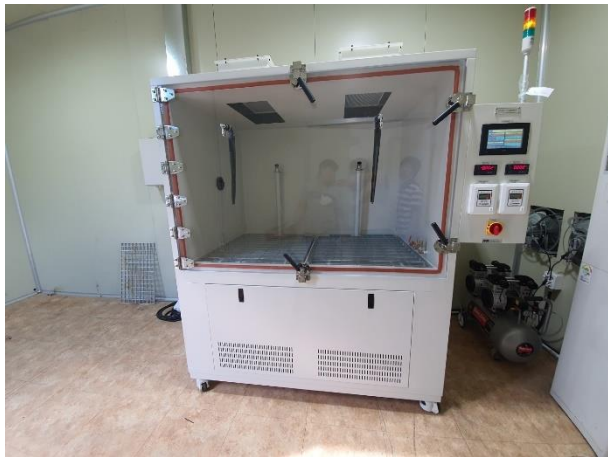
Dust Chamber

First characteristic numeral	Degree of protection	Application
6	<p>In Dust Testing Equipment, the test sample must have no ingress of dust after testing atmospheric pressure present condition for 8 h.</p> <p>(The talcum powder must pass through a calibrated sieve with a 50 µm wire mesh, spaced at 75 µm intervals in a square pattern. Additionally, the bulk density of the talcum powder should be 2 kg/m<sup>3</sup>)</p> <p>Products in volume .....: <b>13 398.82 cm<sup>3</sup> → 13.40 L</b></p> <p>Target intake volume (Products in volume 80) : <b>1 071.91 L</b></p> <p>Suction volume (Max product in volume 60) ..: <b>803.93 LPH → 13.40 LPM</b></p> <p>Actual Suction volume .....: <b>13.40 L</b></p> <p>Suction pressure (Up to 2 kPa) .....: <b>1.81 kPa</b></p> <p>Test time (Up to 8 time) .....: <b>8 hr</b></p>	<input checked="" type="checkbox"/>

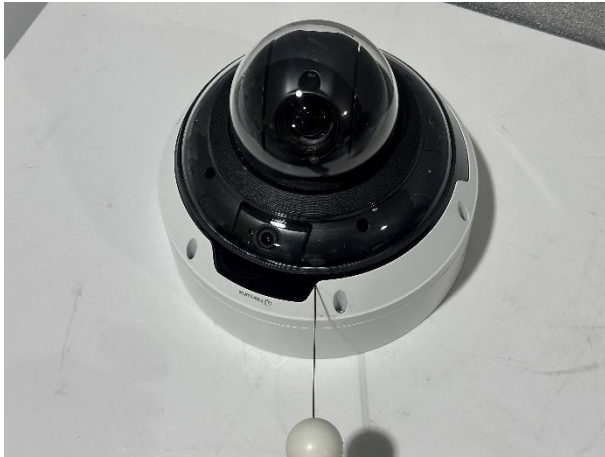
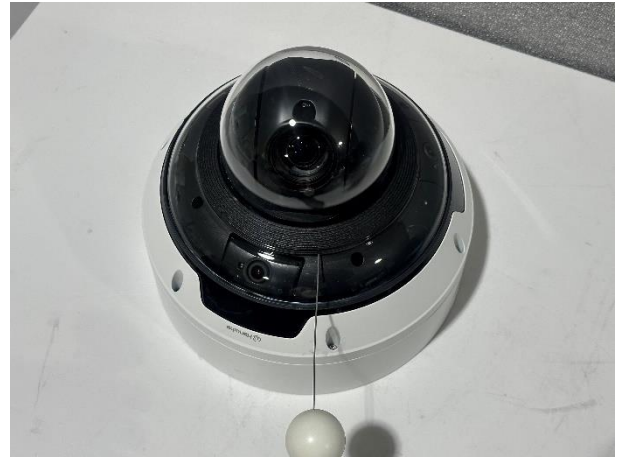
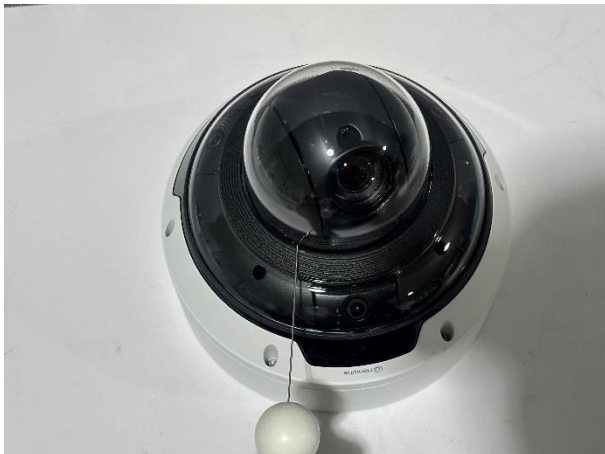
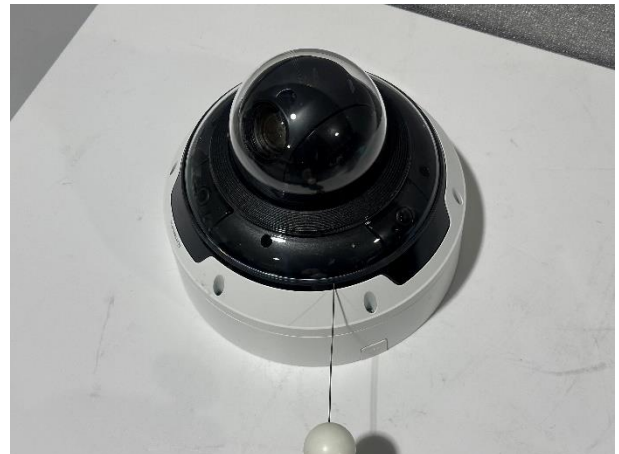
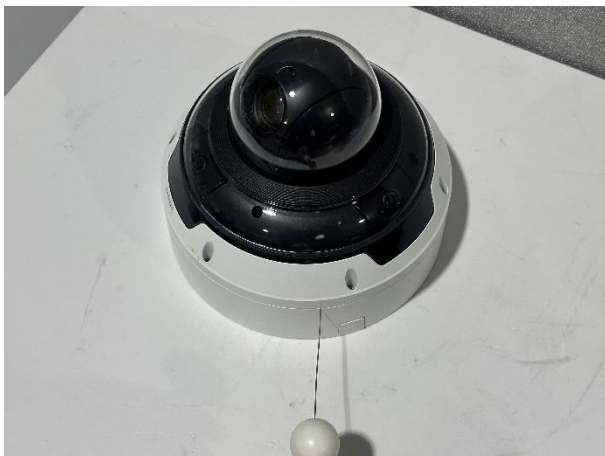
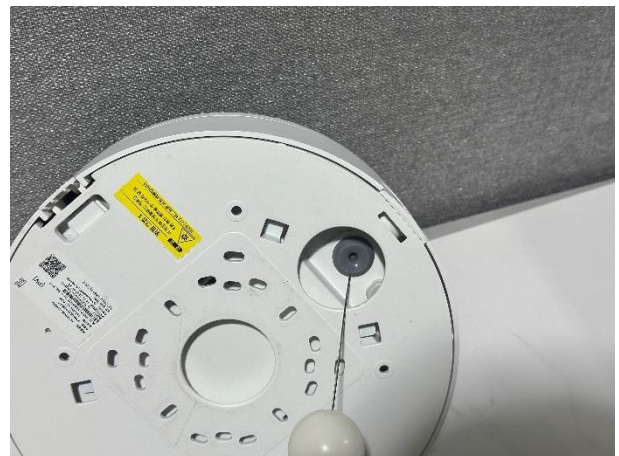
#### 3.3.1 Evidence of test setting (1)

First characteristic numeral	Degree of protection	Application
6	Protected against access to hazardous parts with a wire. The access probe of 1.0 mmØ, shall not penetrate. Test force: 1 N ± 10 %	<input checked="" type="checkbox"/>

Probe test

IP code	Evaluation Criteria	Test Results	Remark
IP 6X	No ingress of Probe	Normal	-
	No ingress of dust	Normal	-
IP X6	No ingress of water	Normal	-

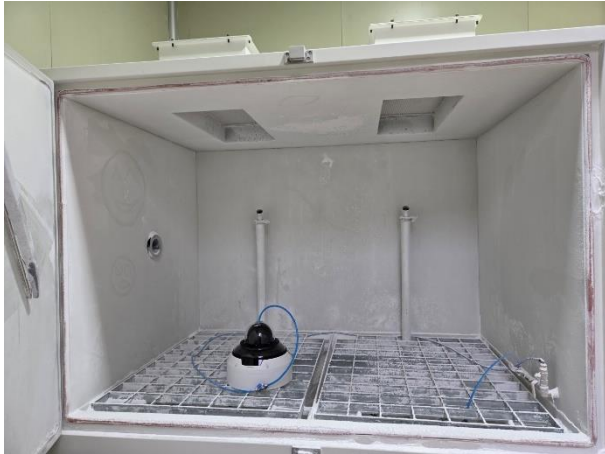
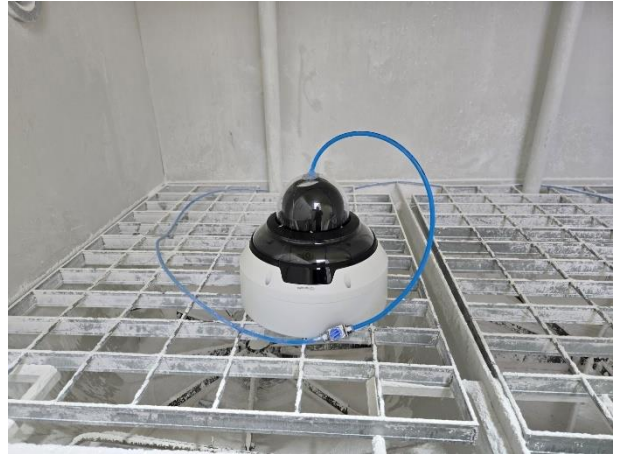
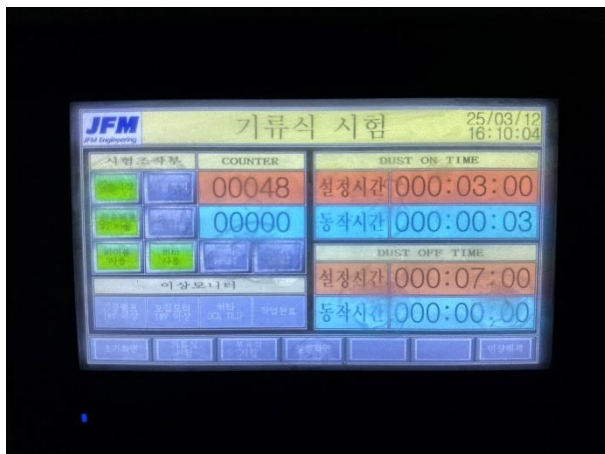
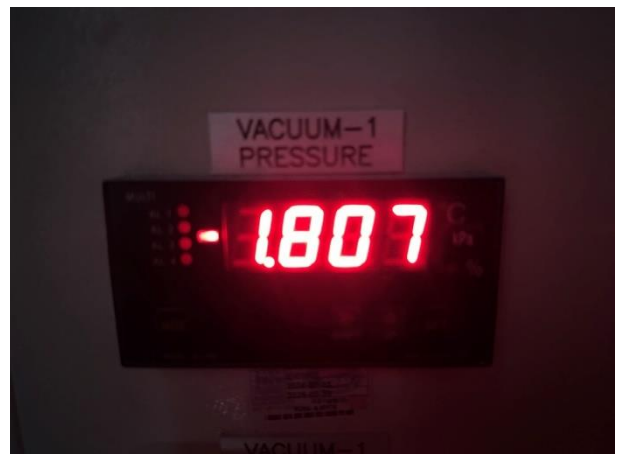
### 3.3.2 Evidence of test setting (2)

Dust test

Dust test Monitor

Digital Vacuum Pressure

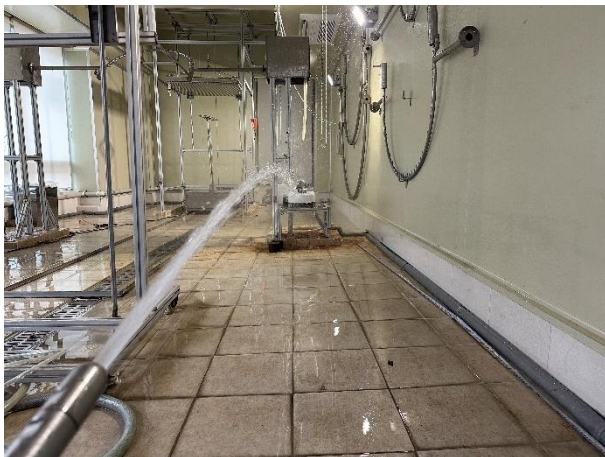
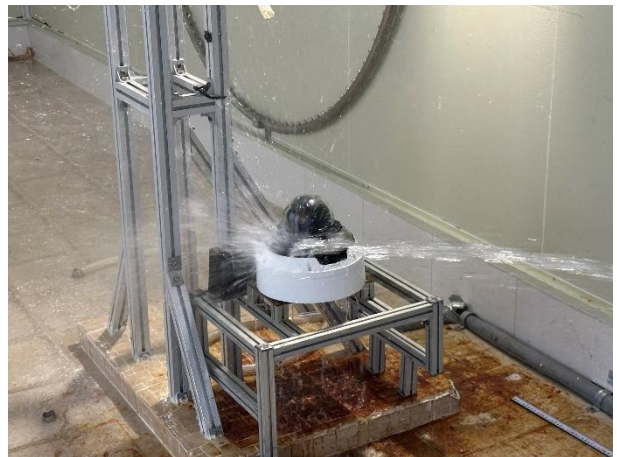
Second characteristic numeral	Degrees of protection	Application
6	<p>The product must not be harmed in any direction even strong jet water.</p> <p>Water jet hose nozzle Fig.6, Nozzle 12.5 mm diameter</p> <p>Water flow rate: 100 l/min ± 5 % : <b>100 LPM</b></p> <p>Distance: 2.5 m to 3 m: <b>3 m</b></p> <p>Duration of test: 1 min/m<sup>2</sup> at least 3 min: <b>3 min</b></p>	<input checked="" type="checkbox"/>

Water test
