# TEST REPORT

REPORT No.:  
CTK-2025-00626  
Page (1) / (14) pages

NETWORK CAMERA / XNV-A9084R

IEC 60529:1989 +A1:1999+A2:2013

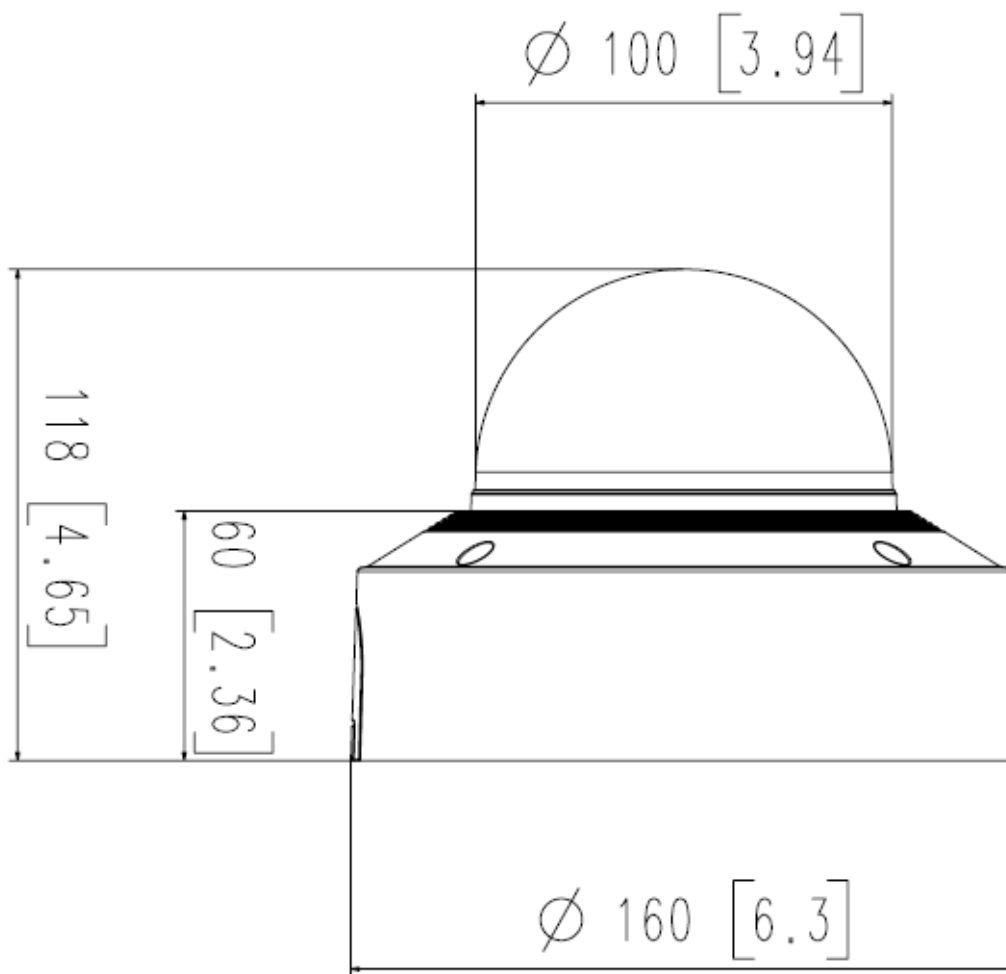
Enclosure dimensions [unit : mm]

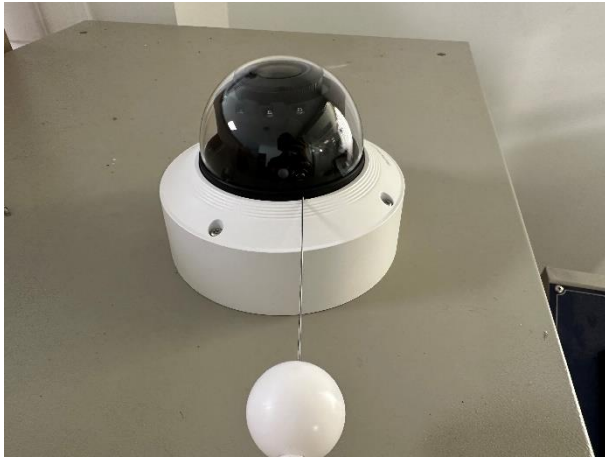
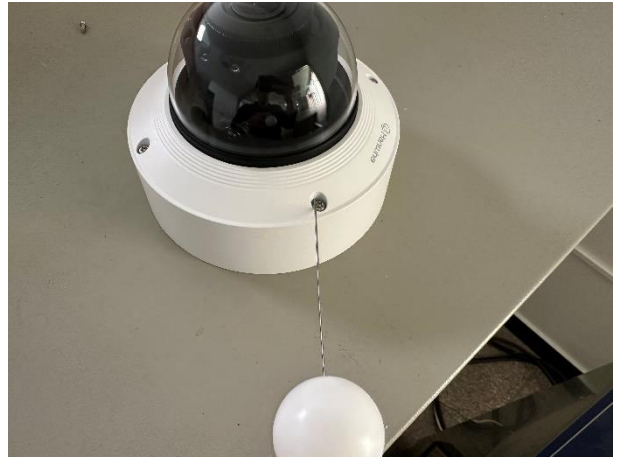
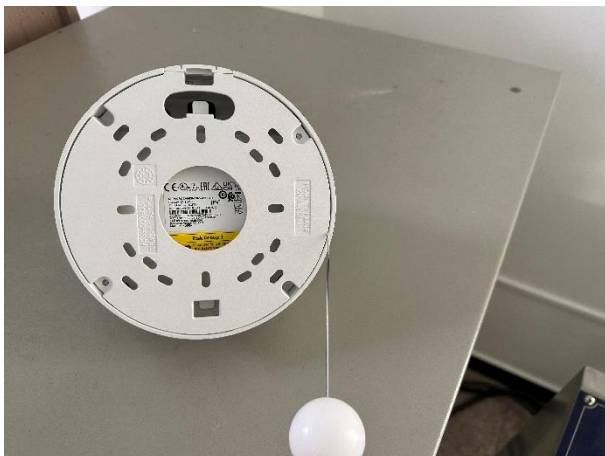
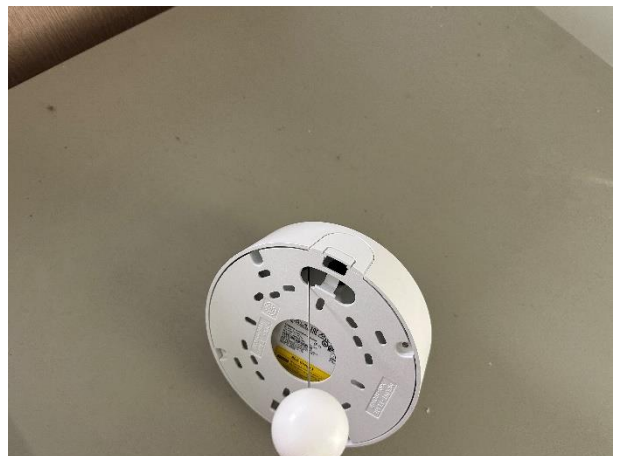
First characteristic numeral	Degree of protection	Application
6	Protected against access to hazardous parts with a wire. The access probe of 1.0 mmØ, shall not penetrate. Test force: 1 N ± 10 %	<input checked="" type="checkbox"/>

Probe test

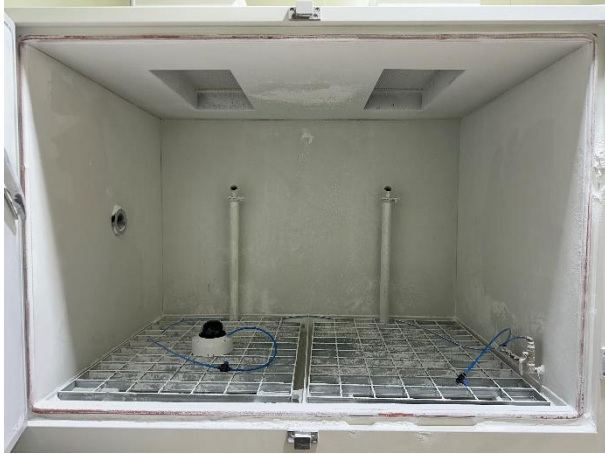
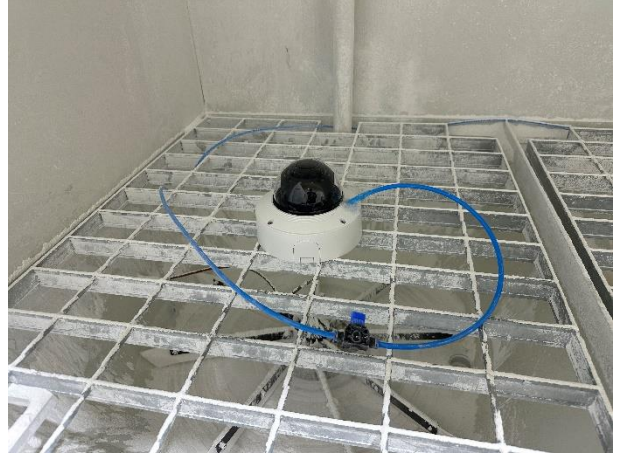
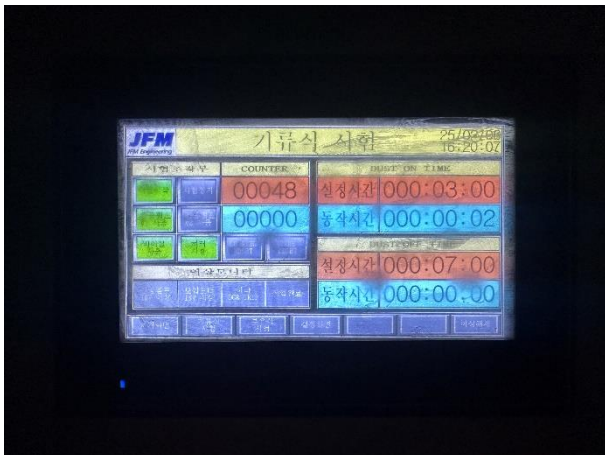
First characteristic numeral	Degree of protection	Application
6	<p>In Dust Testing Equipment, the test sample must have no ingress of dust after testing atmospheric pressure present condition for 8 h.</p> <p>(The talcum powder must pass through a calibrated sieve with a 50 µm wire mesh, spaced at 75 µm intervals in a square pattern. Additionally, the bulk density of the talcum powder should be 2 kg/m³)</p> <p>Products in volume .....: <b>3 020.8 cm³ → 3.02 L</b></p> <p>Target intake volume (Products in volume 80) : <b>241.66 L</b></p> <p>Suction volume (Max product in volume 60) ..: <b>181.25 LPH → 3.02 LPM</b></p> <p>Actual Suction volume .....: <b>3.02 L</b></p> <p>Suction pressure (Up to 2 kPa) .....: <b>1.81 kPa</b></p> <p>Test time (Up to 8 time) .....: <b>8 hr</b></p>	<input checked="" type="checkbox"/>

Dust test

Dust test Monitor

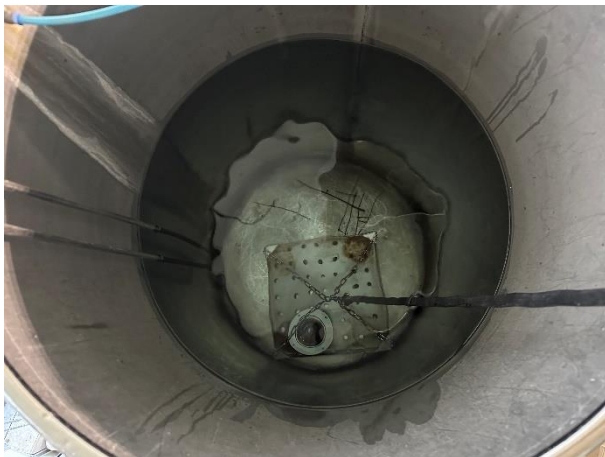
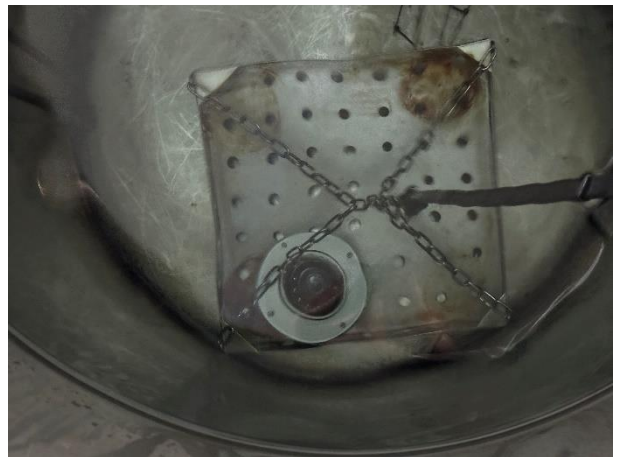
Second characteristic numeral	Degrees of protection	Application
7	<p>Sink the product in the water by the Pressure and Time according to regulation and the product must not be harmed.</p> <p>Immersion tank water-level on enclosure with:</p> <p><input type="checkbox"/> height equal to or greater than 850 mm: the highest point of enclosures located 0.15 m below the surface of the water</p> <p><input checked="" type="checkbox"/> height less than 850 mm: the lowest point of enclosures located 1 m below the surface of the water</p> <p>Duration of test: 30 min</p>	<input checked="" type="checkbox"/>

Water test

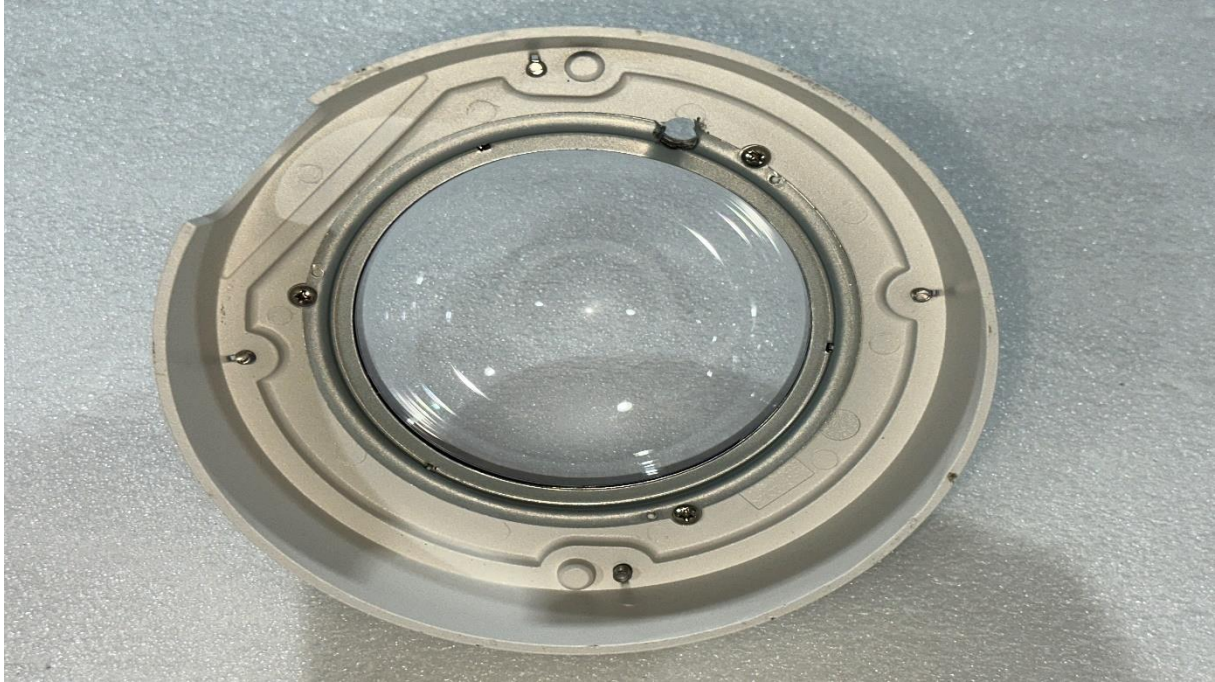
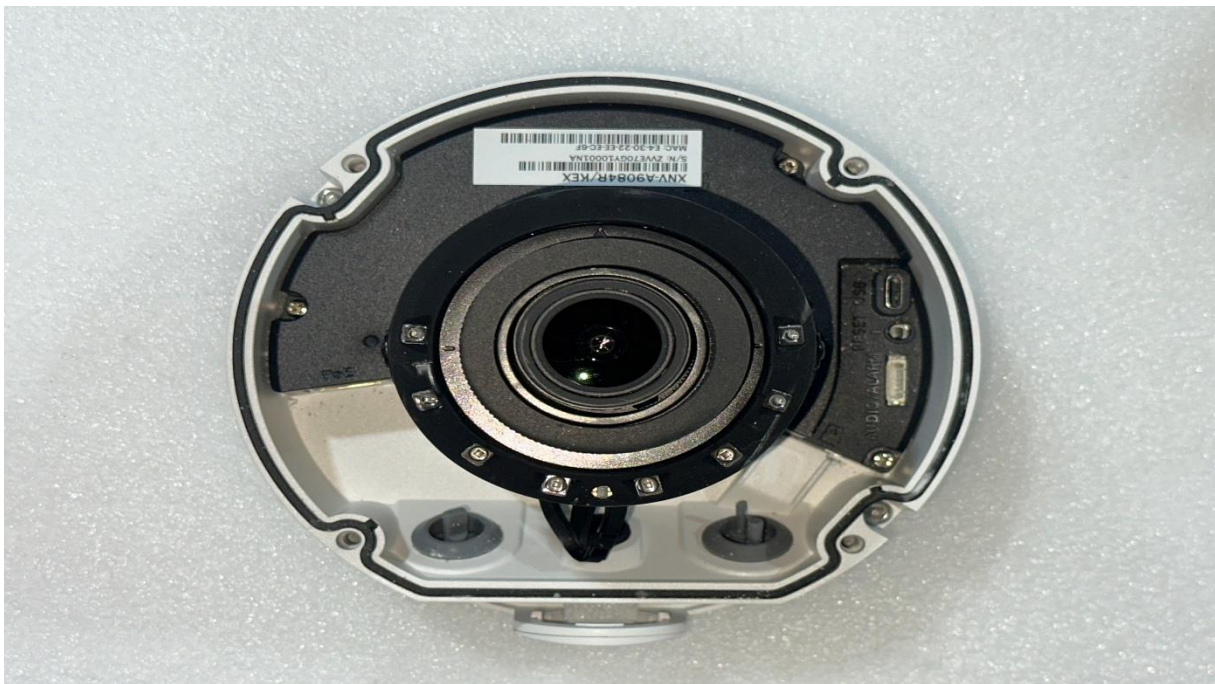
#### 3.5.1 Product internal images after test [The first characteristic numeral test]

IP code	Evaluation Criteria	Test Results	Remark
IP 6X	No ingress of Probe	Normal	-
	No ingress of dust	Normal	-
IP X7	No ingress of water	Normal	-
