TEST REPORT

REPORT No.:
CTK-2025-00624
Page (1) / (14) pages

NETWORK CAMERA / XNV-A9084R

IEC 60529:1989 +A1:1999+A2:2013

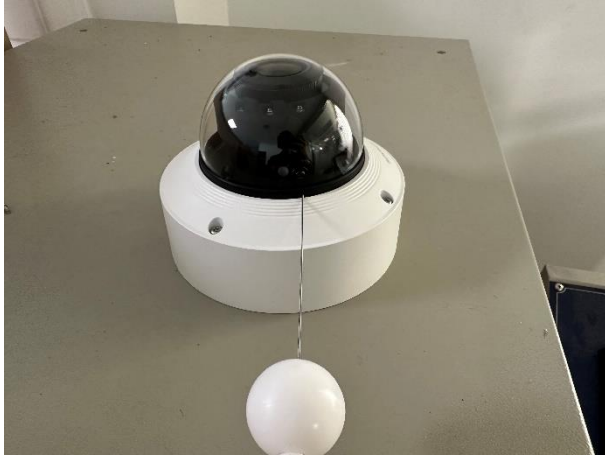
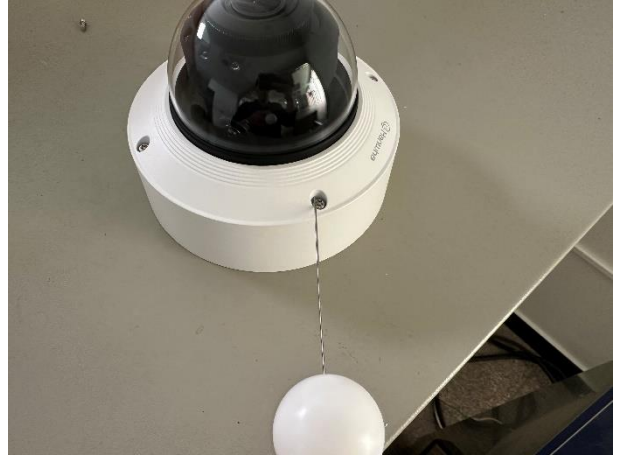
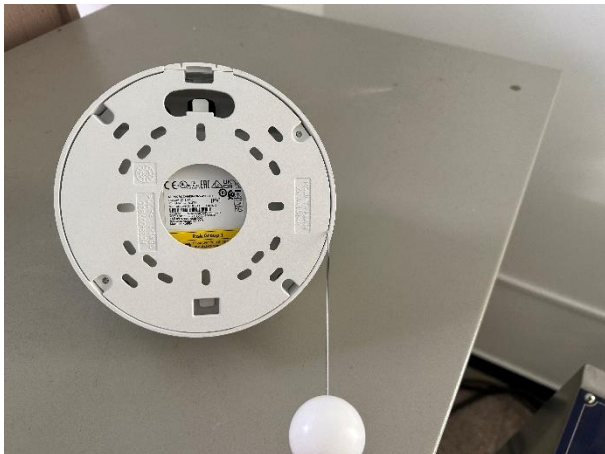
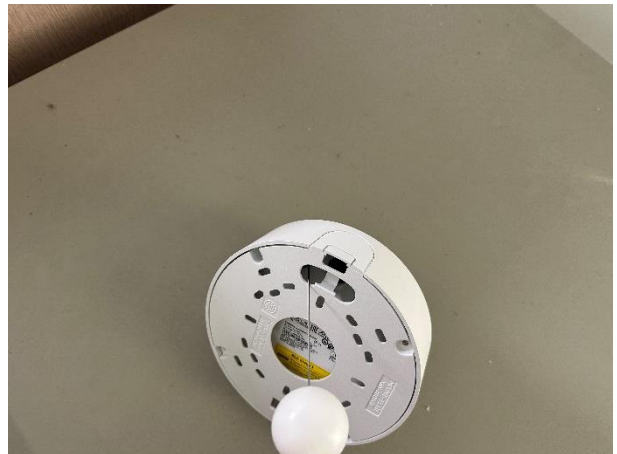
3.3.1 Evidence of test setting (1)

First characteristic numeral	Degree of protection	Application
6	Protected against access to hazardous parts with a wire. The access probe of 1.0 mmØ, shall not penetrate. Test force: 1 N ± 10 %	<input checked="" type="checkbox"/>

Probe test

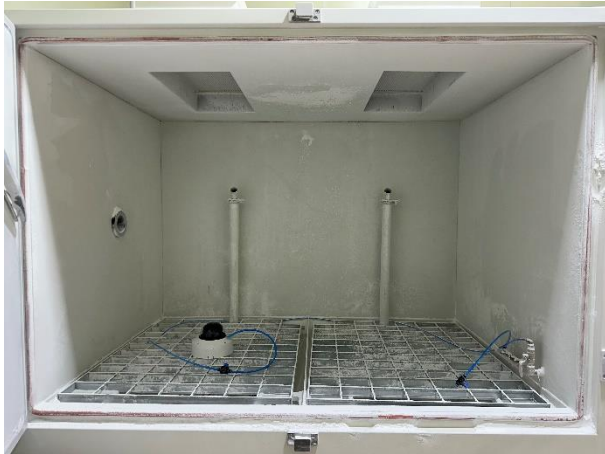
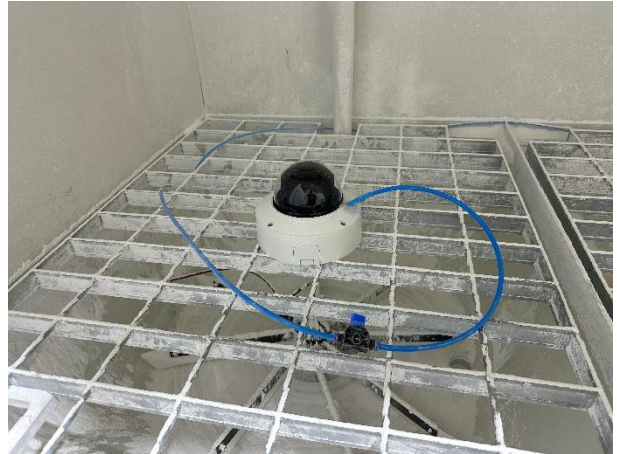
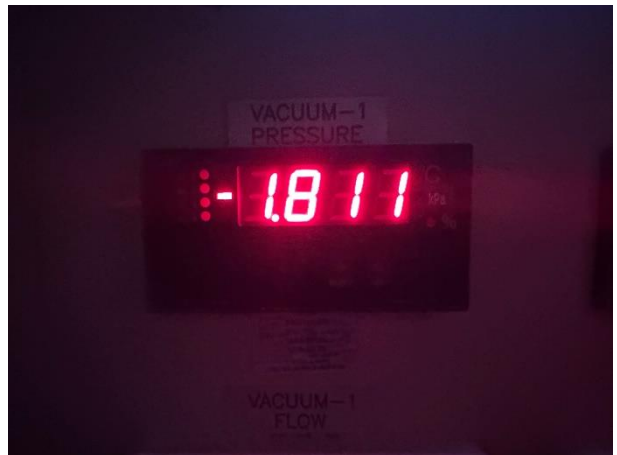
3.3.2 Evidence of test setting (2)

First characteristic numeral	Degree of protection	Application
6	<p>In Dust Testing Equipment, the test sample must have no ingress of dust after testing atmospheric pressure present condition for 8 h.</p> <p>(The talcum powder must pass through a calibrated sieve with a 50 µm wire mesh, spaced at 75 µm intervals in a square pattern. Additionally, the bulk density of the talcum powder should be 2 kg/m³)</p> <p>Products in volume: 3 020.8 cm³ → 3.02 L</p> <p>Target intake volume (Products in volume 80) : 241.66 L</p> <p>Suction volume (Max product in volume 60) ..: 181.25 LPH → 3.02 LPM</p> <p>Actual Suction volume: 3.02 L</p> <p>Suction pressure (Up to 2 kPa): 1.81 kPa</p> <p>Test time (Up to 8 time): 8 hr</p>	<input checked="" type="checkbox"/>

Dust test

Dust test Monitor

Digital Vacuum Pressure
