TEST REPORT

CTK-2024-03180

NETWORK CAMERA / TNO-A26081

IEC 60529:1989 +A1:1999+A2:2013

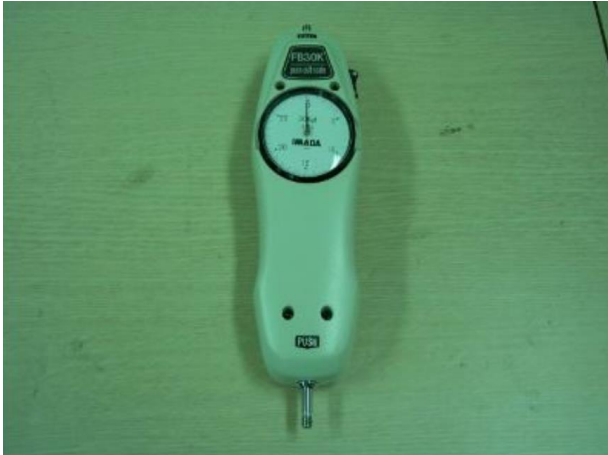
Push Pull Gage

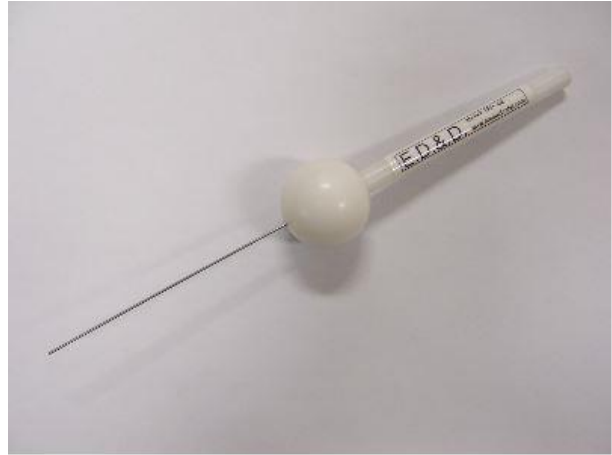
Test Rod Probe Ø1.0

First characteristic numeral	Degree of protection	Application
6	Protected against access to hazardous parts with a wire. The access probe of 1.0 mmØ, shall not penetrate. Test force: 1 N ± 10 %	<input checked="" type="checkbox"/>

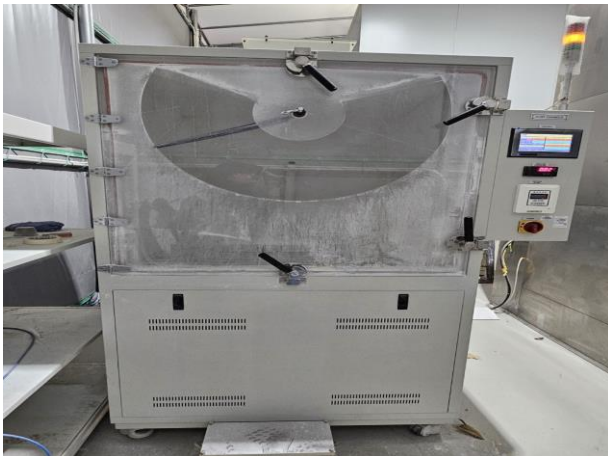
Dust Chamber

First characteristic numeral	Degree of protection	Application
6	<p>In Dust Testing Equipment, the test sample must have no ingress of dust after testing atmospheric pressure present condition for 8 h.</p> <p>(The talcum powder must pass through a calibrated sieve with a 50 µm wire mesh, spaced at 75 µm intervals in a square pattern. Additionally, the bulk density of the talcum powder should be 2 kg/m³)</p> <p>Products in volume: 19 919.28 cm³ → 19.92 L</p> <p>Target intake volume (Products in volume 80): 1 593.54 L</p> <p>Suction volume (Max product in volume 60) ..: 1 195.17 LPH → 19.92 LPM</p> <p>Actual Suction volume: 19.92 L</p> <p>Suction pressure (Up to 2 kPa): 1.73 kPa</p> <p>Test time (Up to 8 time): 8 hr</p>	<input checked="" type="checkbox"/>
¹⁾ The full diameter of the object probe shall not pass through an opening of the enclosure. Due to the simultaneous requirement specified in table 2, the definition “shall not penetrate” is given in table 1.

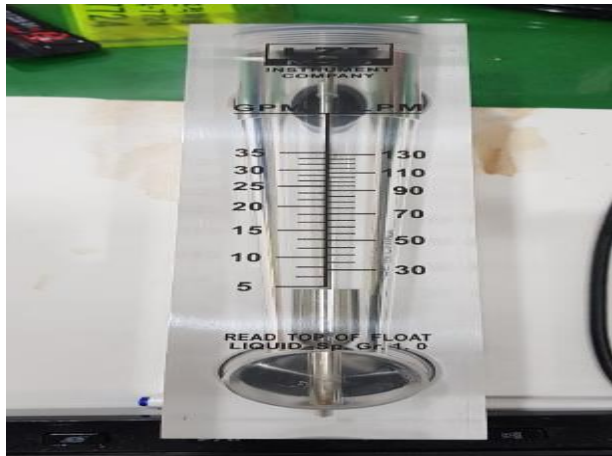
Water flow meter with IPX6

Second characteristic numeral	Degrees of protection	Application
6	<p>The product must not be harmed in any direction even strong jet water.</p> <p>Water jet hose nozzle Fig.6, Nozzle 12.5 mm diameter</p> <p>Water flow rate: 100 l/min ± 5 % : 100 LPM</p> <p>Distance: 2.5 m to 3 m: 3 m</p> <p>Duration of test: 1 min/m² at least 3 min: 3 min</p>	<input checked="" type="checkbox"/>

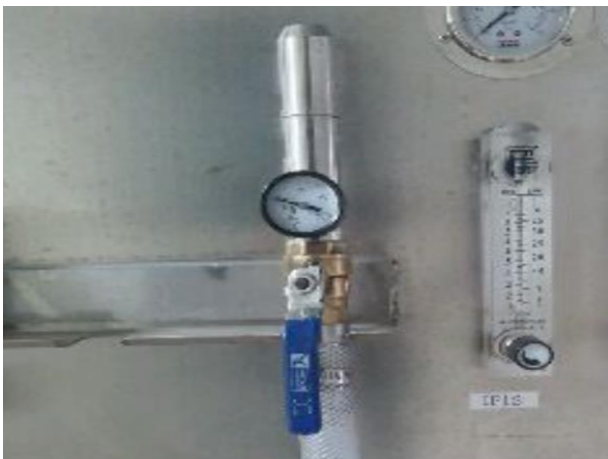
Hose Nozzle (12.5 mm)

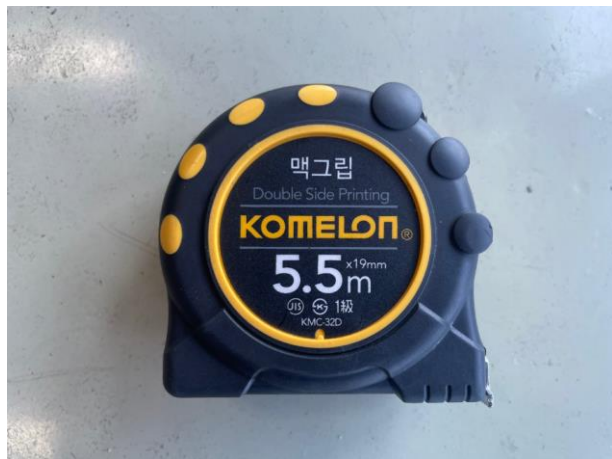
Steel measuring meter

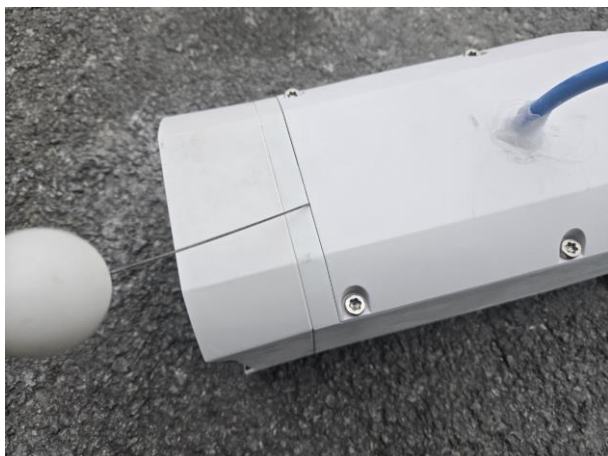
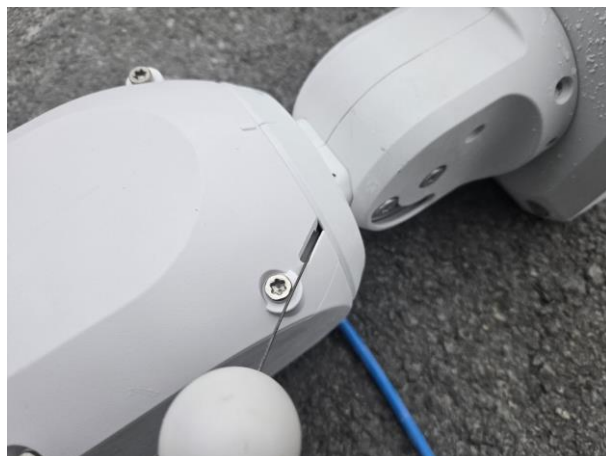
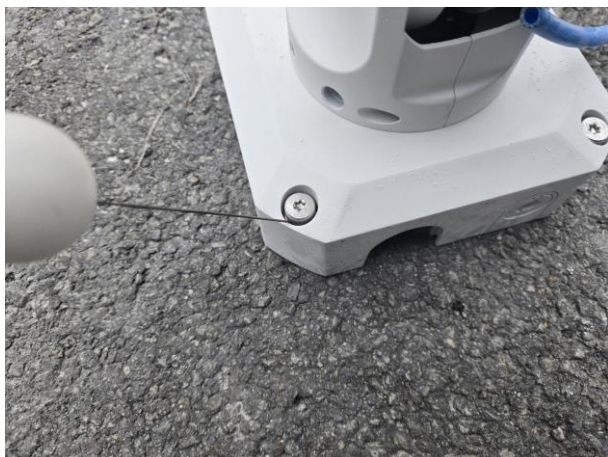
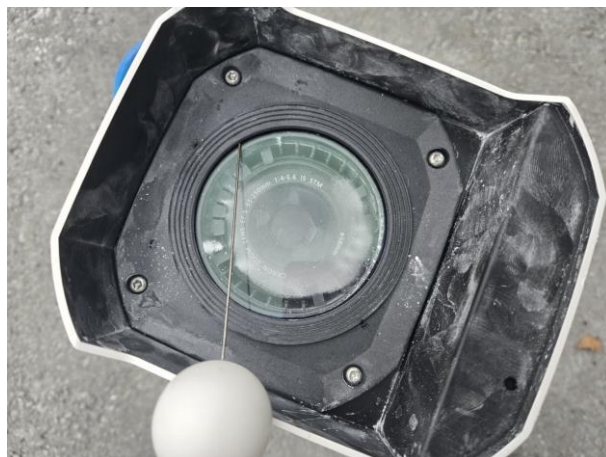
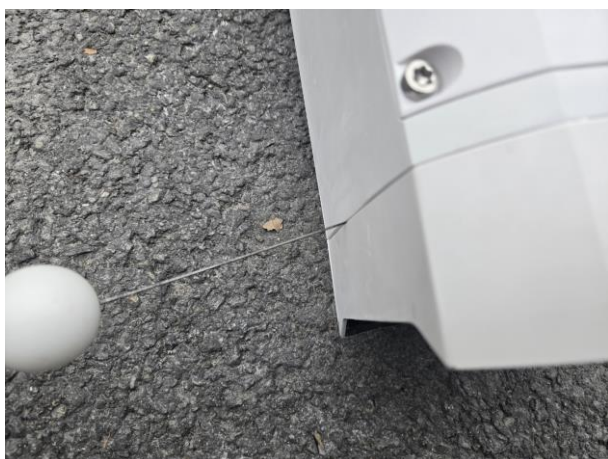
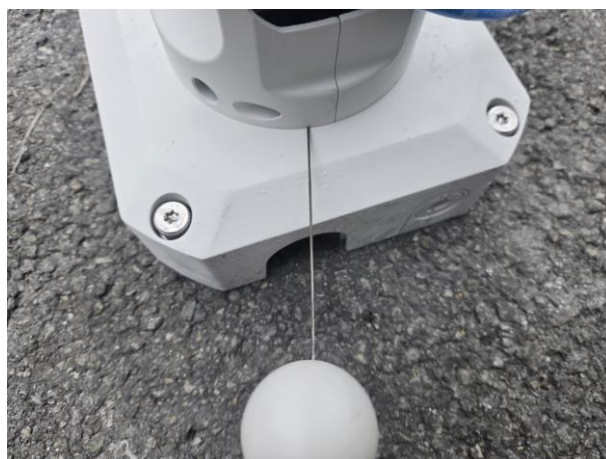
Probe test

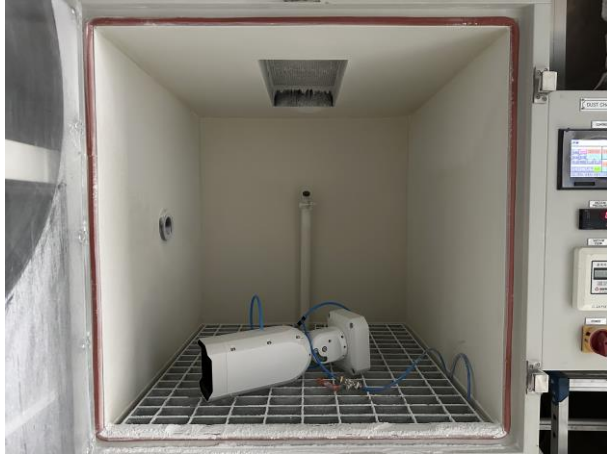
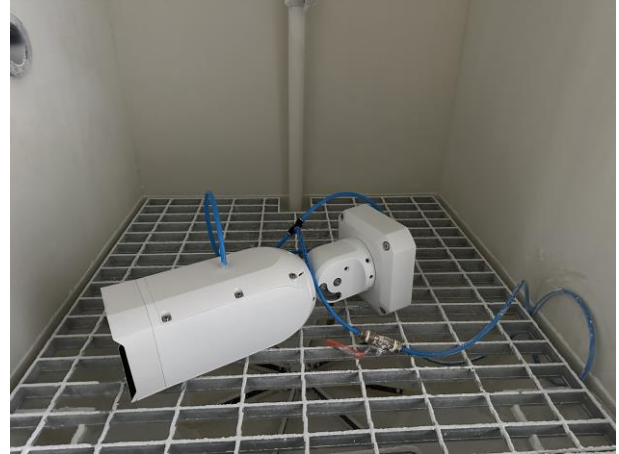
Dust test

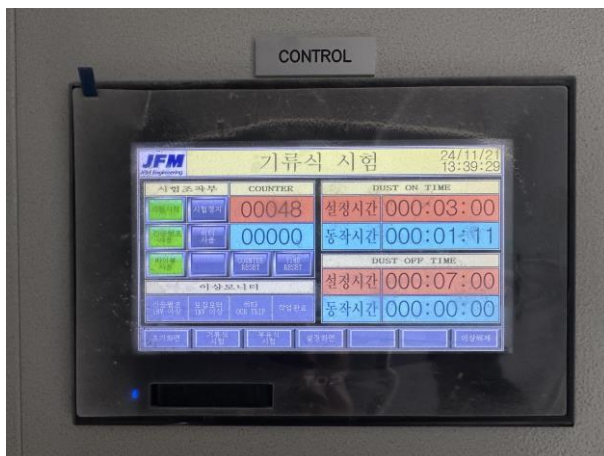
Dust test Monitor

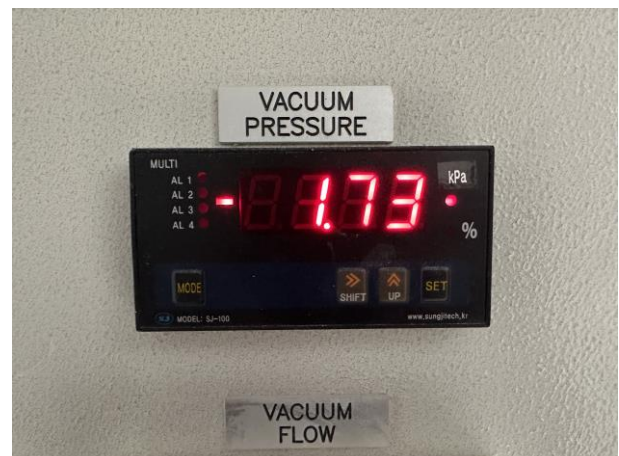
Digital Vacuum Pressure

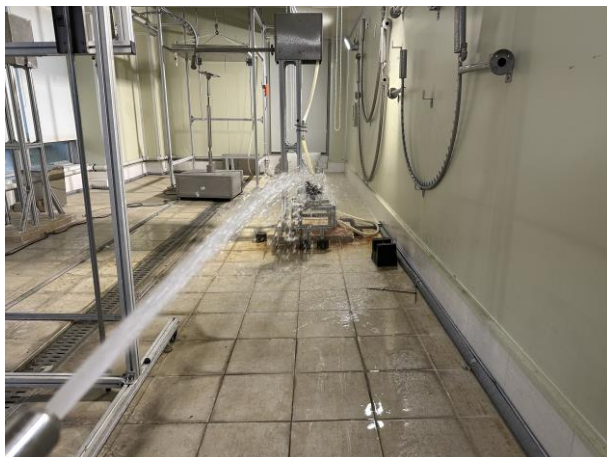
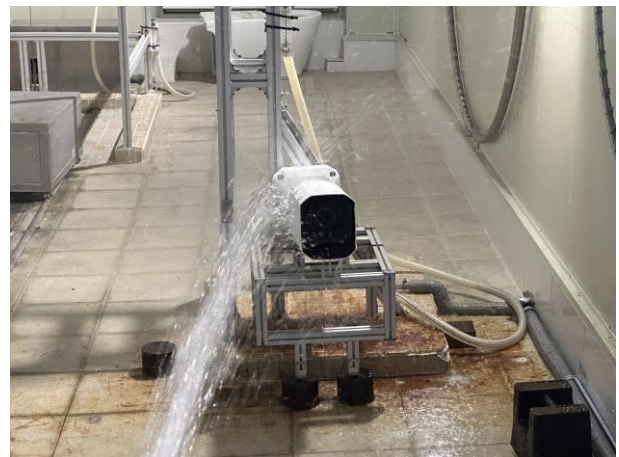
Water test

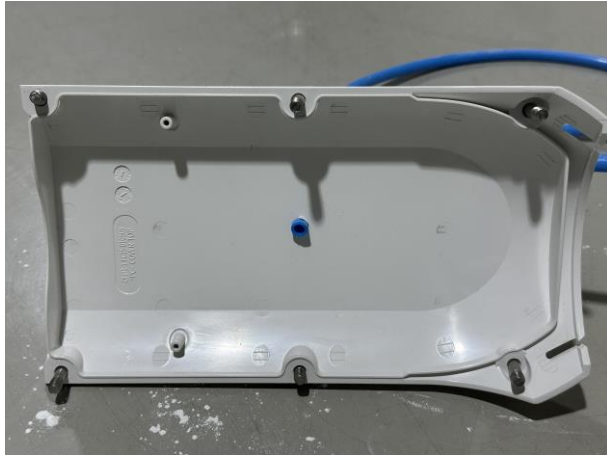
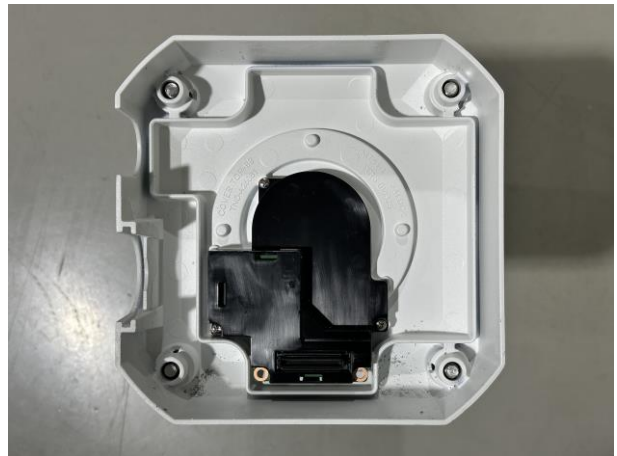
4.2.1 Product internal images after test [The first characteristic numeral test]

IP code	Evaluation Criteria	Test Results	Remark
IP 6X	No ingress of water	Normal	-
	No ingress of dust	Normal	
IP X6	No ingress of water	Normal

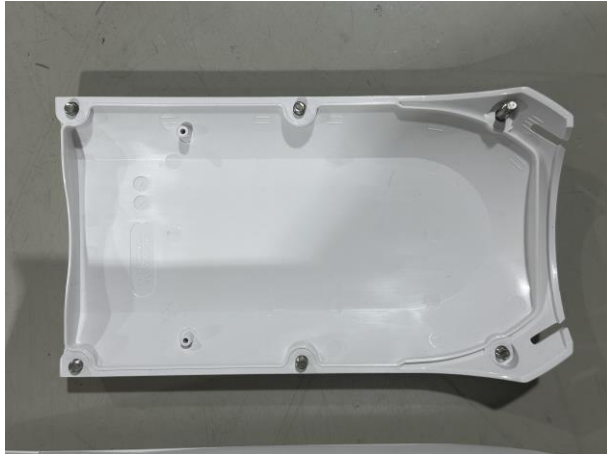
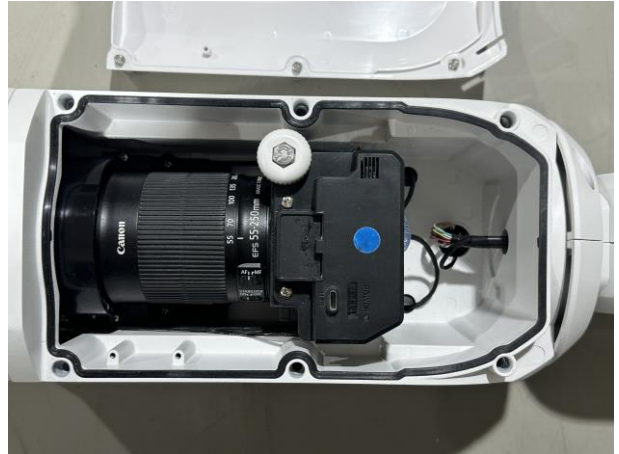
4.2.2 Product internal images after test [The second characteristic numeral test]
